WINDHAM STREET BRIDGE

Site Number 000010

WINDHAM STREET, SIMCOE

Ontario Structure Inspection Manual - Inspection Form

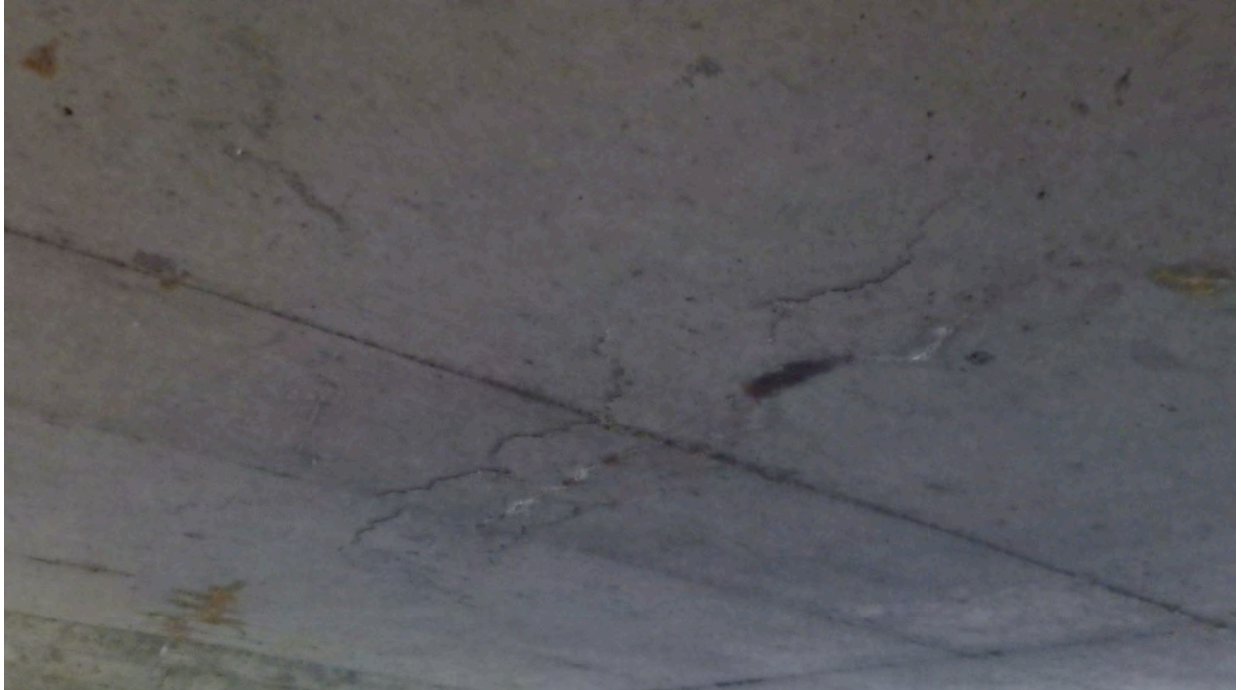
Figure 8 Crack on Culvert Soffit

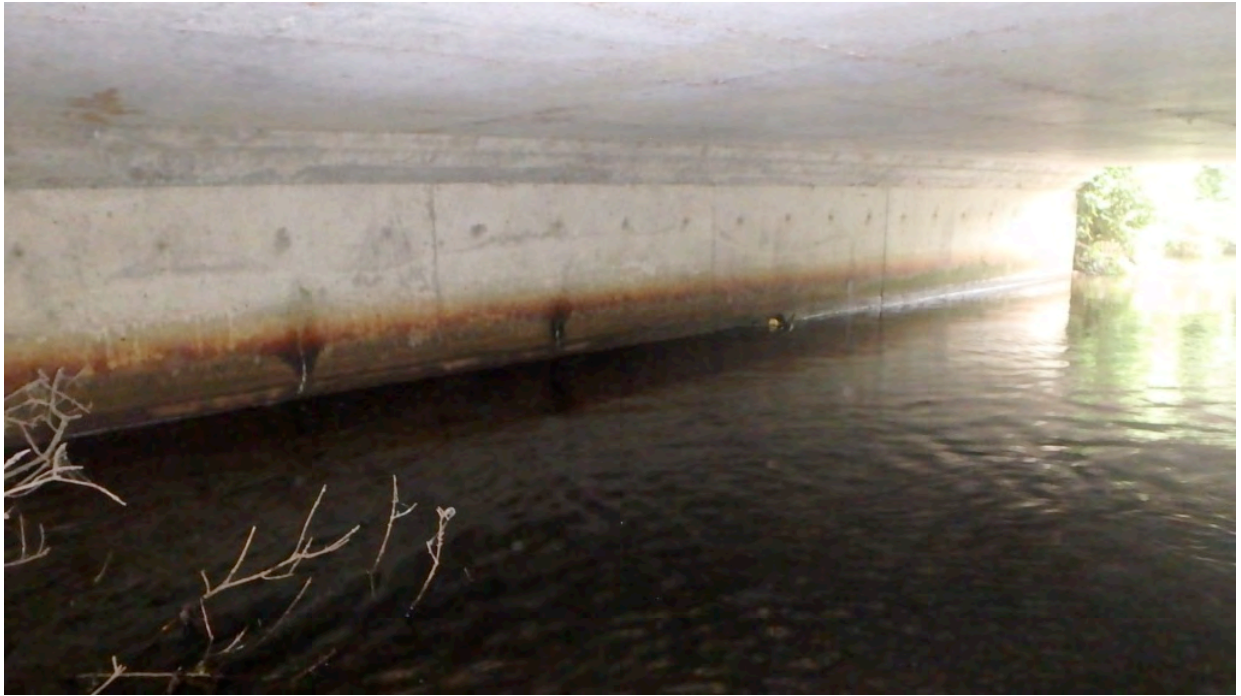
Figure 9 Staining on Culvert Walls at Waterline

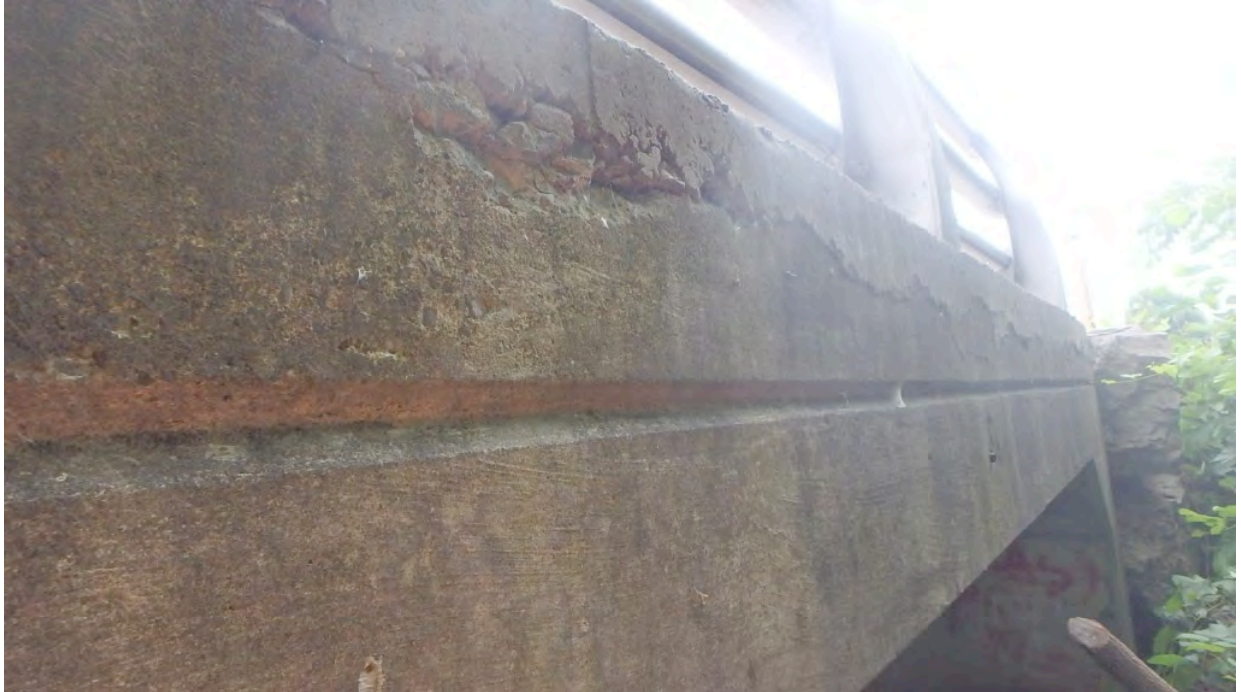
Figure 10 Spall at Construction Joint

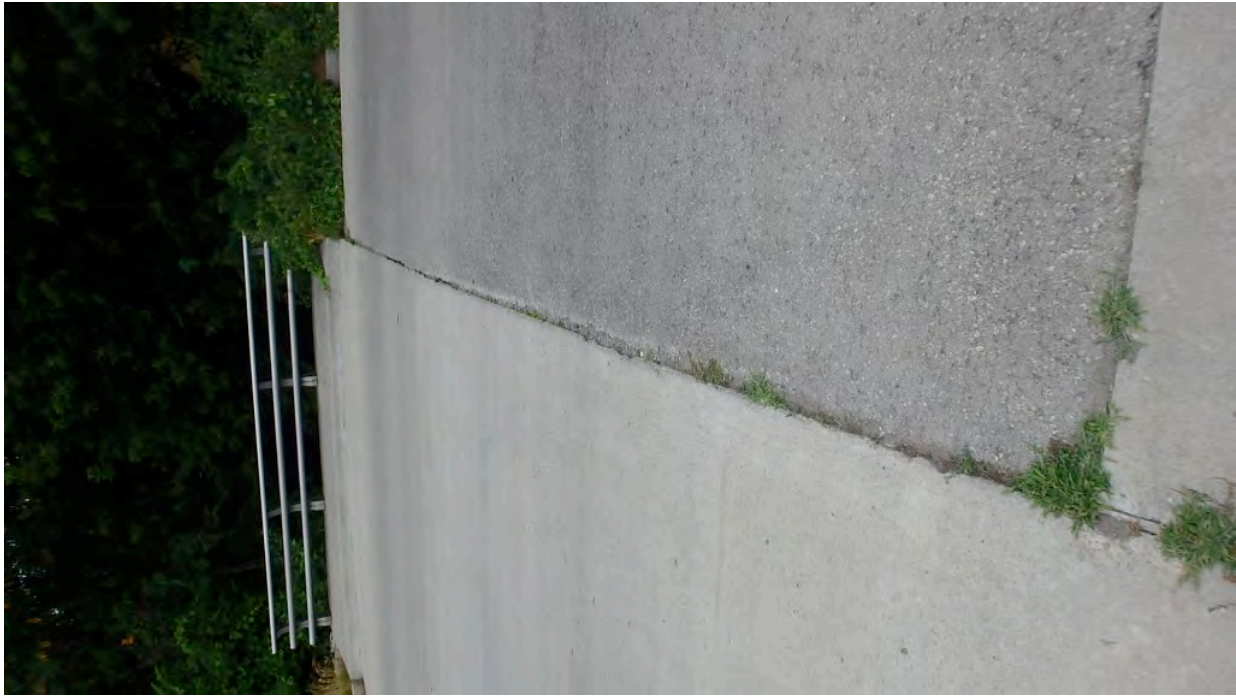
Figure 11 Asphalt Approach Slightly Lower than Concrete Deck

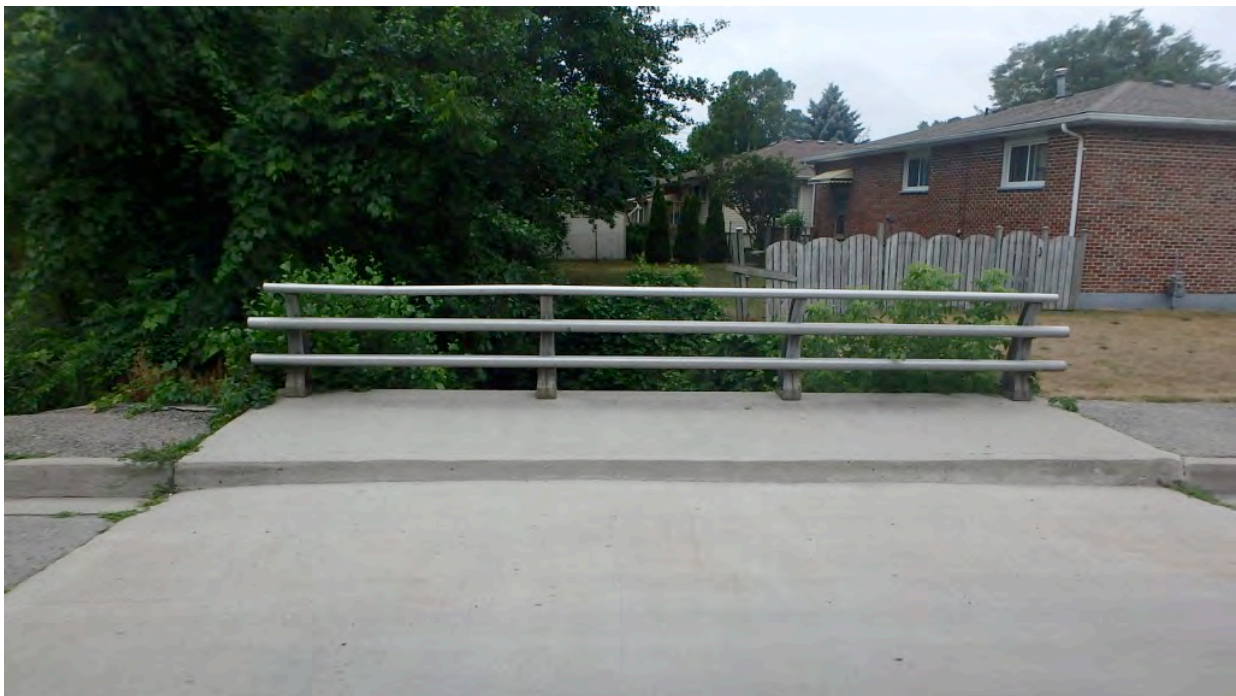
Figure 12 Slight Bend in Top Rail of North Barrier

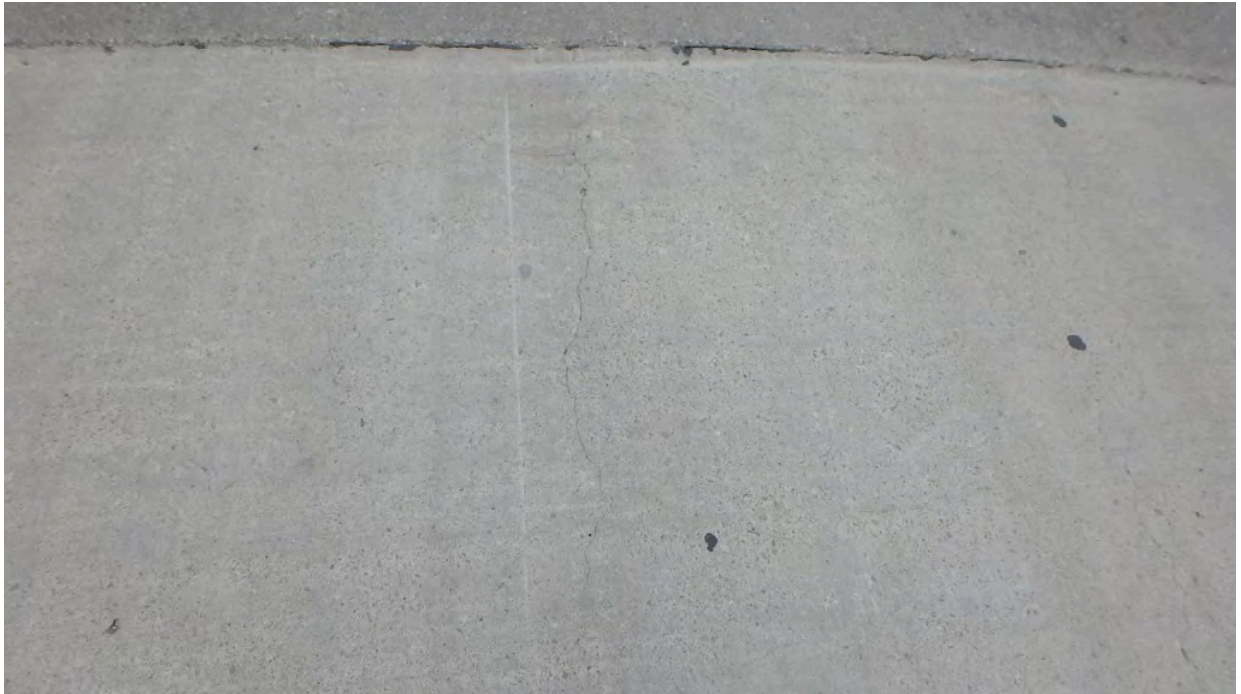
Figure 13 Longitudinal Crack in Concrete Deck Wearing Surface

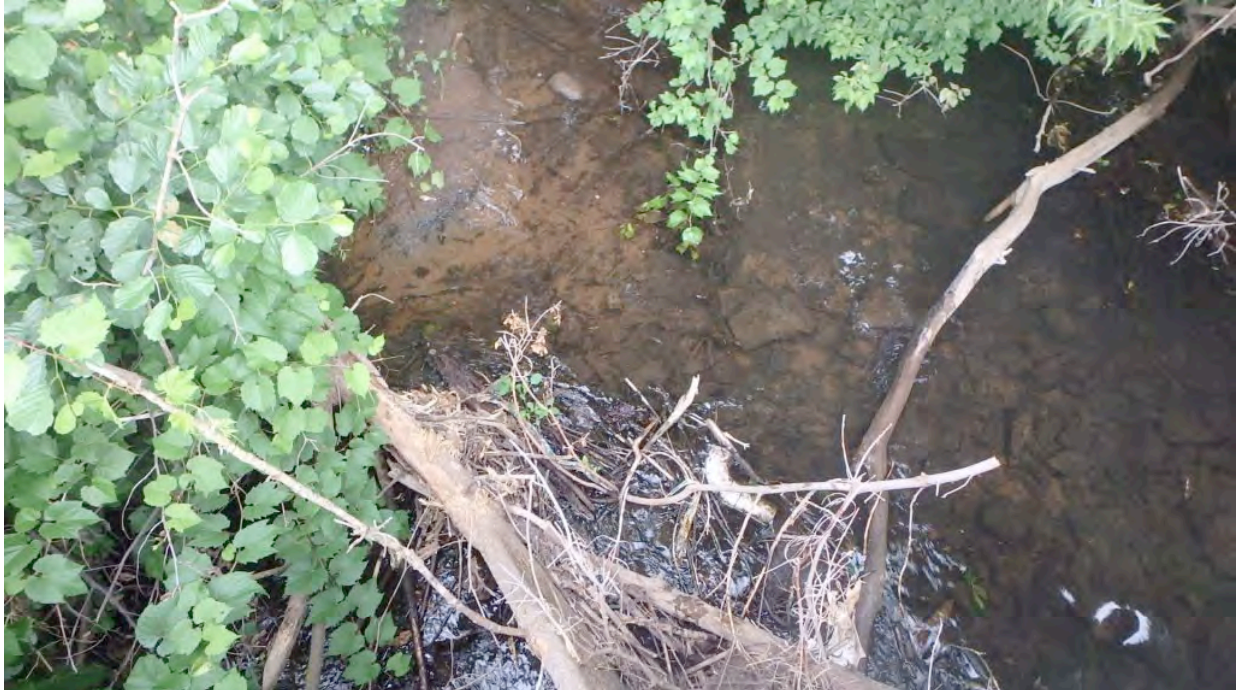
Figure 14 Debris at Outlet
