VENISON CREEK BRIDGE

Site Number 000103

TROYER ROAD, SOUTH WALSINGHAM

Ontario Structure Inspection Manual - Inspection Form

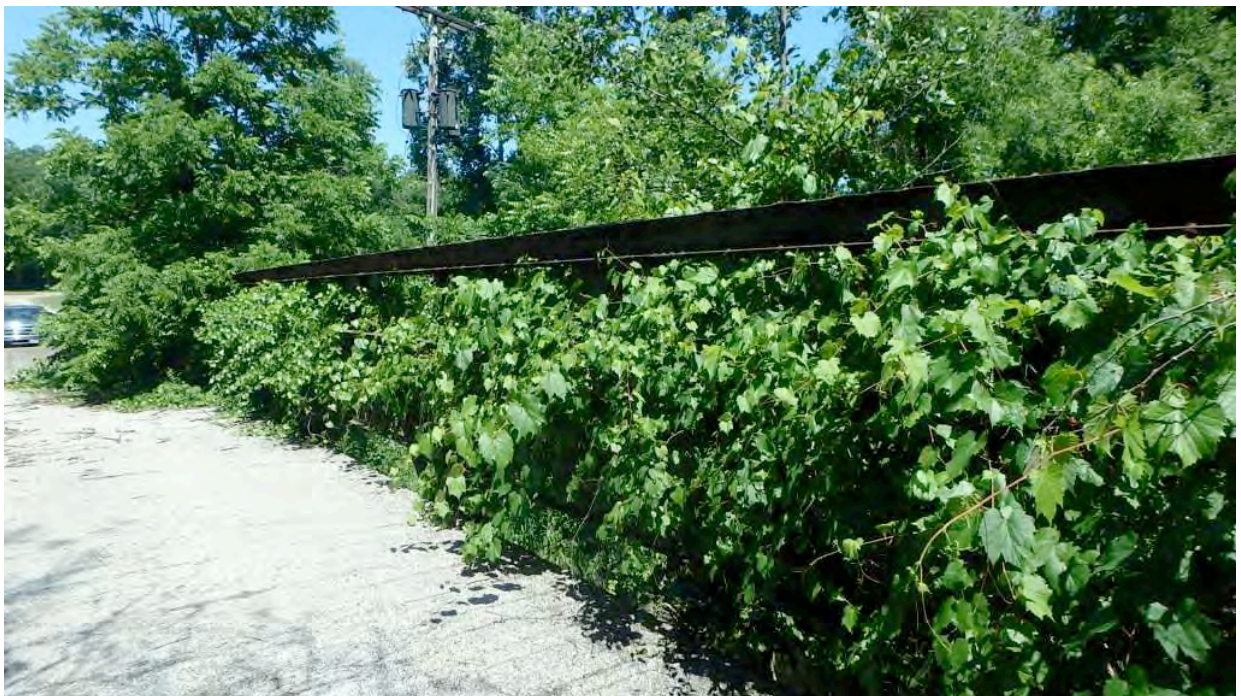
Figure 6 South Truss Overgrown

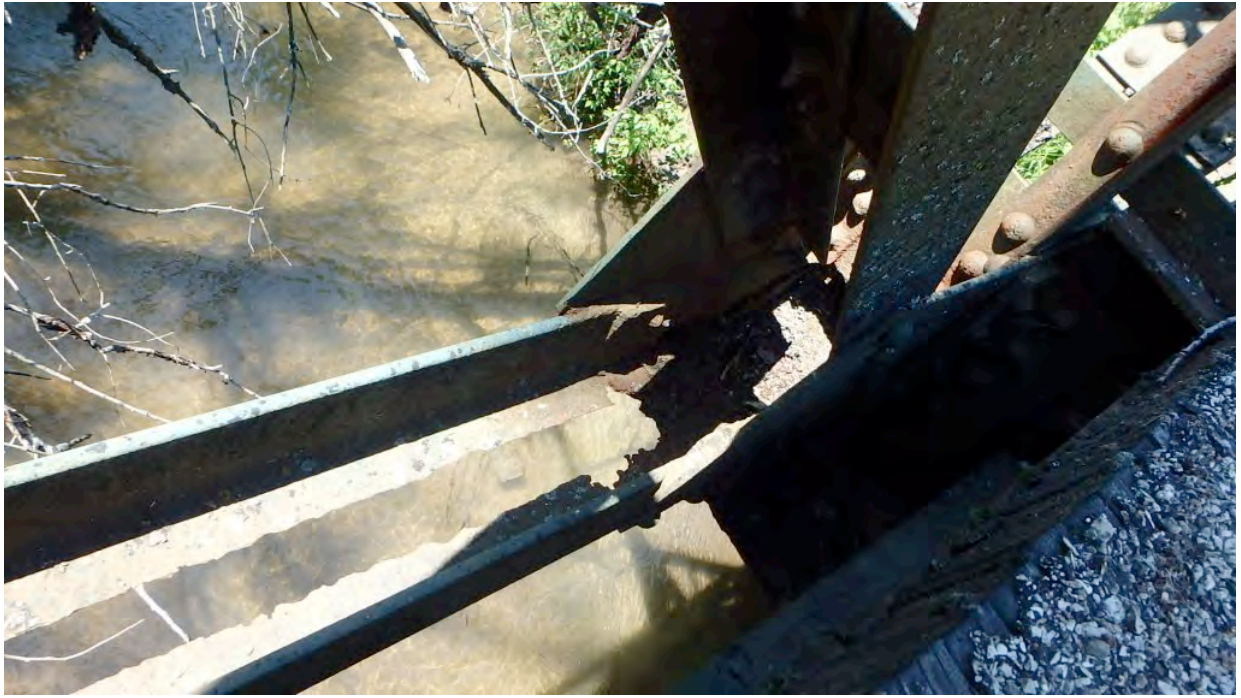
Element Group:		600 Trusses/Arches				Length:	21.8
Element Name:		602 Bottom Chords				Width:	
Location:						Height:	
Material:		14 Steel				Count:	2
Element Type:						Total Quantity:	43.6 m
Environment:		Severe				Limited Inspection:	
Protection System:		Unknown				Perform. Deficiencies	
Condition	Units	Exc.	Good	Fair	Poor	Load Carrying Capacity	
Data:	m	0	0	0	43.6		
Comments: Load posted 12 tonnes. Road closed. Corroded with section loss up to 100% through on several areas - estimate 50% loss. Evaluation recommended.							
Recommended Work: Rehab <input type="checkbox"/> Replace <input checked="" type="checkbox"/>				Maintenance Needs: Repair to Structural Steel			
Timing: Urgent <input checked="" type="checkbox"/> < 1yr <input type="checkbox"/> 1 - 5 yr <input type="checkbox"/> 6 - 10 yr <input type="checkbox"/>				<input type="checkbox"/> Urgent <input type="checkbox"/> 1 year <input checked="" type="checkbox"/> 2 year

Figure 7 Severe Corrosion of Bottom Chord

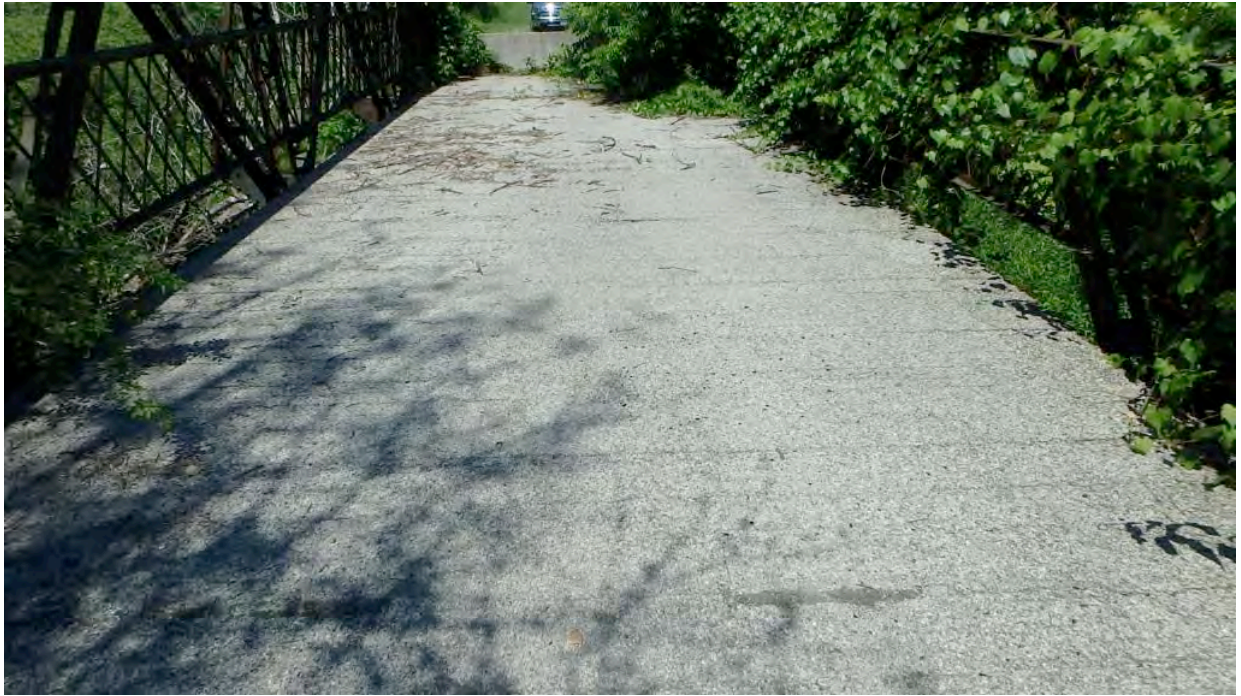
Figure 9 Deck

Element Group:		100 Decks				Length:	21.8
Element Name:		102 Deck Top				Width:	4.9
Location:		Top of Deck				Height:	
Material:		18 Wood				Count:	1
Element Type:		Laminated wood decking - transverse				Total Quantity:	106.8 sq.m
Environment:		Severe				Limited Inspection:	
Protection System:		Other type of waterproofing				Perform. Deficiencies	
Condition Data:	Units sq.m	Exc. 0	Good 0	Fair 106.8	Poor 0		
Comments: Leaks into beams. DST evident.							
Recommended Work:				Rehab <input checked="" type="checkbox"/> Replace <input type="checkbox"/>		Maintenance Needs: Concrete Sealing	
Timing:				Urgent <input type="checkbox"/> < 1yr <input type="checkbox"/> 1 - 5 yr <input checked="" type="checkbox"/> 6 - 10 yr <input type="checkbox"/>		<input type="checkbox"/> Urgent <input type="checkbox"/> 1 year <input checked="" type="checkbox"/> 2 year
