13TH STREET WEST ARCH

Site Number 000018

CONCESSION 13 ROAD, SIMCOE

Ontario Structure Inspection Manual - Inspection Form

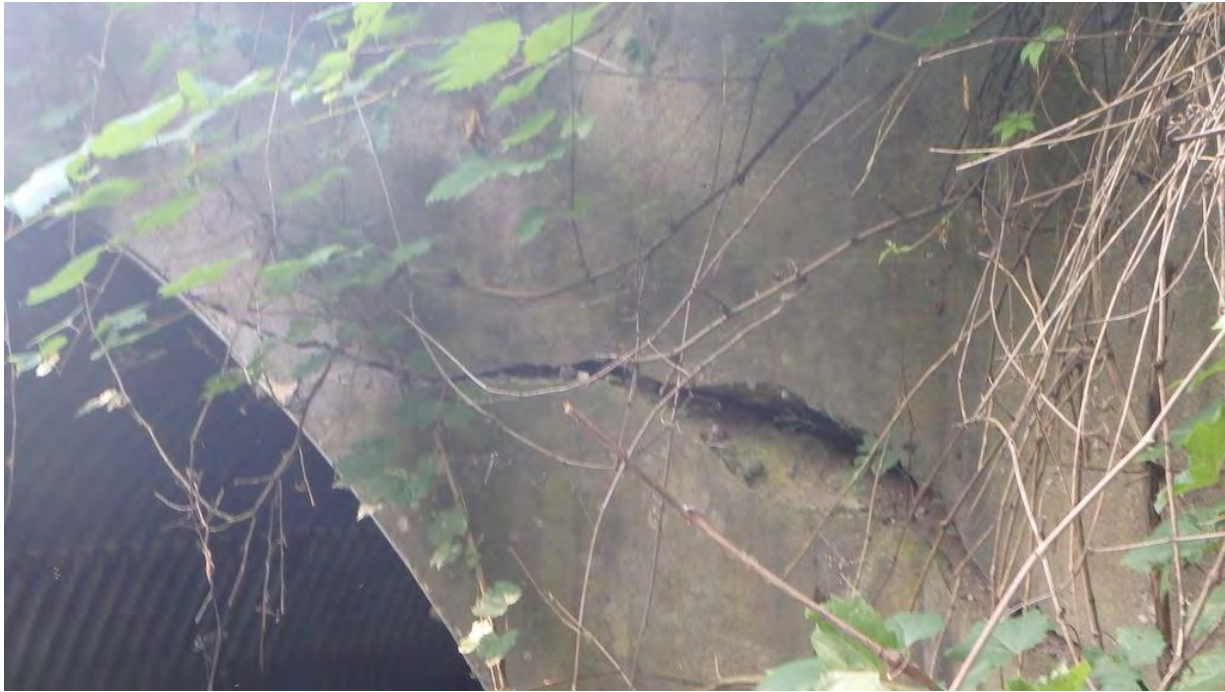
Figure 9 Large Crack in North Fascia

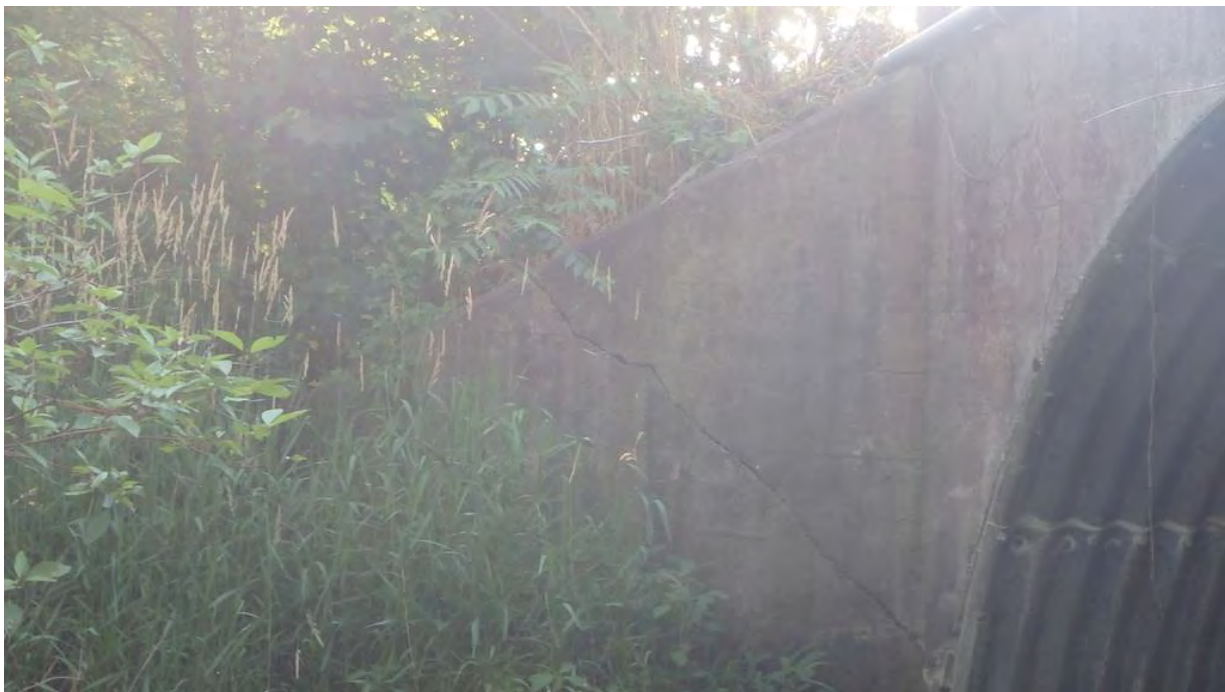
Additional Investigation Required:	Priority		
	None	Normal	Urgent
Material Condition Survey			
<input checked="" type="checkbox"/> Detailed Deck Condition Survey:		X	
<input checked="" type="checkbox"/> Non-destructive Delamination Survey of Asphalt-Covered Deck:	X		
<input checked="" type="checkbox"/> Concrete Substructure Condition Survey:	X		
<input checked="" type="checkbox"/> Detailed Coating Condition Survey:	X		
<input checked="" type="checkbox"/> Detailed Timber Investigation	X		
<input checked="" type="checkbox"/> Post-Tensioned Strand Investigation	X		
Underwater Investigation:	X		
Fatigue Investigation:	X		
Seismic Investigation:	X		
Structure Evaluation:	X		
Monitoring			
<input checked="" type="checkbox"/> Monitoring of Deformations, Settlements and Movements:	X		
<input checked="" type="checkbox"/> Monitoring Crack Widths:	X		
Investigation Notes:	Wingwall deterioration severe. Cracking, delamination and spalling.

Figure 10 Large Crack in Northeast Wingwall

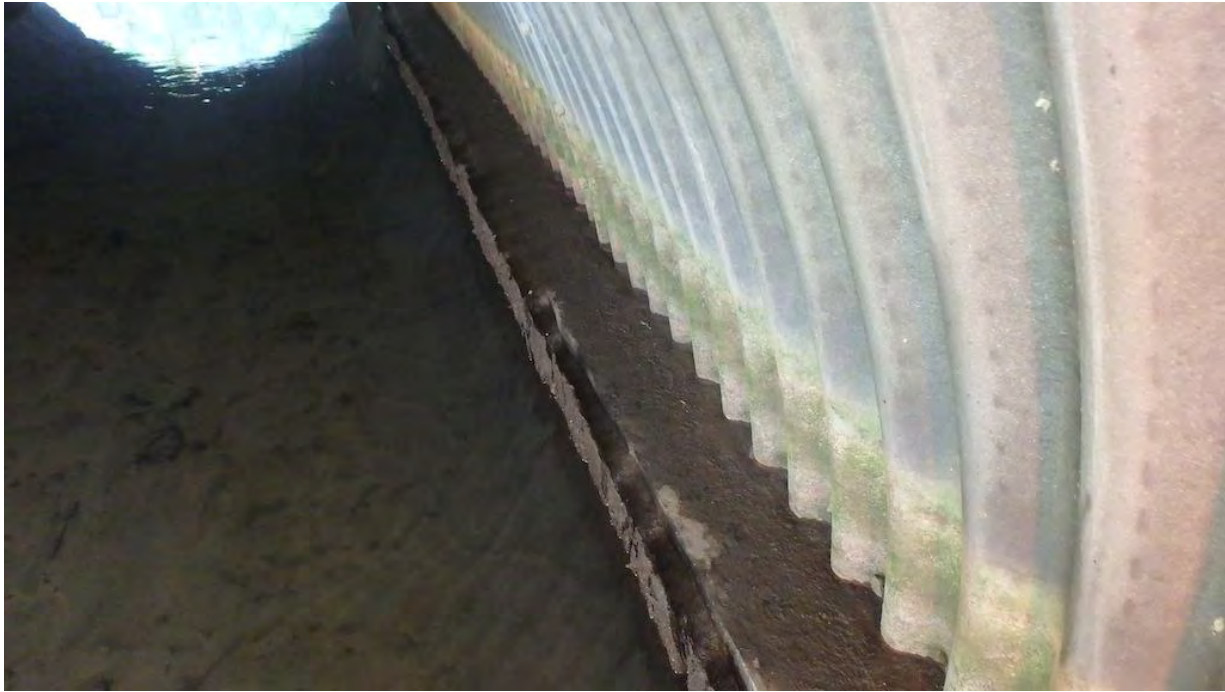
Figure 11 Typical Corrosion at Waterline in Barrel

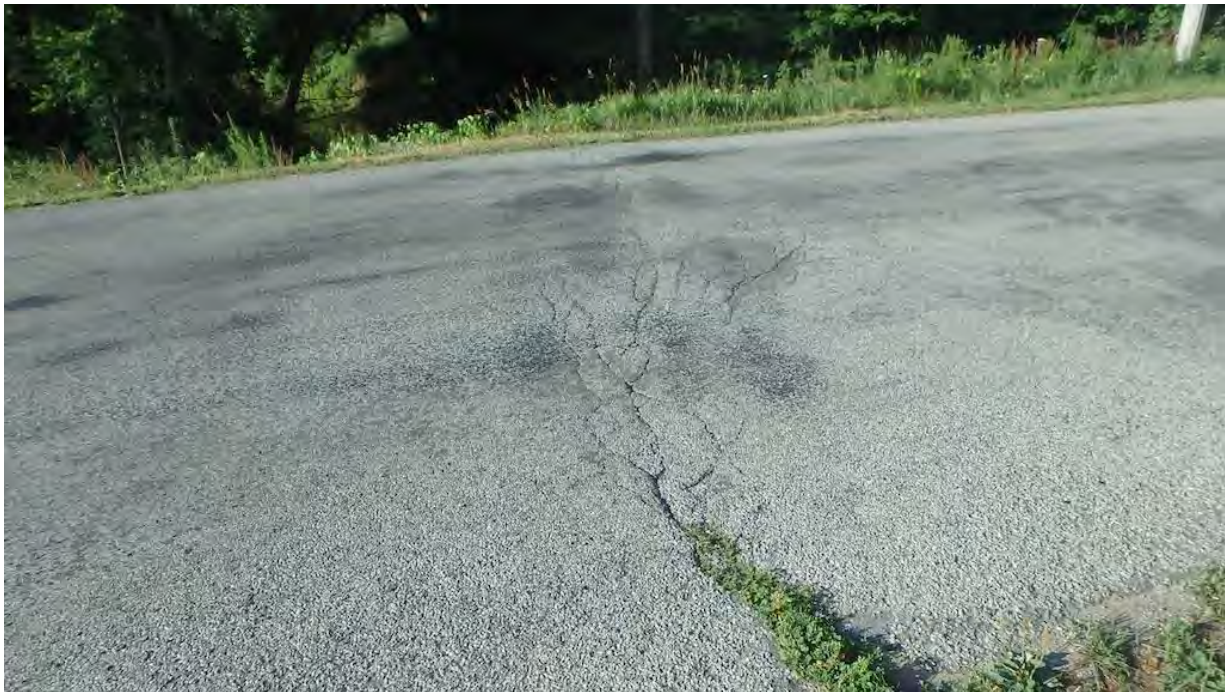
Figure 12 Transverse Cracking in Wearing Surface
