WINDHAM EAST ¼ LINE BRIDGE

Site Number 000019

WINDHAM EAST ¼ LINE ROAD, SIMCOE

Ontario Structure Inspection Manual - Inspection Form

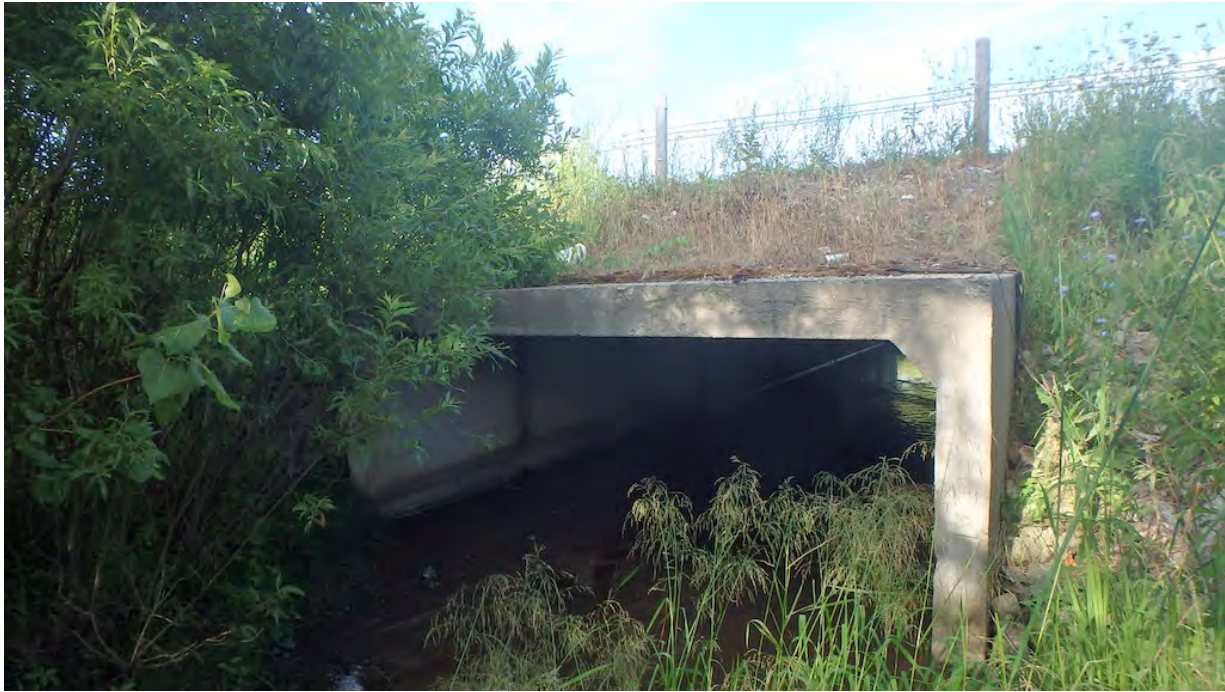
Figure 3 East Profile, Outlet

Element Group:		1200 Culverts				Length:	2
Element Name:		1202 Outlet Components				Width:	4
Location:		East				Height:	0.8
Material:						Count:	1
Element Type:						Total Quantity:	6.4 sq.m
Environment:		Moderate				Limited Inspection:	
Protection System:		Unknown				Perform. Deficiencies	
Condition	Units	Exc.	Good	Fair	Poor		
Data:	sq.m	0	6.4	0	0		
Comments:							
Some riprap at outfall to protect from scour. Cut off wall below floor for protection.							
Recommended Work: Rehab <input type="checkbox"/> Replace <input type="checkbox"/>						Maintenance Needs:	
Timing: Urgent <input type="checkbox"/> < 1yr <input type="checkbox"/> 1 - 5 yr <input type="checkbox"/> 6 - 10 yr <input type="checkbox"/>						<input type="checkbox"/> Urgent <input type="checkbox"/> 1 year <input type="checkbox"/> 2 year

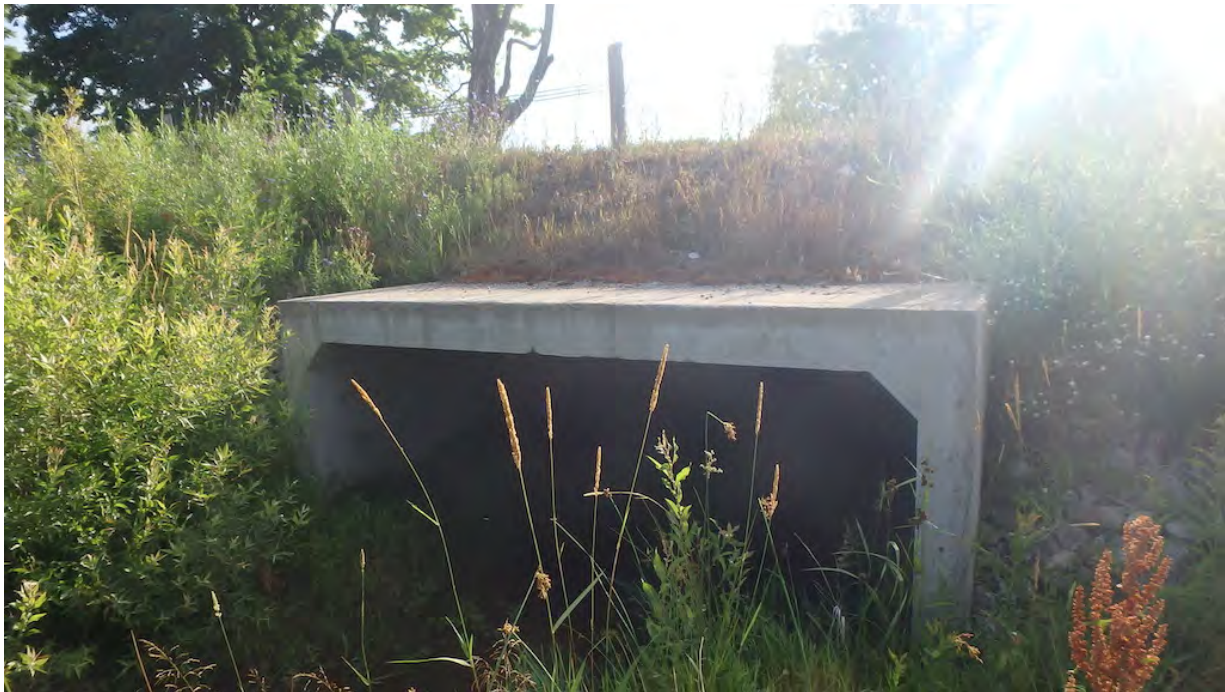
Figure 4 West Profile, Inlet

Element Group:		1200 Culverts				Length:	2
Element Name:		1201 Inlet Components				Width:	4
Location:		West				Height:	0.8
Material:						Count:	1
Element Type:						Total Quantity:	6.4 Each
Environment:		Moderate				Limited Inspection:	
Protection System:		Unknown				Perform. Deficiencies	
Condition	Units	Exc.	Good	Fair	Poor		
Data:	Each	0	6.4	0	0		
Comments:							
Recommended Work: Rehab <input type="checkbox"/> Replace <input type="checkbox"/>						Maintenance Needs:	
Timing: Urgent <input type="checkbox"/> < 1yr <input type="checkbox"/> 1 - 5 yr <input type="checkbox"/> 6 - 10 yr <input type="checkbox"/>						<input type="checkbox"/> Urgent <input type="checkbox"/> 1 year <input type="checkbox"/> 2 year

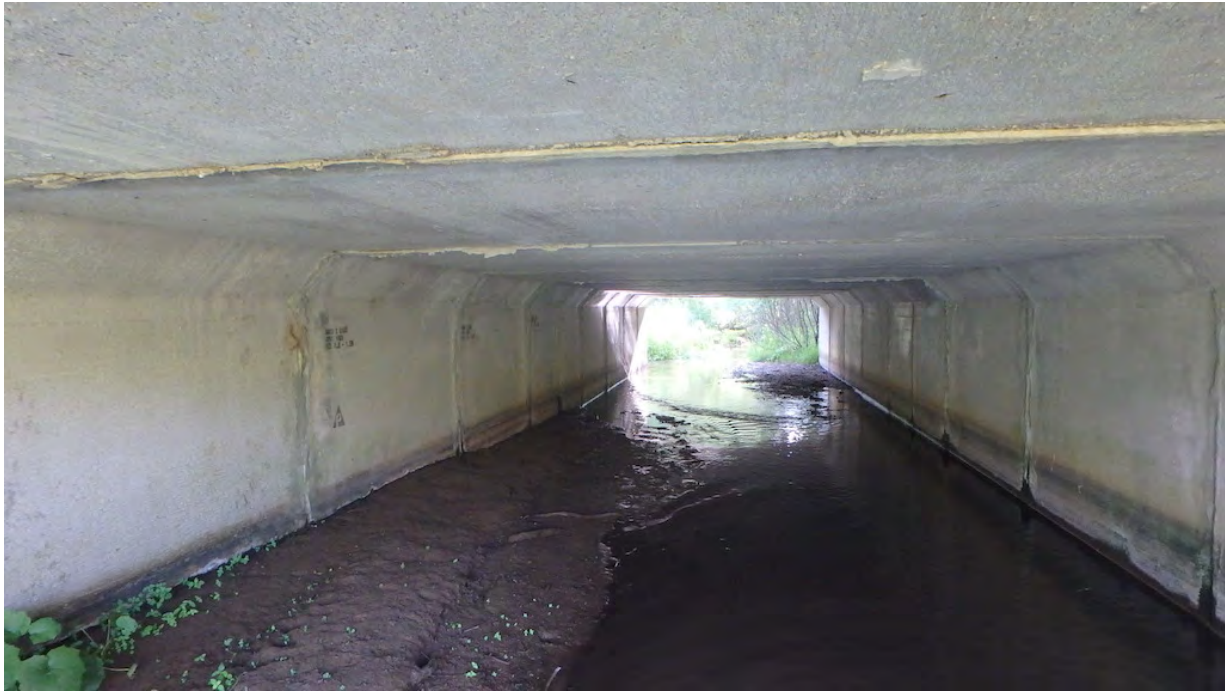
Figure 7 Barrel

Element Group:		1200 Culverts				Length:		
Element Name:		1203 Barrels				Width:		
Location:		North and South				Height:		
Material:		4 Cast-in-place Concrete				Count:		1
Element Type:						Total Quantity:		1 Each
Environment:		Moderate				Limited Inspection:		
Protection System:		Unknown				Perform. Deficiencies		
Condition	Units	Exc.	Good	Fair	Poor			
Data:	Each	0	1	0	0			
Comments: Joint parging deterioration. No leaks. Staining at water level.								
Recommended Work: Rehab <input type="checkbox"/> Replace <input type="checkbox"/>				Maintenance Needs:				
Timing: Urgent <input type="checkbox"/> < 1yr <input type="checkbox"/> 1 - 5 yr <input type="checkbox"/> 6 - 10 yr <input type="checkbox"/>				<input type="checkbox"/> Urgent <input type="checkbox"/> 1 year <input type="checkbox"/> 2 year

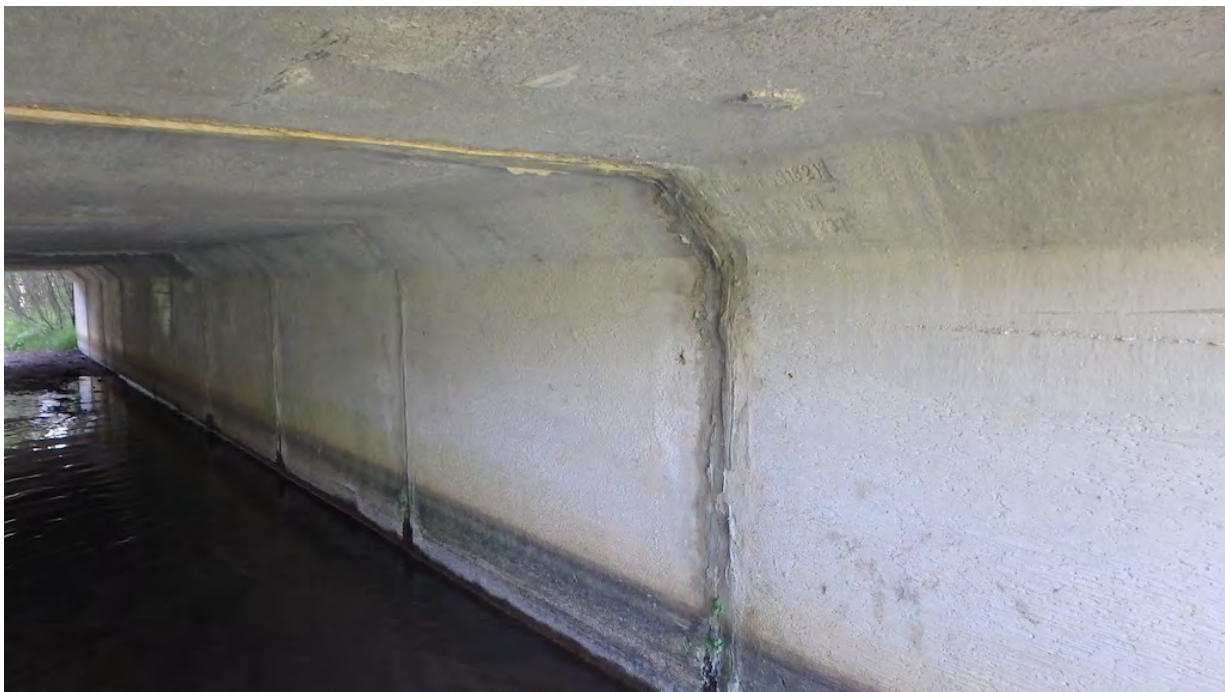
Structure Evaluation:	<input checked="" type="checkbox"/>		
Monitoring			
<input checked="" type="checkbox"/> Monitoring of Deformations, Settlements and Movements:	<input checked="" type="checkbox"/>		
<input checked="" type="checkbox"/> Monitoring Crack Widths:	<input checked="" type="checkbox"/>		
Investigation Notes:			
Deterioration of joint parging within culvert on soffit. Maintenance.

Figure 8 Typical Cracking and Deterioration of Parging at Joint

Overall Structure Notes:	
Recommended Work on Structure:	<input type="checkbox"/> None <input type="checkbox"/> Minor Rehab. <input type="checkbox"/> Replace <input checked="" type="checkbox"/> Maintenance <input type="checkbox"/> Major Rehab.
Timing of Recommended Work:	<input type="checkbox"/> 1 to 5 years <input type="checkbox"/> 6 to 10 years
Overall Comments:	Maint. repair to be made within a year.
Date of next Inspection:	July 11, 2018

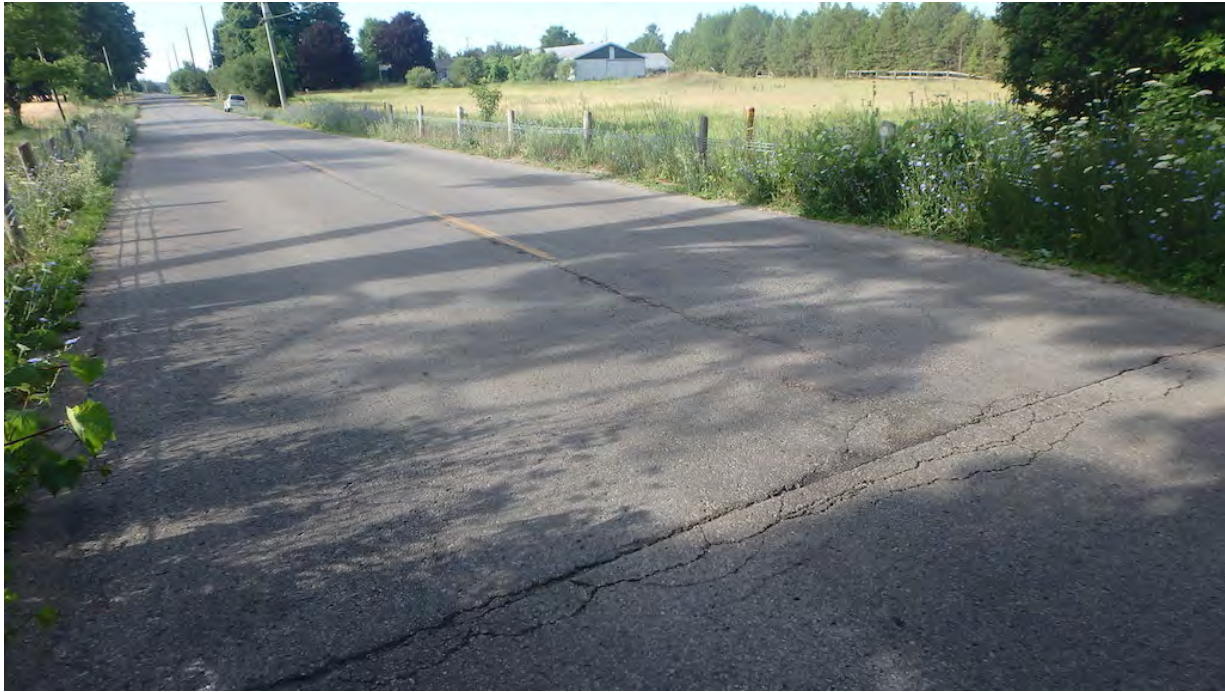
Element Group:		1600 Approaches				Length:		
Element Name:		1601 Wearing Surface (Approaches)				Width:		
Location:		On Fill / Deck				Height:		
Material:		2 Asphalt				Count:		1
Element Type:						Total Quantity:		1 Each
Environment:		Severe				Limited Inspection:		
Protection System:		Unknown				Perform. Deficiencies		
Condition	Units	Exc.	Good	Fair	Poor			
Data:	Each	0	0.9	0.1	0			
Comments: Surface in good condition. Centerline crack and transverse cracks at both approaches in wearing surface.								
Recommended Work: Rehab <input type="checkbox"/> Replace <input type="checkbox"/>				Maintenance Needs: Rout and Seal				
Timing: Urgent <input type="checkbox"/> < 1yr <input type="checkbox"/> 1 - 5 yr <input type="checkbox"/> 6 - 10 yr <input type="checkbox"/>				<input type="checkbox"/> Urgent <input type="checkbox"/> 1 year <input checked="" type="checkbox"/> 2 year

Figure 9 Transverse and Longitudinal Cracking in Wearing Surface
