NORFOLK STREET SOUTH BRIDGE

Site Number 000021

NORFOLK STREET SOUTH, SIMCOE

Ontario Structure Inspection Manual - Inspection Form

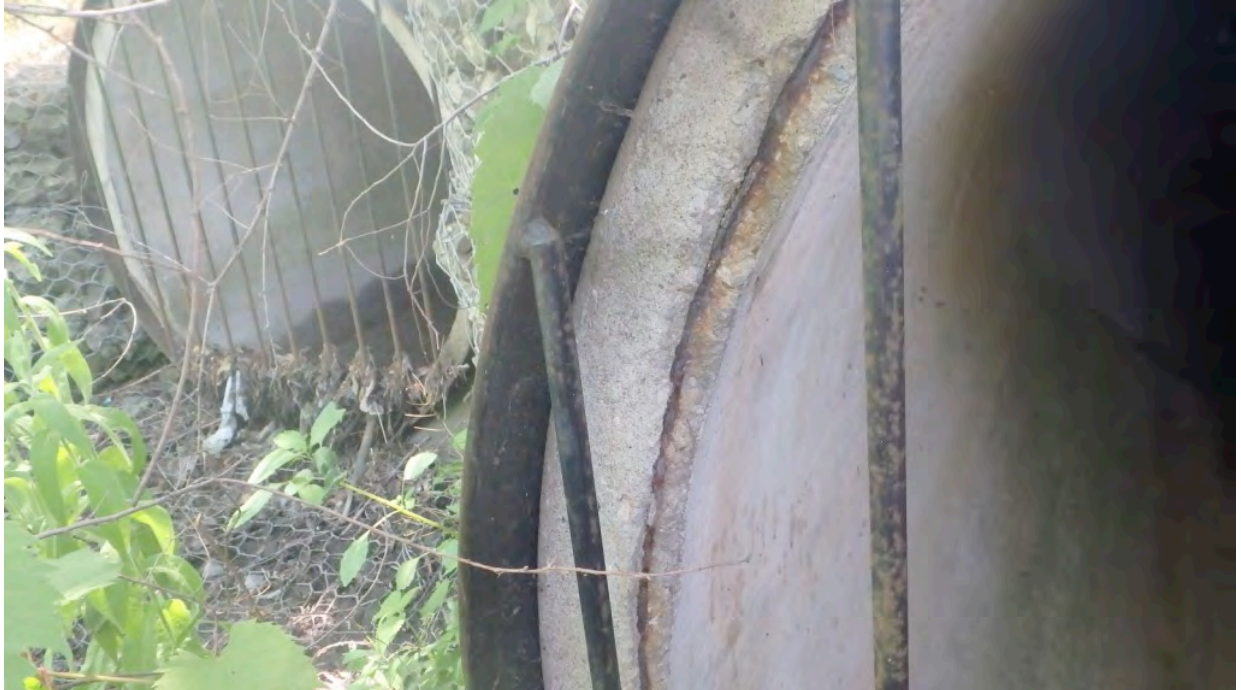
Figure 8 Small Spalling with Exposed Rebar on Pipe Exterior

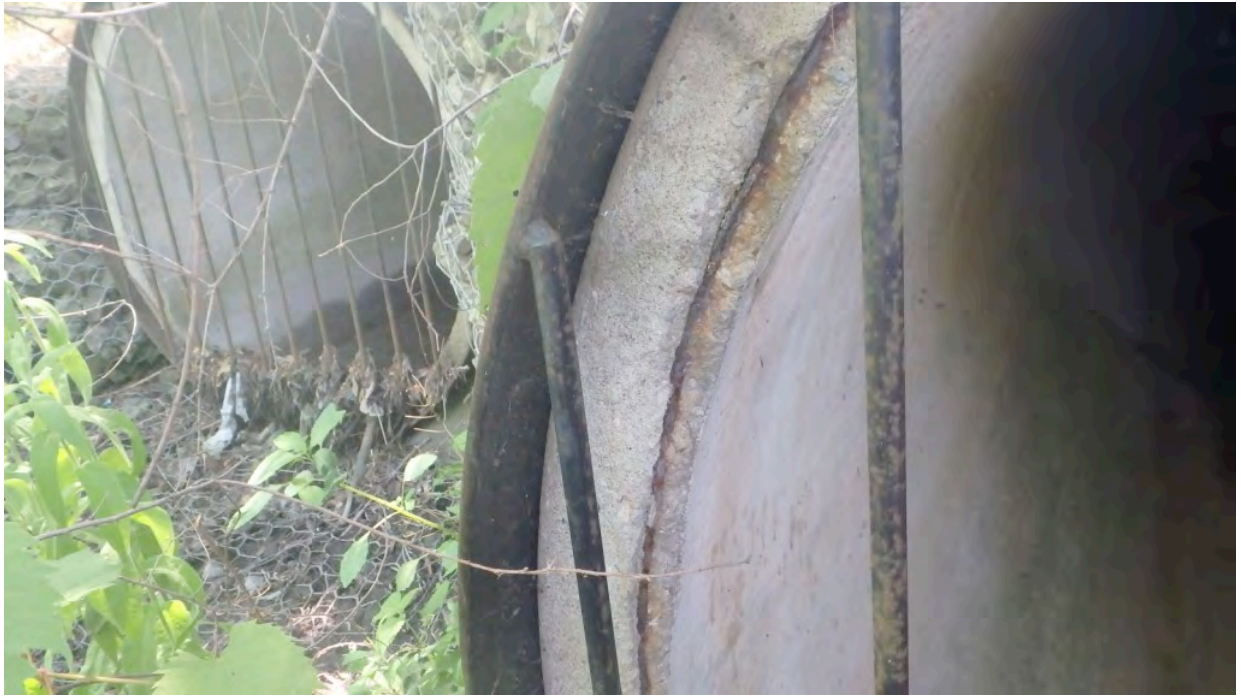
Figure 11 Small Spalling with Exposed Rebar on Pipe Exterior

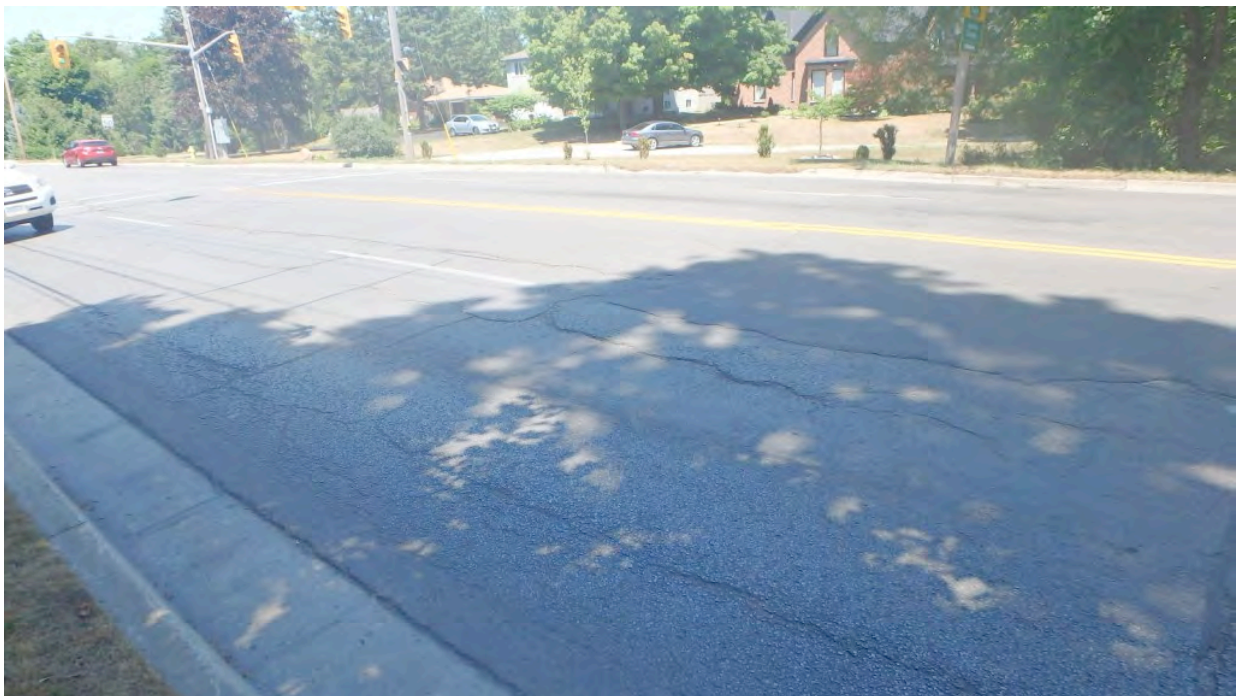
Figure 12 Longitudinal & Transverse Cracking throughout Wearing Surface
