NORFOLK STREET BRIDGE

Site Number 000022

NORFOLK STREET NORTH, SIMCOE

Ontario Structure Inspection Manual - Inspection Form

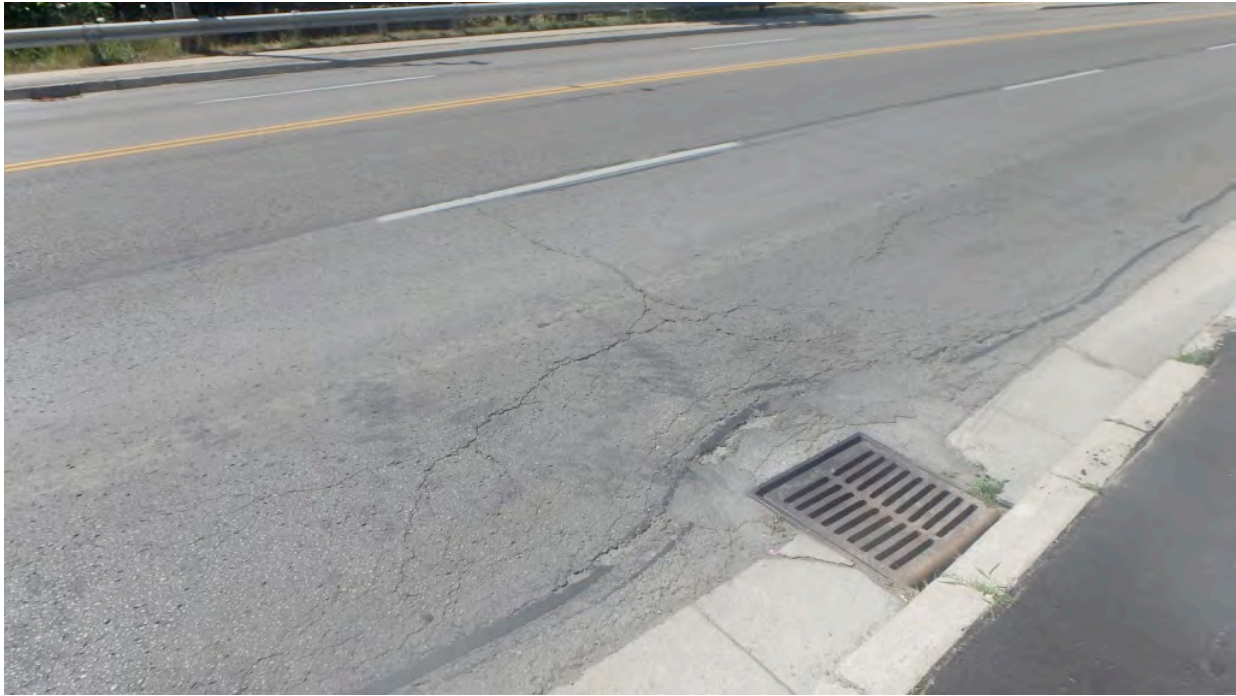
Figure 9 Longitudinal & Transverse Cracking throughout Wearing Surface

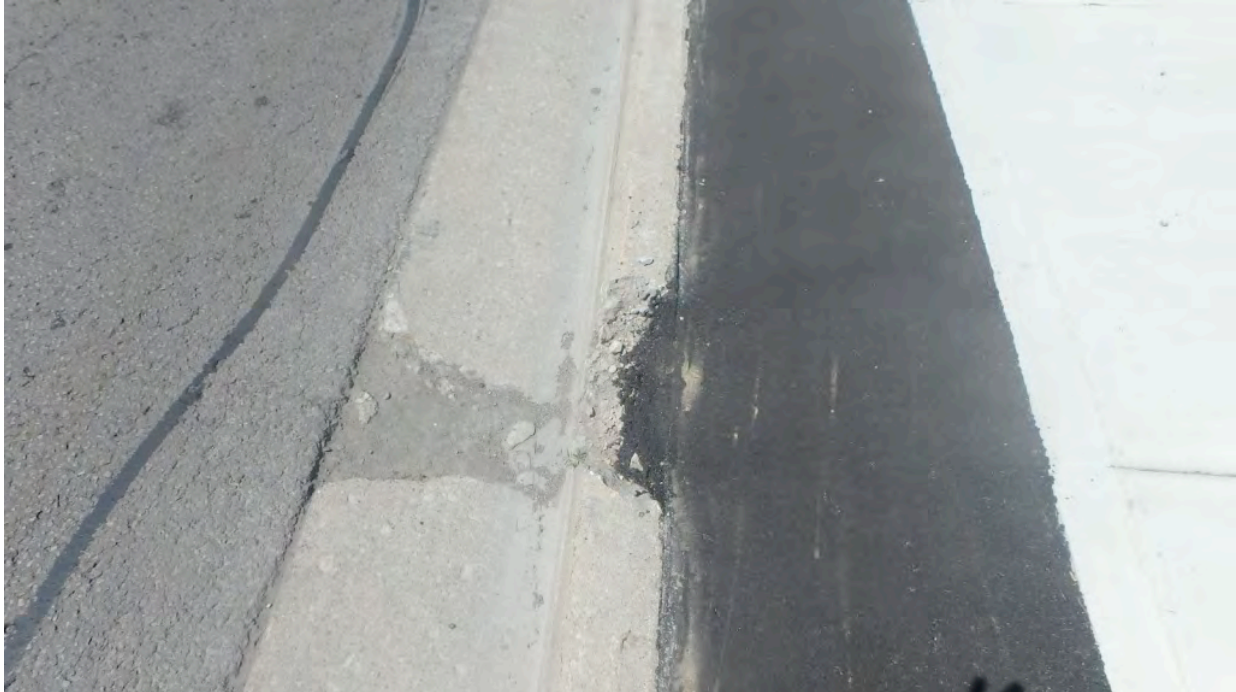
Figure 10 Spall in East Curb
