VENISON CREEK CULVERT, 8TH CONCESSION

Site Number 000301

8TH CONCESSION ROAD, NORTH WALSINGHAM

Ontario Structure Inspection Manual - Inspection Form

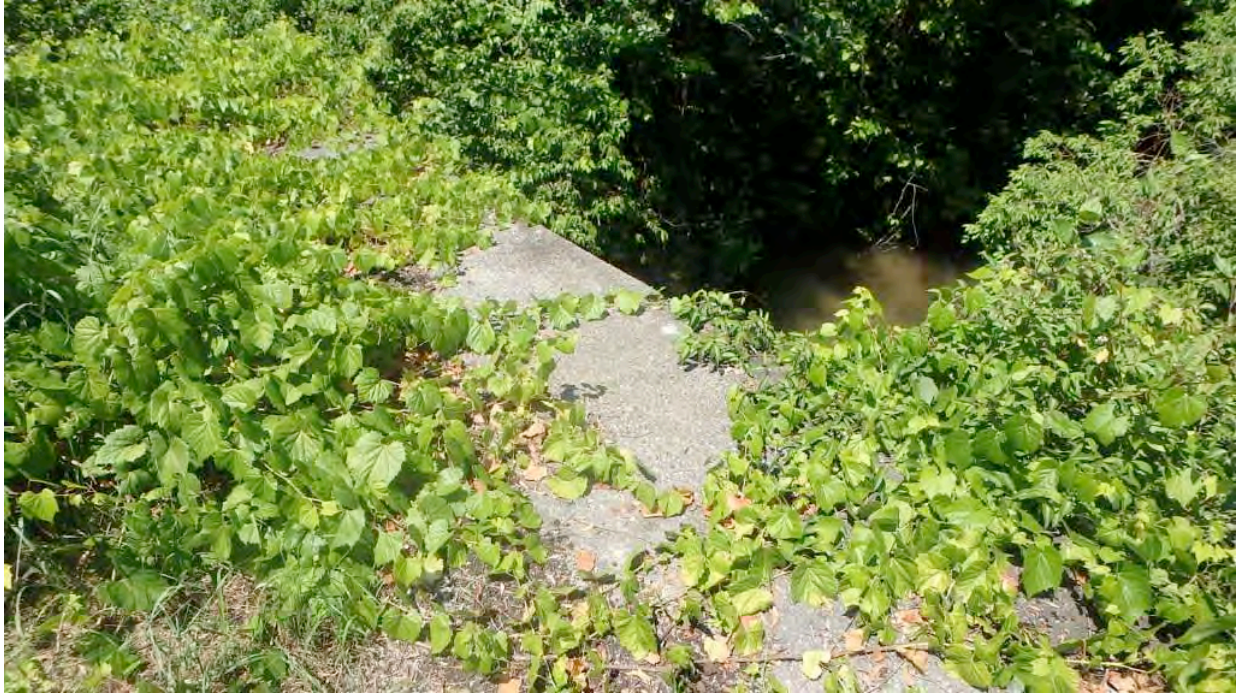
Figure 3 North Culvert Top

Element Group:		1200 Culverts				Length:		6
Element Name:		1201 Inlet Components				Width:		
Location:		North End				Height:		3
Material:		4 Cast-in-place Concrete				Count:		1
Element Type:						Total Quantity:		18 sq.m
Environment:		Moderate				Limited Inspection:		
Protection System:		Unknown				Perform. Deficiencies		
Condition	Units	Exc.	Good	Fair	Poor			
Data:	sq.m	0	15	3	0			
Comments:								
Clear brush. Hand rail installed on south end top. Scour at inlet.								
Recommended Work:				Rehab <input type="checkbox"/>		Replace <input type="checkbox"/>		
Timing:				Urgent <input type="checkbox"/>		< 1yr <input type="checkbox"/>		
				1 - 5 yr <input type="checkbox"/>		6 - 10 yr <input type="checkbox"/>		
				Maintenance Needs:				
				<input type="checkbox"/> Urgent <input type="checkbox"/> 1 year <input type="checkbox"/> 2 year

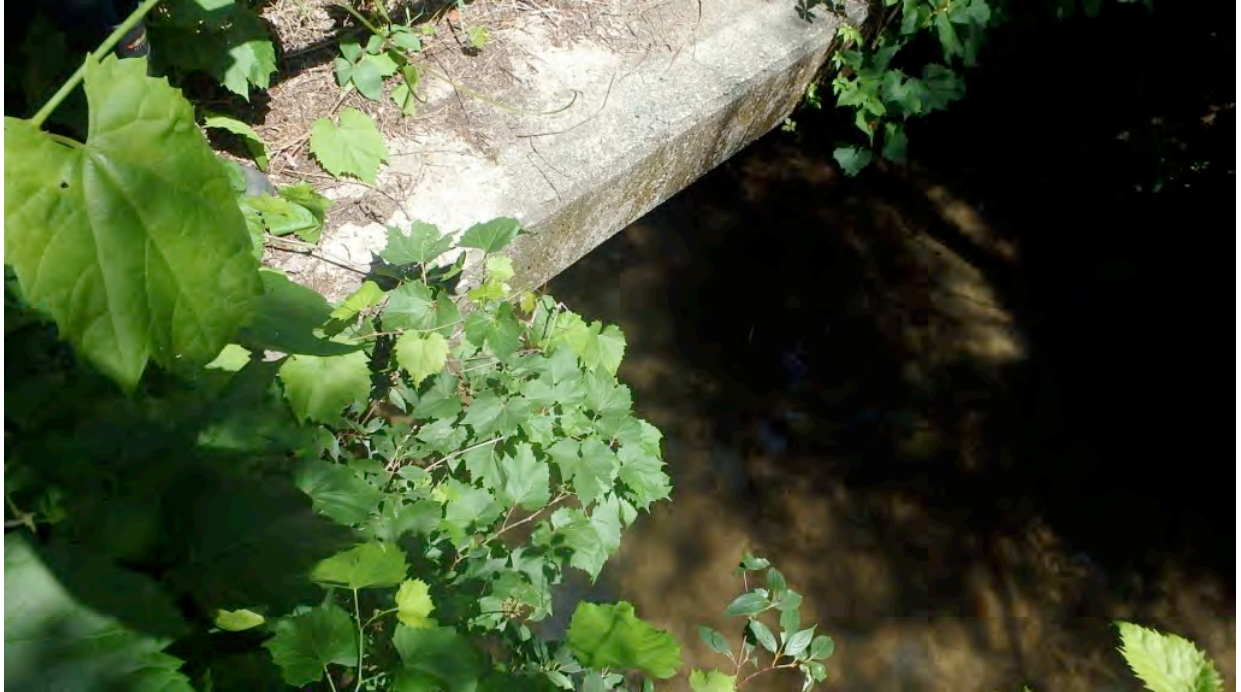
Figure 4 South Profile

Element Group:		1200 Culverts				Length:	6
Element Name:		1202 Outlet Components				Width:	
Location:		South End				Height:	3
Material:		4 Cast-in-place Concrete				Count:	1
Element Type:						Total Quantity:	18 sq.m
Environment:		Moderate				Limited Inspection:	
Protection System:		Unknown				Perform. Deficiencies	
Condition Data:	Units	Exc.	Good	Fair	Poor		
	sq.m	0	15	3	0		
Comments: Overgrown vegetation on top of inlet.							
Recommended Work: Rehab <input type="checkbox"/> Replace <input type="checkbox"/>					Maintenance Needs:		
Timing: Urgent <input type="checkbox"/> < 1yr <input type="checkbox"/> 1 - 5 yr <input type="checkbox"/> 6 - 10 yr <input type="checkbox"/>					<input type="checkbox"/> Urgent <input type="checkbox"/> 1 year <input type="checkbox"/> 2 year

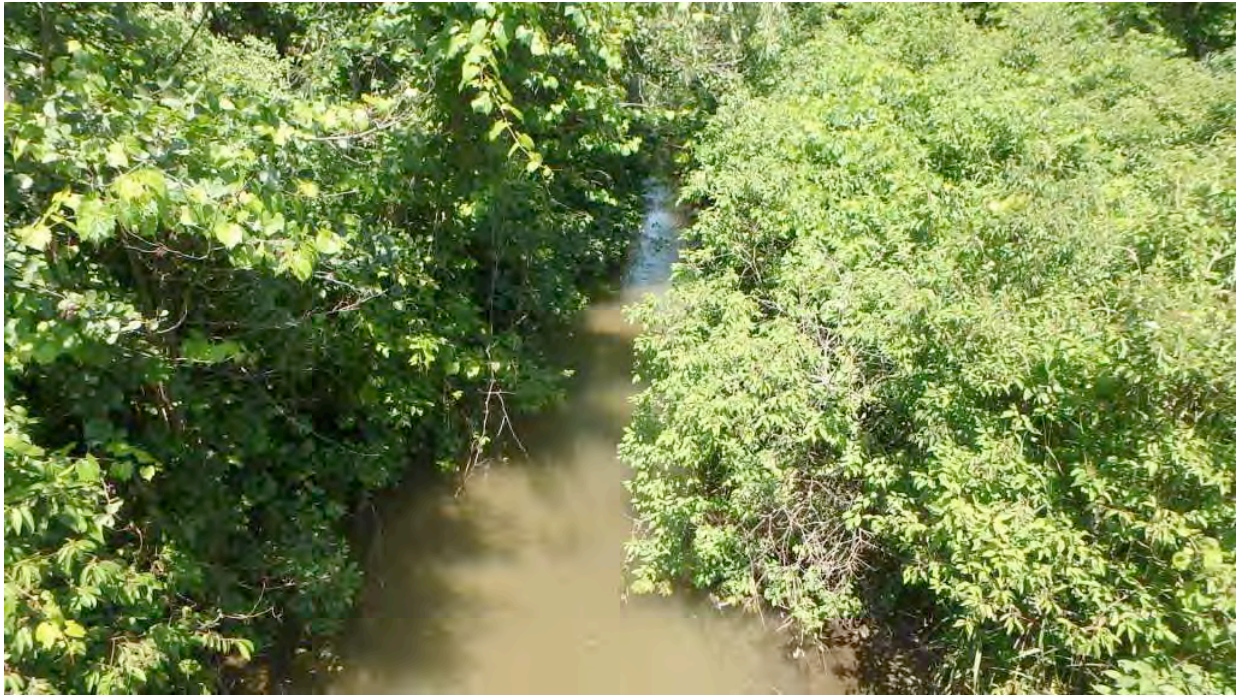
Figure 5 Upstream

Element Group:		1400 Embankments & Streams				Length:	
Element Name:		1401 Streams and Waterways				Width:	
Location:						Height:	
Material:						Count:	1
Element Type:						Total Quantity:	1 Each
Environment:						Limited Inspection:	
Protection System:		Unknown				Perform. Deficiencies	
Condition Data:	Units	Exc.	Good	Fair	Poor		
	Each	0	0	1	0		
Comments: Very over grown.							
Recommended Work: Rehab <input type="checkbox"/> Replace <input type="checkbox"/>					Maintenance Needs:		
Timing: Urgent <input type="checkbox"/> < 1yr <input type="checkbox"/> 1 - 5 yr <input type="checkbox"/> 6 - 10 yr <input type="checkbox"/>					<input type="checkbox"/> Urgent <input type="checkbox"/> 1 year <input type="checkbox"/> 2 year

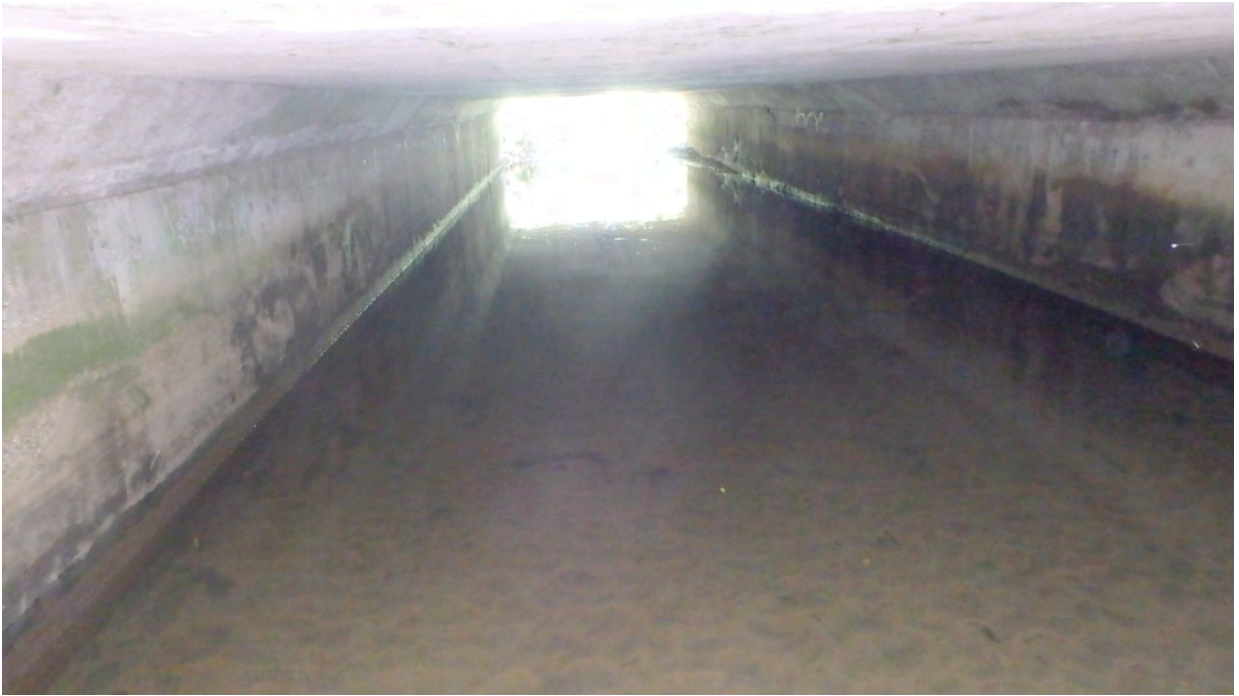
Figure 7 Barrel, Looking North

Element Group:		1200 Culverts				Length:		
Element Name:		1203 Barrels				Width:		6
Location:		Walls and soffit inside				Height:		3
Material:		4 Cast-in-place Concrete				Count:		1
Element Type:						Total Quantity:		18 sq.m
Environment:		Moderate				Limited Inspection:		X
Protection System:		Unknown				Perform. Deficiencies		
Condition	Units	Exc.	Good	Fair	Poor			
Data:	sq.m	0	0	18	0			
Comments:								
Limited inspection due to access. Some staining on walls & soffit.								
Recommended Work:				Rehab <input type="checkbox"/>		Replace <input type="checkbox"/>		
Timing:				Urgent <input type="checkbox"/>		< 1yr <input type="checkbox"/>		
				1 - 5 yr <input type="checkbox"/>		6 - 10 yr <input type="checkbox"/>		
				Maintenance Needs:				
				<input type="checkbox"/> Urgent <input type="checkbox"/> 1 year <input type="checkbox"/> 2 year

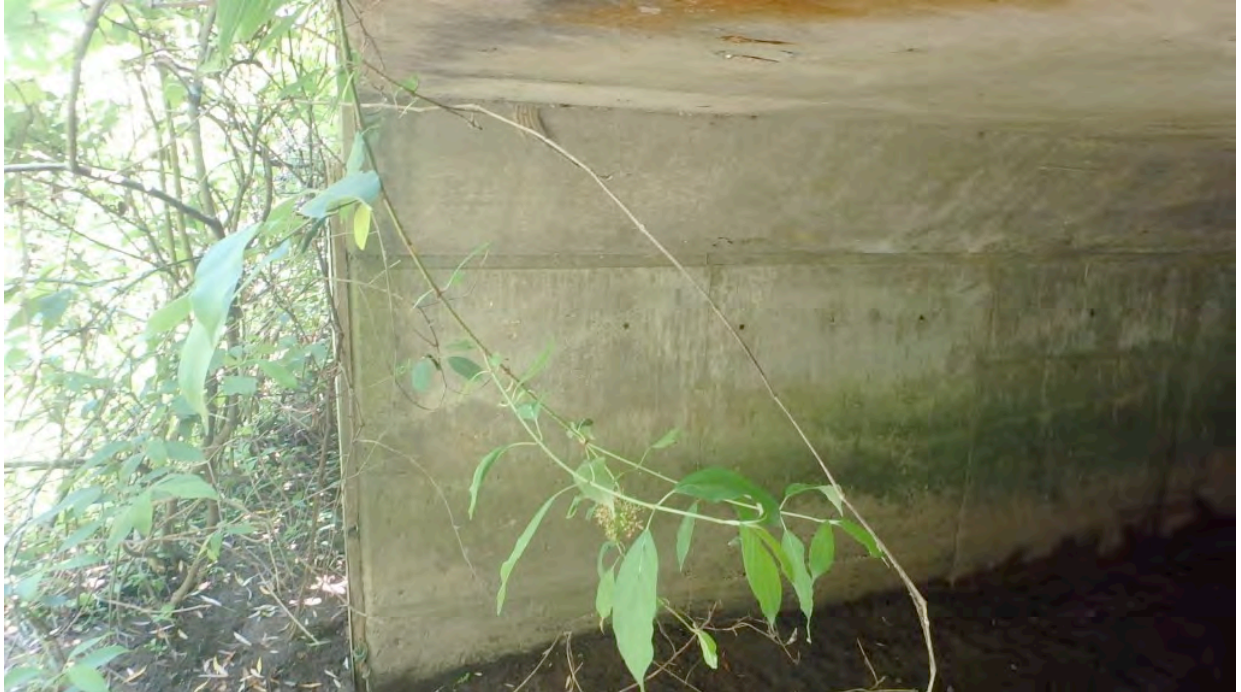
Figure 10 Minor Staining East Wall
