HOSNER CULVERT

Site Number 000101

TOWNLINEROAD (7TH CONCESSION RD), WALSINGHAM

Ontario Structure Inspection Manual - Inspection Form

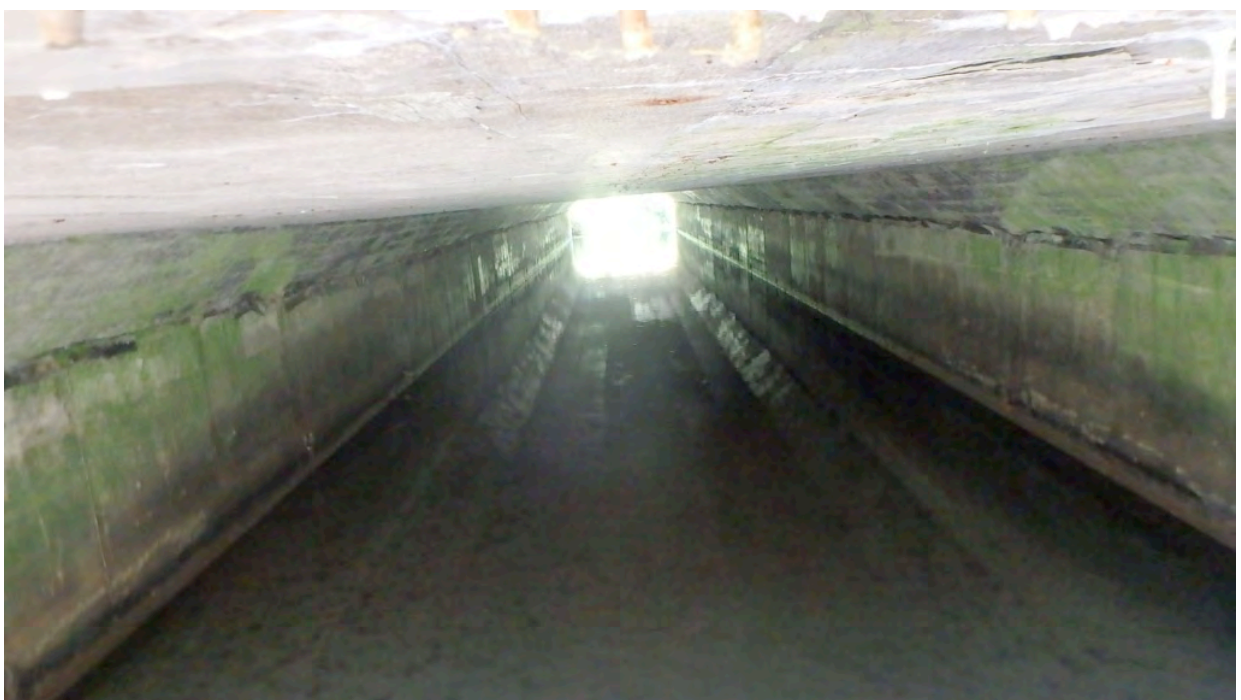
Element Group:		1200 Culverts				Length:		48
Element Name:		1203 Barrels				Width:		6.1
Location:		North				Height:		3
Material:		4 Cast-in-place Concrete				Count:		1
Element Type:						Total Quantity:		878.4 sq.m
Environment:		Benign				Limited Inspection:		X
Protection System:		Unknown				Perform. Deficiencies		
Condition	Units	Exc.	Good	Fair	Poor			
Data:	sq.m	0	0	875.4	3			
Comments:								
Limited inspection due to access. Remove large trees on ends. Delamination on north end soffit. Possible delamination on south end soffit. Limited inspection at South end.								
Recommended Work:				Rehab <input type="checkbox"/>		Replace <input type="checkbox"/>		
Timing:				Urgent <input type="checkbox"/>		< 1yr <input type="checkbox"/>		
				1 - 5 yr <input type="checkbox"/>		6 - 10 yr <input type="checkbox"/>		
Maintenance Needs:						Repair of Bridge Concrete		
						<input type="checkbox"/>		
						Urgent <input checked="" type="checkbox"/>

Figure 6 Barrel, Looking South

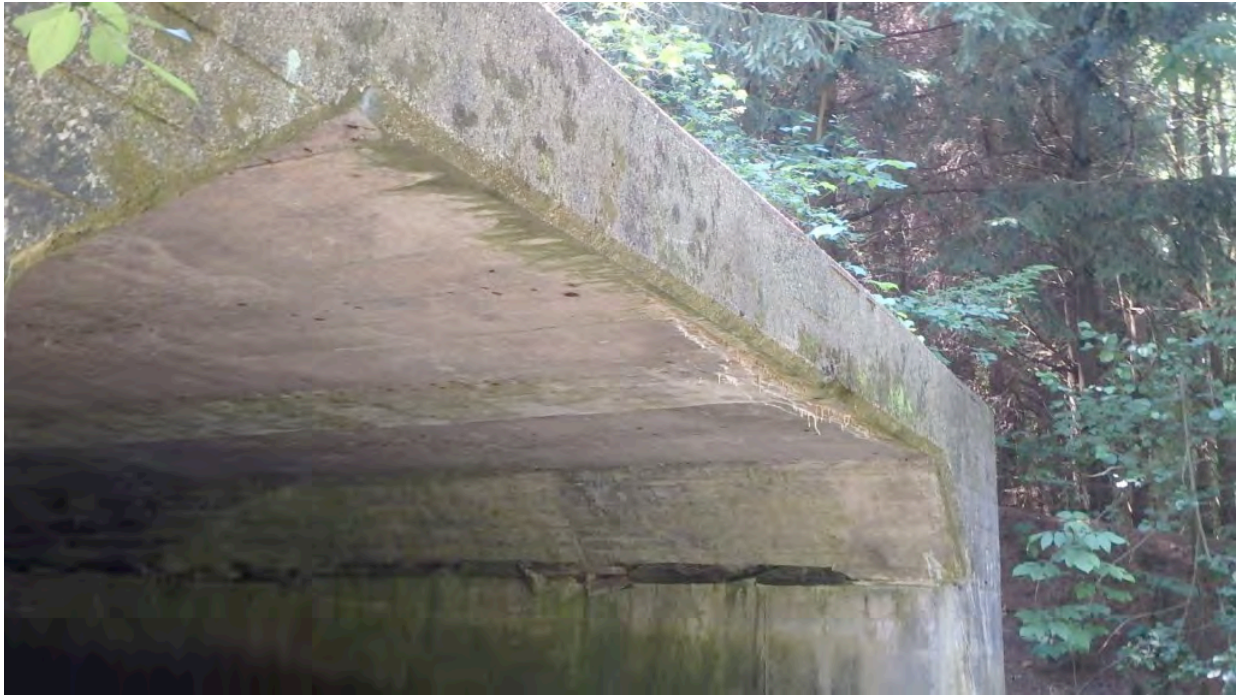
Element Group:		1200 Culverts				Length:		
Element Name:		1201 Inlet Components				Width:		7
Location:		North End				Height:		3
Material:		4 Cast-in-place Concrete				Count:		2
Element Type:						Total Quantity:		42 sq.m
Environment:		Moderate				Limited Inspection:		
Protection System:		Unknown				Perform. Deficiencies		
Condition	Units	Exc.	Good	Fair	Poor			
Data:	sq.m	0	0	36	6			
Comments:								
Efflorescence and delamination showing on north and south wall faces .Cracking noted.								
Recommended Work:				Rehab <input checked="" type="checkbox"/> Replace <input type="checkbox"/>		Maintenance Needs:		
Timing:				Urgent <input type="checkbox"/> < 1yr <input type="checkbox"/> 1 - 5 yr <input checked="" type="checkbox"/> 6 - 10 yr <input type="checkbox"/>		<input type="checkbox"/> Urgent <input type="checkbox"/> 1 year <input type="checkbox"/> 2 year

Figure 7 Efflorescence & Deterioration at Inlet Fascia

Overall Structure Notes:	
Recommended Work on Structure:	<input type="checkbox"/> None <input checked="" type="checkbox"/> Minor Rehab. <input type="checkbox"/> Replace <input type="checkbox"/> Maintenance <input type="checkbox"/> Major Rehab.
Timing of Recommended Work:	<input checked="" type="checkbox"/> 1 to 5 years <input type="checkbox"/> 6 to 10 years
Overall Comments:	Remove large trees and repair culvert ends.
Date of next Inspection:	July 12, 2018

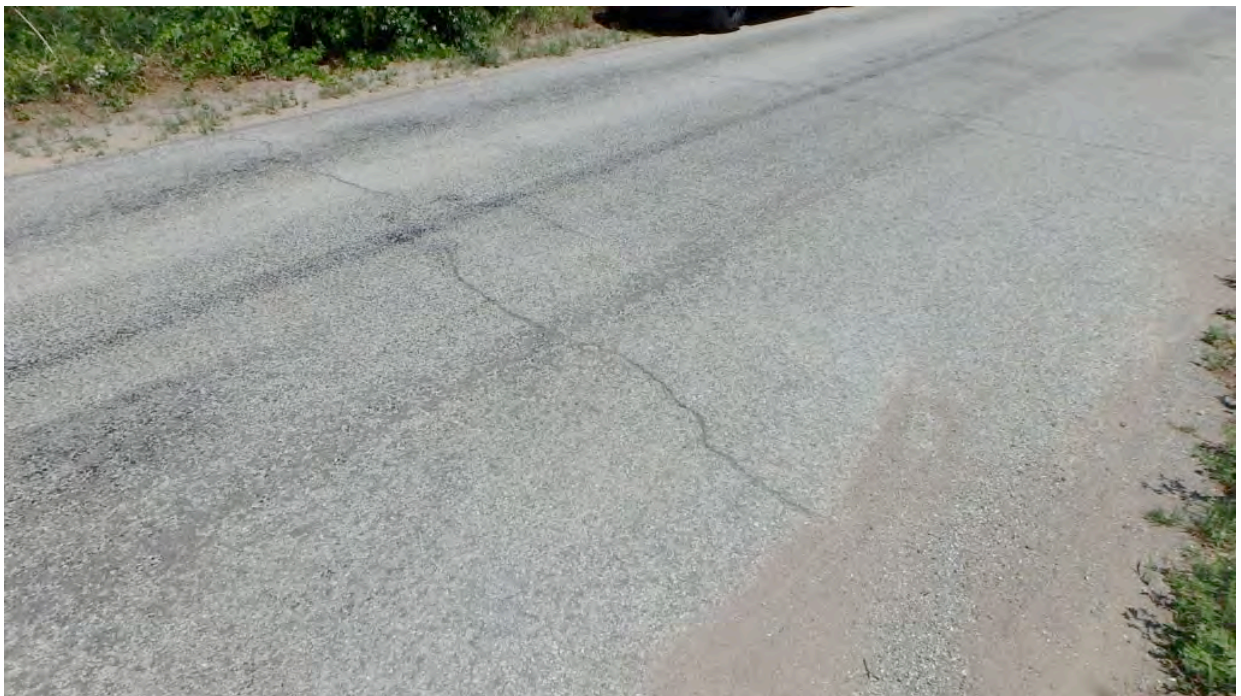
Element Group:		1600 Approaches				Length:		
Element Name:		1601 Wearing Surface (Approaches)				Width:		
Location:		Top of Fill				Height:		
Material:						Count:		1
Element Type:						Total Quantity:		1 Each
Environment:		Severe				Limited Inspection:		
Protection System:		Unknown				Perform. Deficiencies		
Condition	Units	Exc.	Good	Fair	Poor			
Data:	Each	0	1	0	0			
Comments:								
Material is tar and chip. Transverse cracking along center line of culvert.								
Recommended Work:				Rehab <input type="checkbox"/>		Replace <input type="checkbox"/>		
Timing:				Urgent <input type="checkbox"/>		< 1yr <input type="checkbox"/>		
				1 - 5 yr <input type="checkbox"/>		6 - 10 yr <input type="checkbox"/>		
Maintenance Needs:						Rout & Seal		
						<input type="checkbox"/>		
						Urgent <input checked="" type="checkbox"/>		
						1 year <input type="checkbox"/>		
						2 year <input type="checkbox"/>

Figure 8 Transverse Crack in Wearing Surface
