VENISON CREEK CULVERT

Site Number 000102

6TH CONCESSION RD, SOUTH WALSINGHAM

Ontario Structure Inspection Manual - Inspection Form

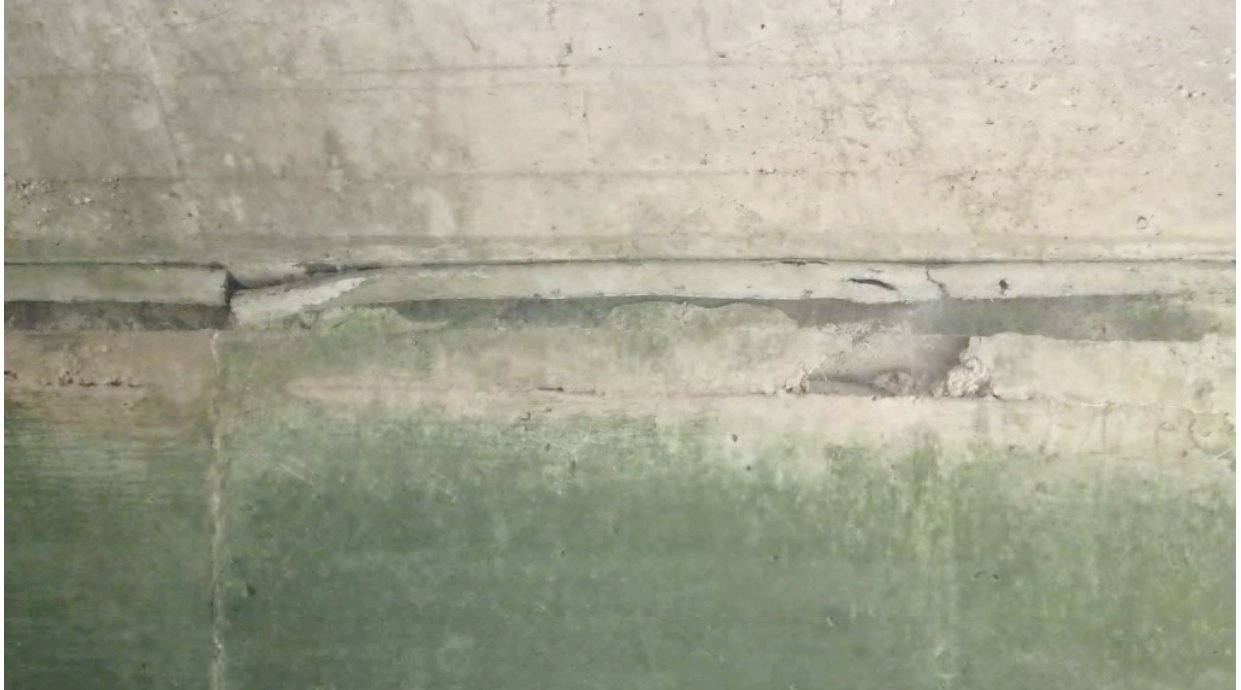
Figure 10 Minor Deterioration of Construction Joint

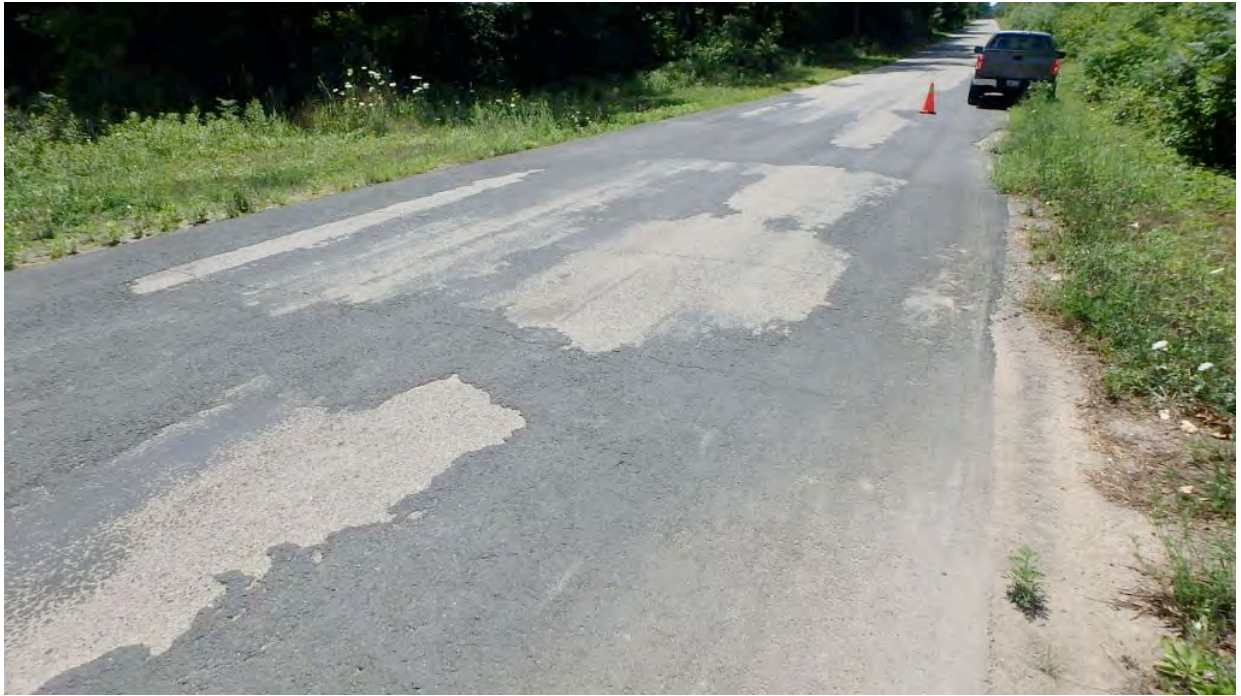
Figure 11 Settlement at Structure Edges Patched

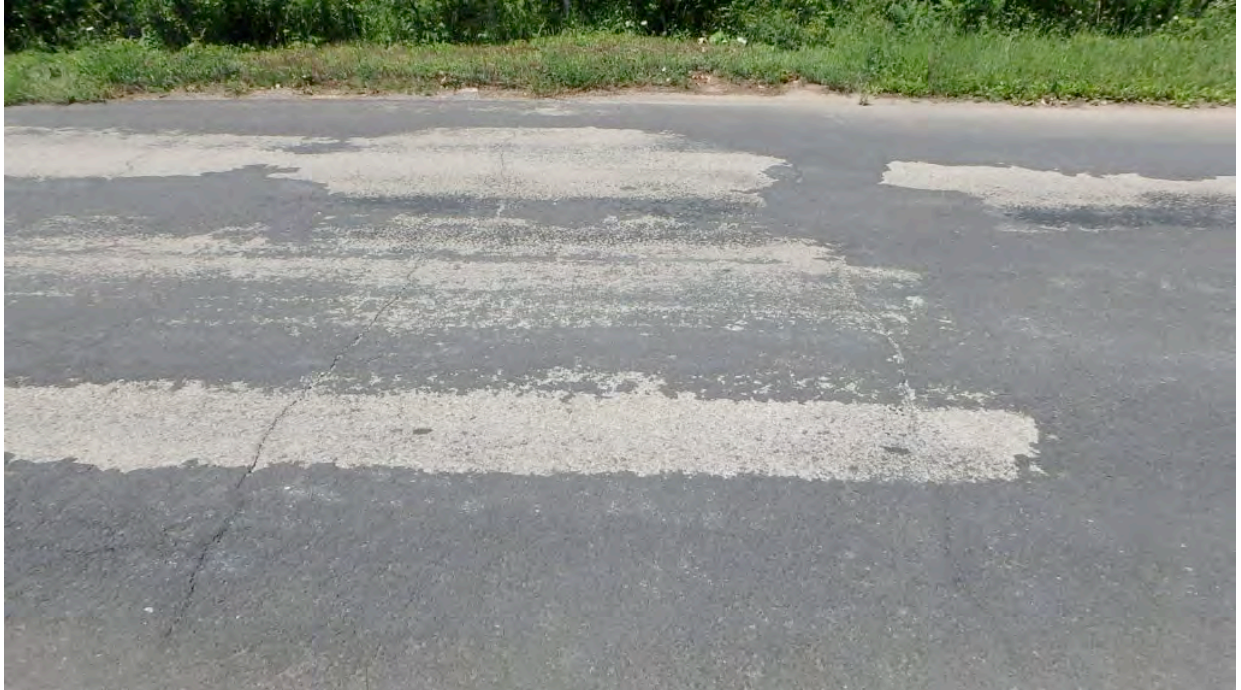
Figure 12 Transverse Cracks at Structure Edges
