LOT 24, 2ND CONCESSION

Site Number 000112

2ND CONCESSION ROAD, SOUTH WALSINGHAM

Ontario Structure Inspection Manual - Inspection Form

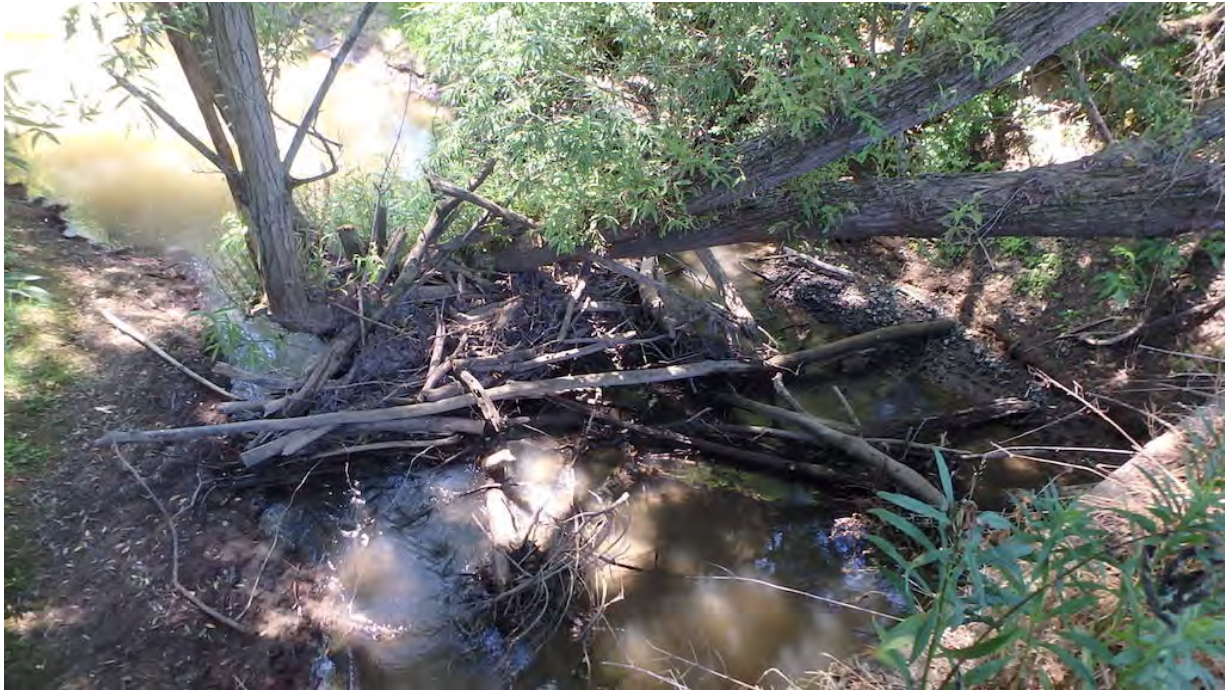
Figure 3 Debris Blocking Outlet

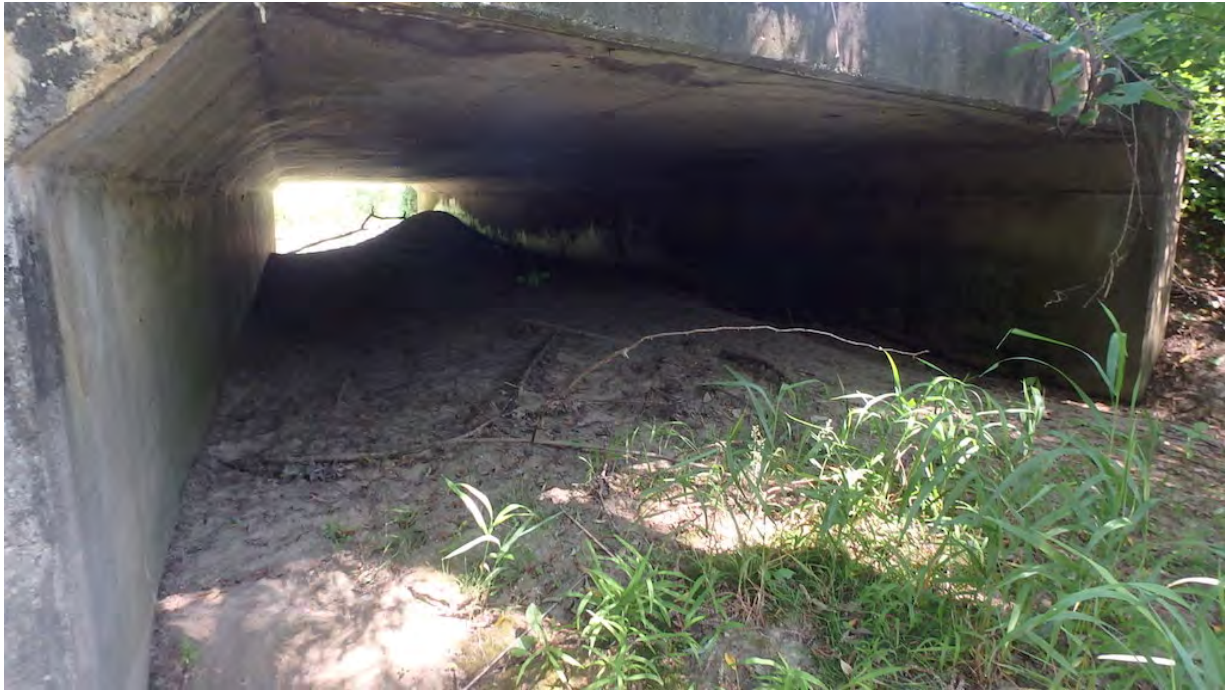
Figure 5 East Barrel, Note Fully Blocked with Sediment

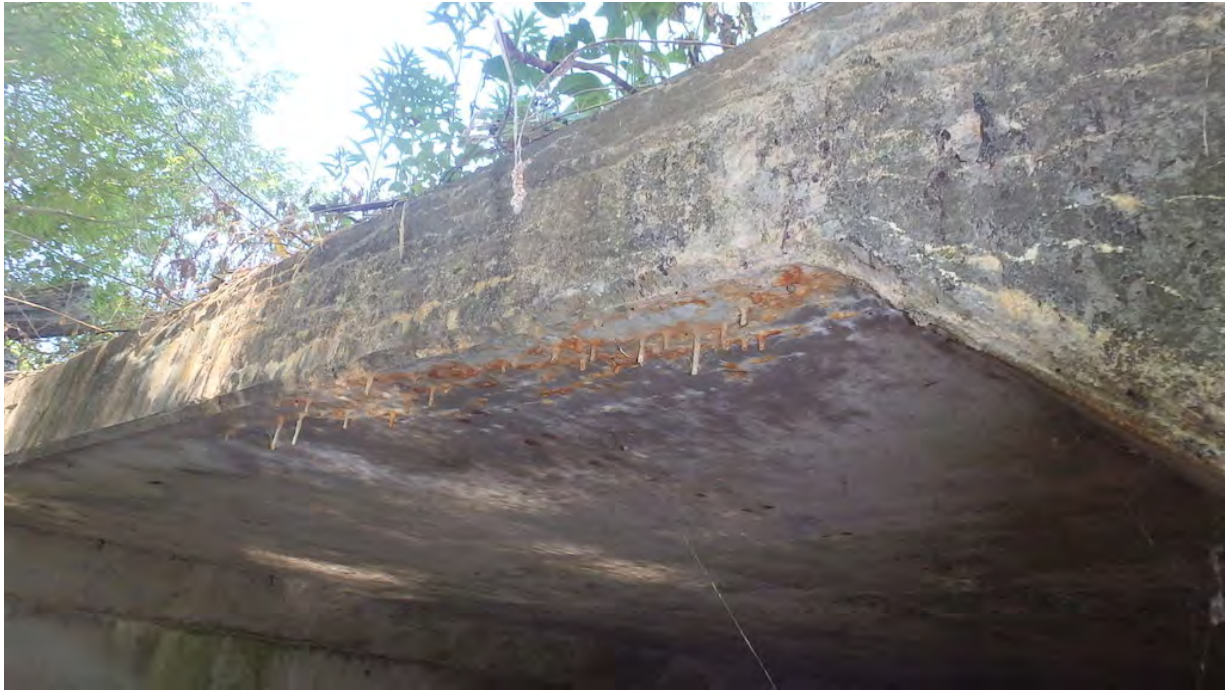
Figure 7 Delamination on South Fascia and Soffit

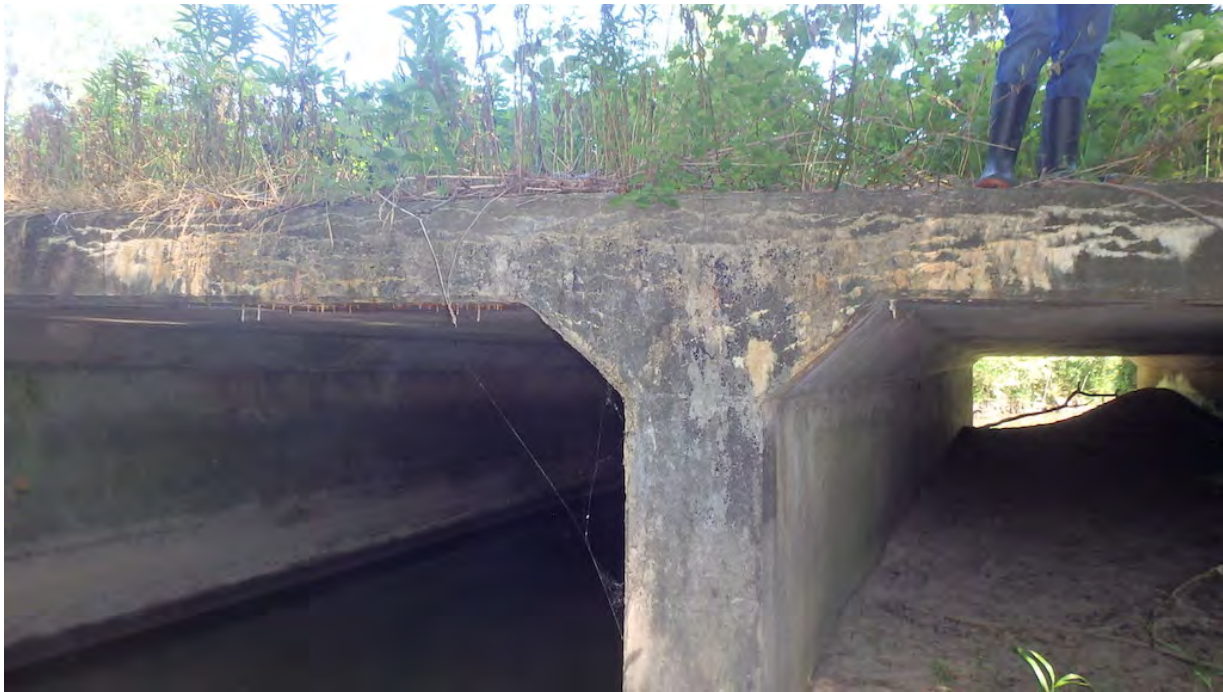
Figure 9 Map Cracking with Efflorescence on South Fascia

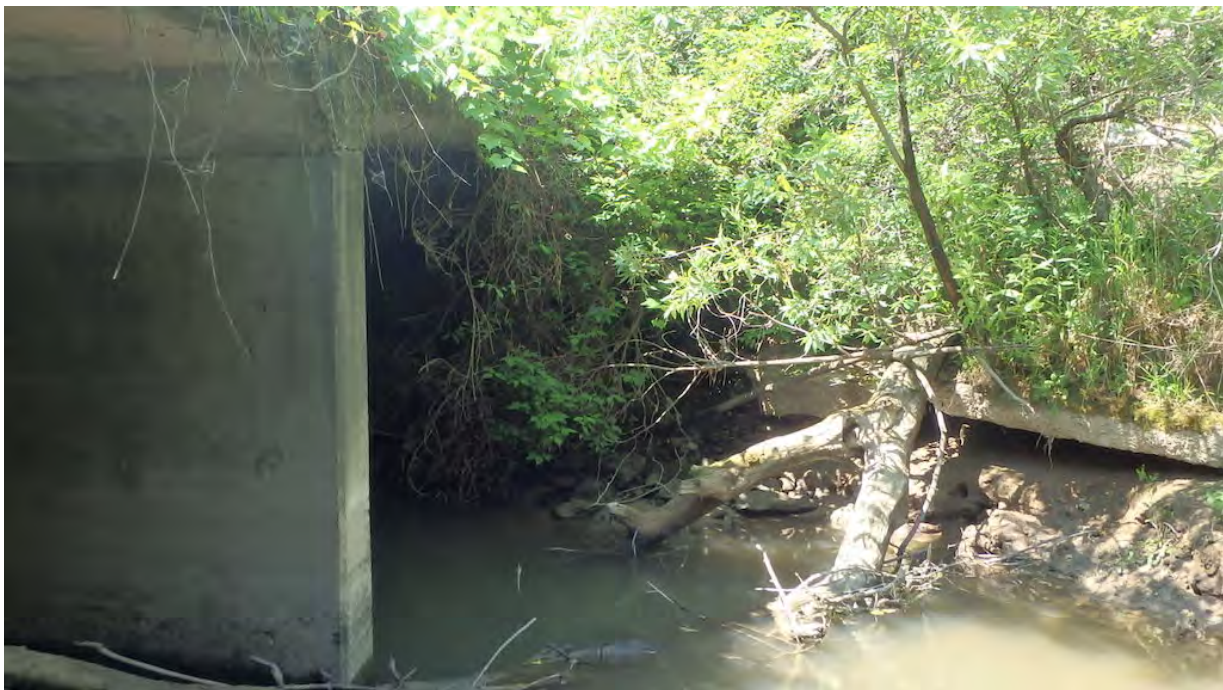
Figure 10 Overgrown at Quadrants

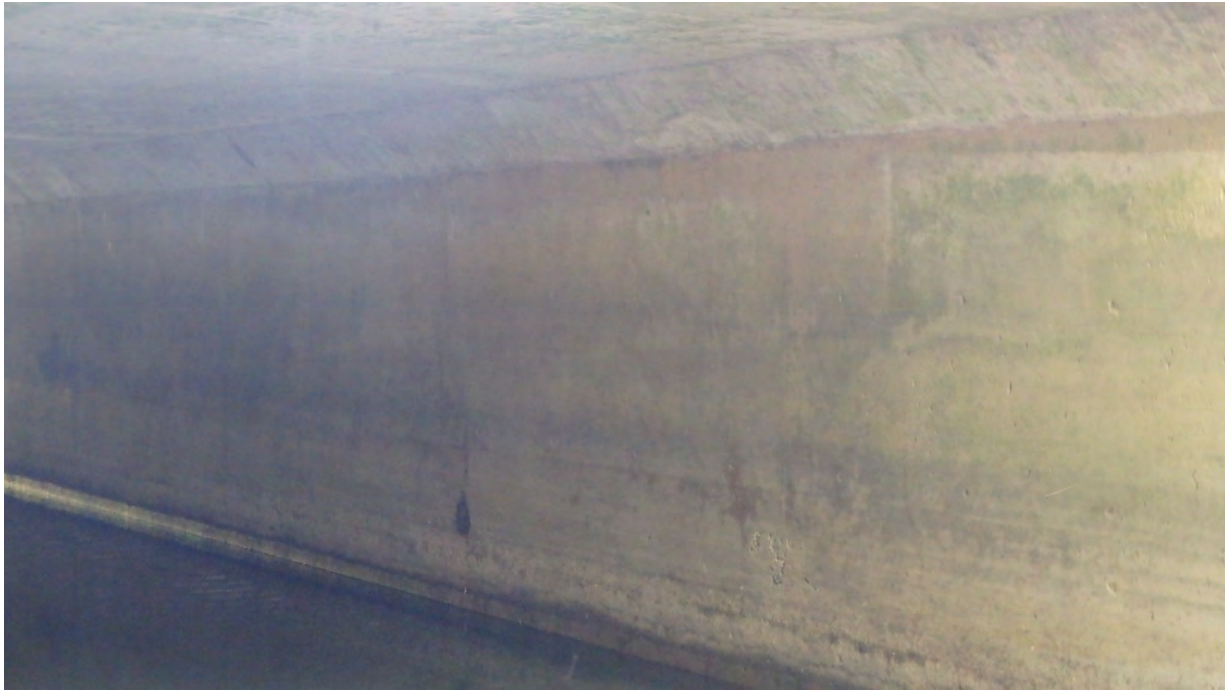
Figure 11 Vertical Crack in Centre Wall, West Barrel
