CONCESSION 2-3 CULVERT S. WALSINGHAM

Site Number 000113

3RD CONCESSION ROAD, SOUTH WALSINGHAM

Ontario Structure Inspection Manual - Inspection Form

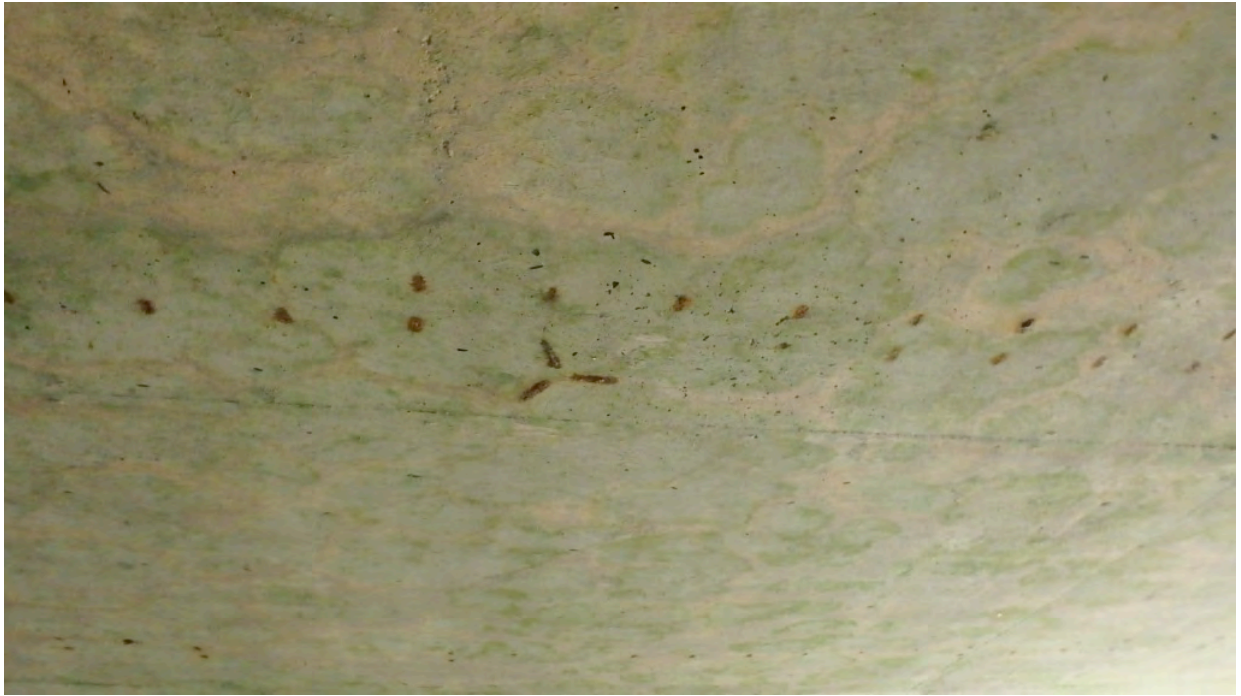
Figure 9 Exposed Reinforcing Ties

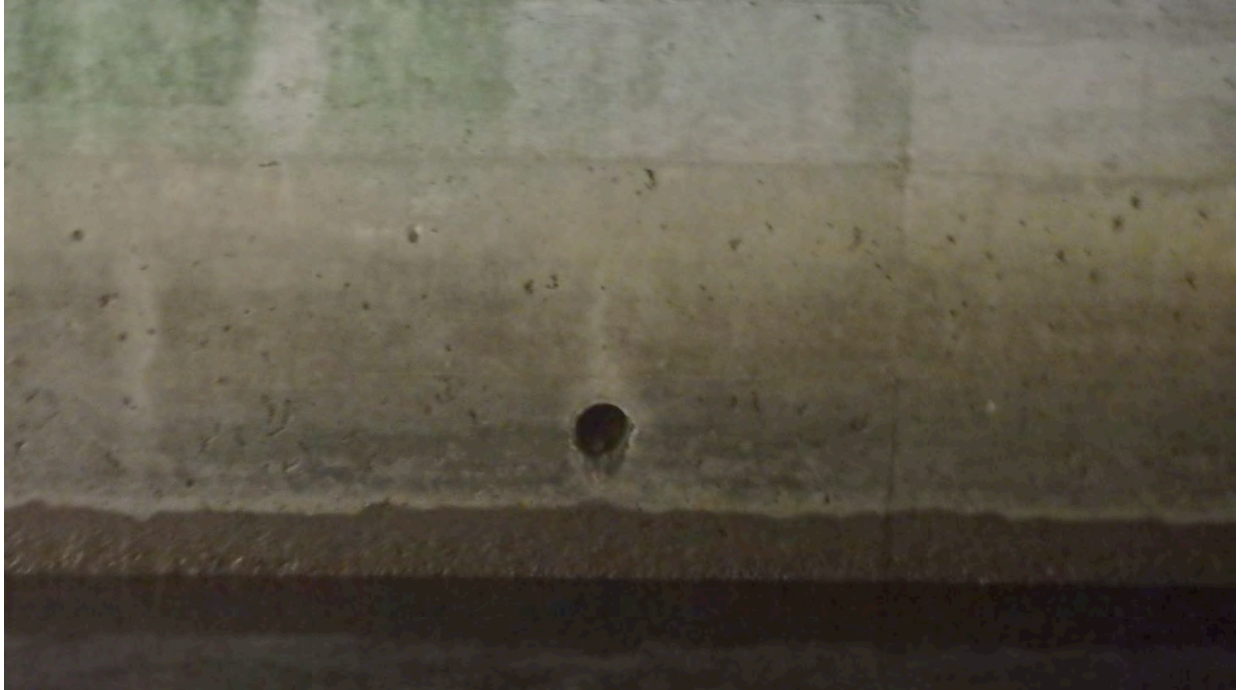
Figure 10 Narrow Crack at Weeping Hole

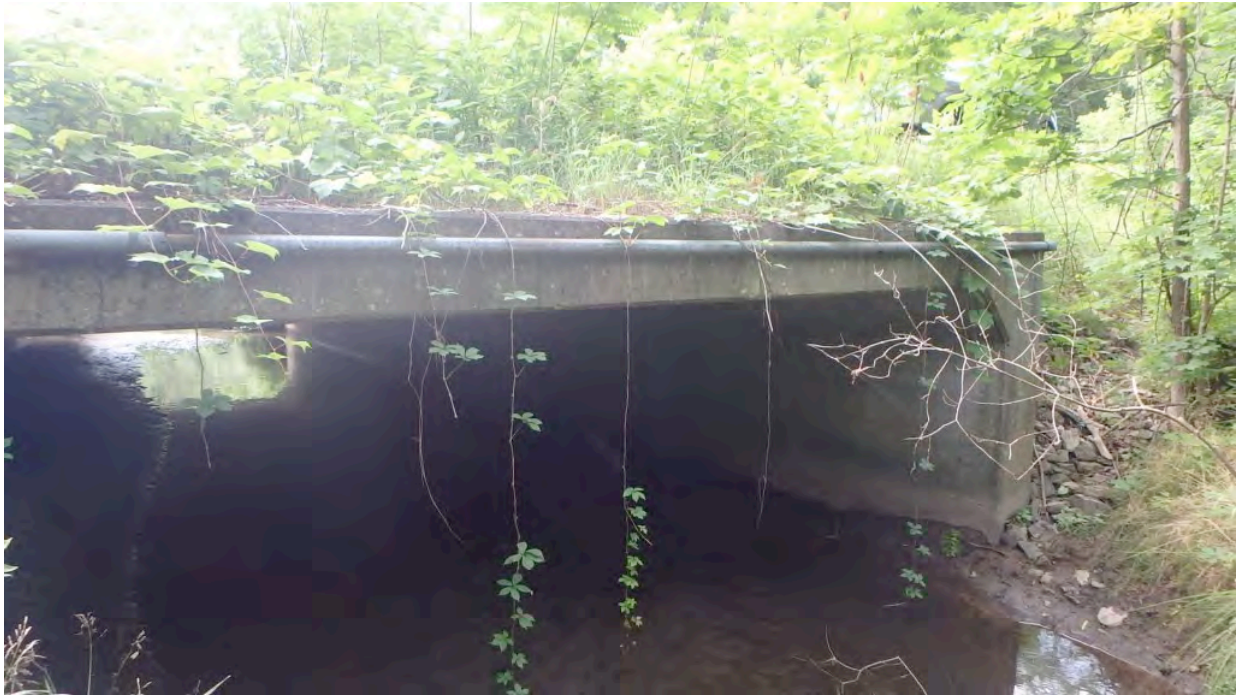
Figure 11 Utility Line on Fascia
