**BILGER'S ROAD CULVERT**

Site Number 000200

**BILGER'S ROAD, MIDDLETON**

**Ontario Structure Inspection Manual - Inspection Form**

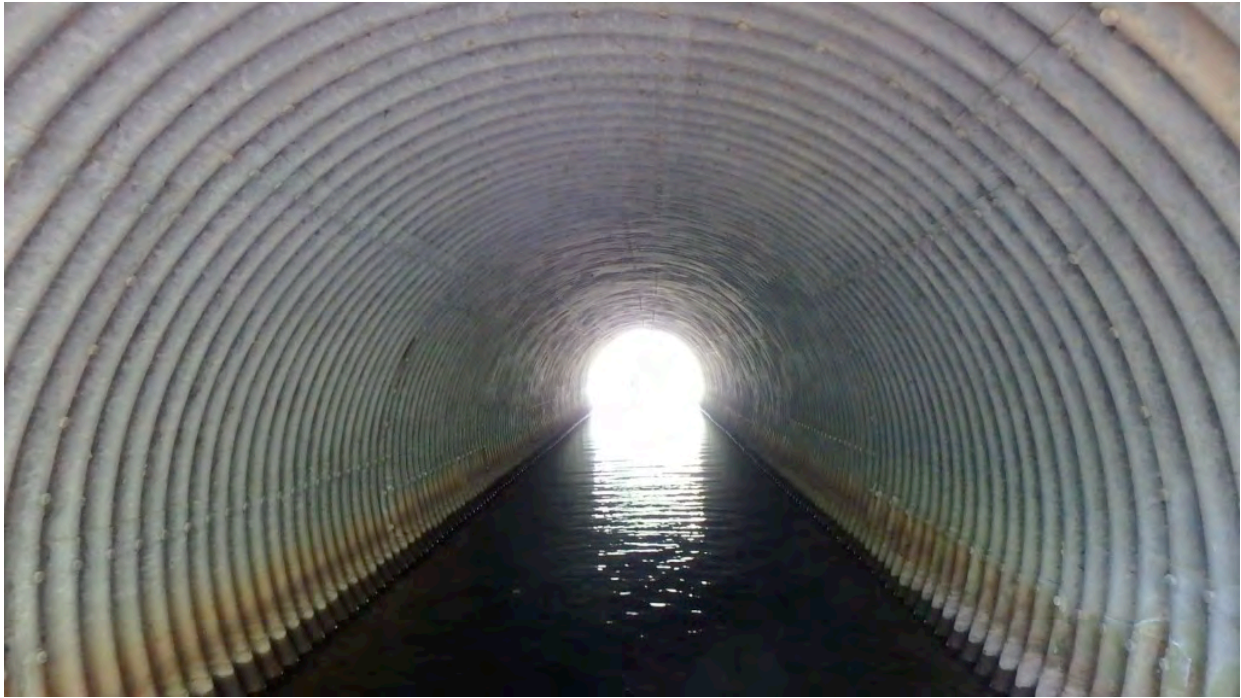
Figure 7 Barrel

Element Group:		1200 Culverts				Length:		
Element Name:		1203 Barrels				Width:		
Location:		Inside				Height:		
Material:		5 Corrugated Steel				Count:		1
Element Type:						Total Quantity:		1 Each
Environment:						Limited Inspection:		
Protection System:		None				Perform. Deficiencies		
Condition	Units	Exc.	Good	Fair	Poor			
Data:	Each	0	0	1	0			
Comments:								
Surface corrosion at water level.								
Recommended Work:				Rehab <input type="checkbox"/>		Replace <input type="checkbox"/>		
Timing:				Urgent <input type="checkbox"/>		< 1yr <input type="checkbox"/>		
				1 - 5 yr <input type="checkbox"/>		6 - 10 yr <input type="checkbox"/>		
Maintenance Needs:				<input type="checkbox"/>		Urgent <input type="checkbox"/>		
				<input type="checkbox"/>		1 year <input type="checkbox"/>		
				<input type="checkbox"/>		2 year <input type="checkbox"/>

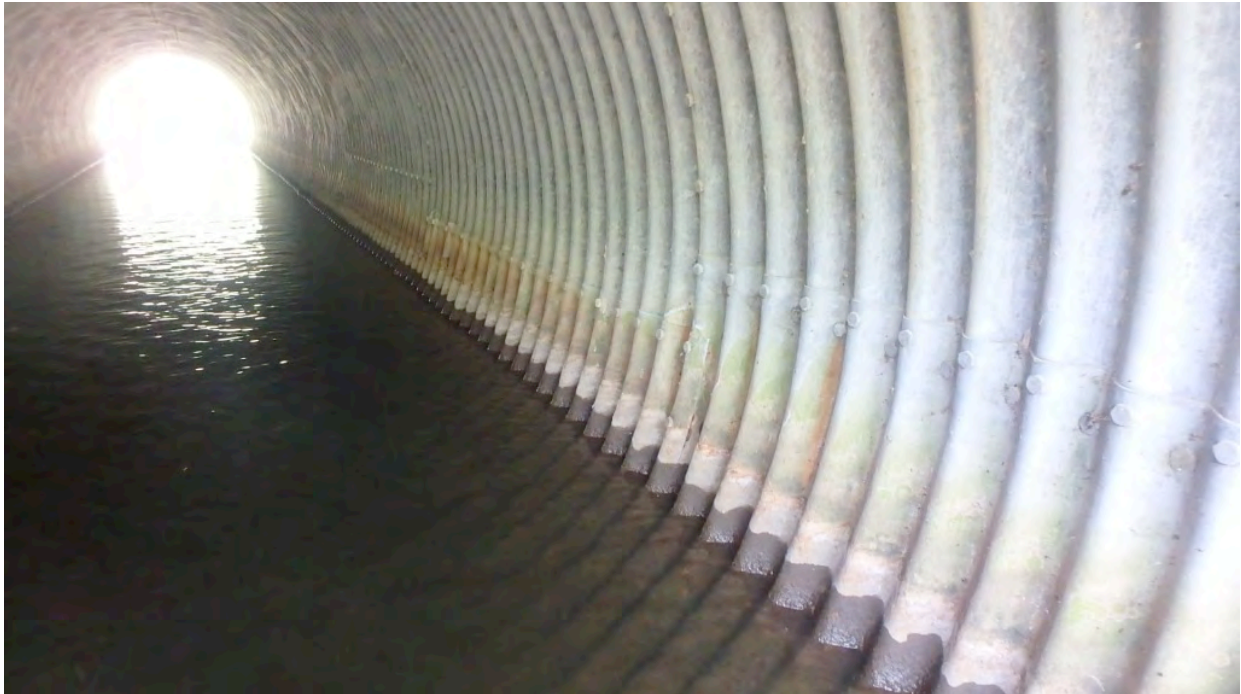
Figure 8 Corrosion and Staining at Water Line

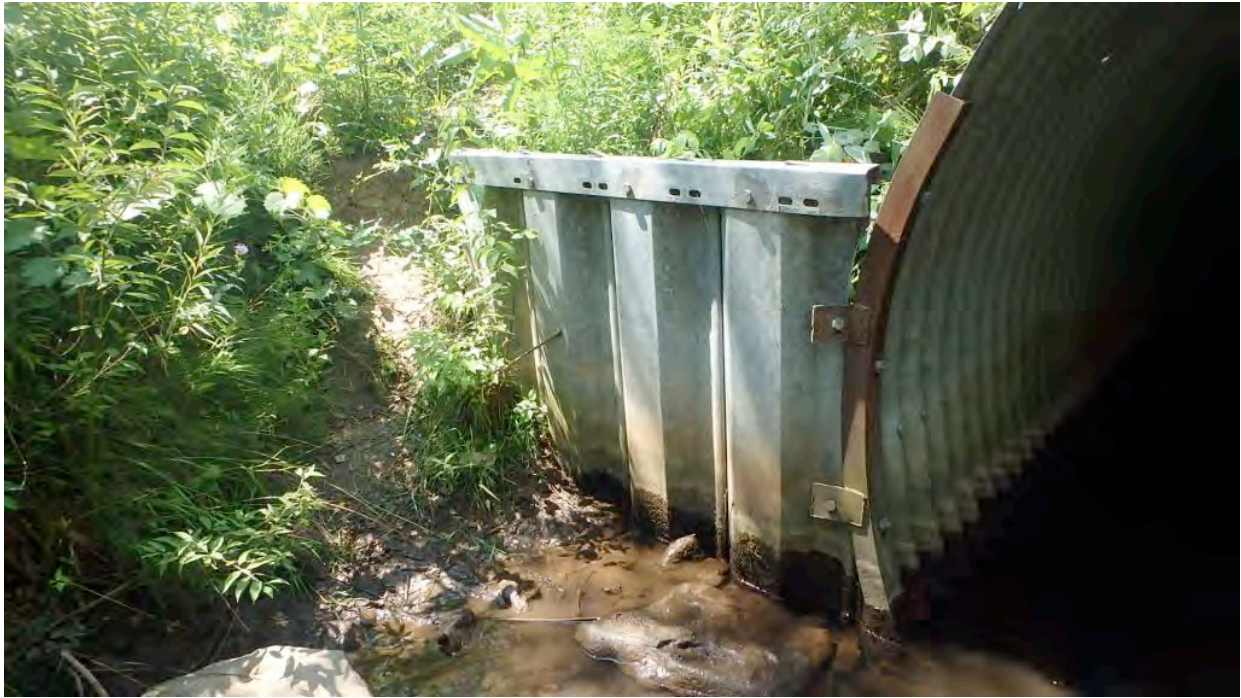
Element Group:	1200 Culverts	Length:											
Element Name:	1202 Outlet Components	Width:	2										
Location:	West	Height:	1.5										
Material:	5 Corrugated Steel	Count:	4										
Element Type:		Total Quantity:	12 sq.m										
Environment:	Moderate	Limited Inspection:											
Protection System:	None	Perform. Deficiencies											
Condition Data:	<table border="1" style="width: 100%; border-collapse: collapse;"> <tr> <th style="width: 10%;">Units</th> <th style="width: 10%;">Exc.</th> <th style="width: 10%;">Good</th> <th style="width: 10%;">Fair</th> <th style="width: 10%;">Poor</th> </tr> <tr> <td>sq.m</td> <td>0</td> <td>11</td> <td>1</td> <td>0</td> </tr> </table>	Units	Exc.	Good	Fair	Poor	sq.m	0	11	1	0		
Units	Exc.	Good	Fair	Poor									
sq.m	0	11	1	0									
Comments: Two short galvanized steel retaining walls. Erosion behind retaining walls.													
Recommended Work:    Rehab <input type="checkbox"/> Replace <input type="checkbox"/> Timing:    Urgent <input type="checkbox"/> < 1yr <input type="checkbox"/> 1 - 5 yr <input type="checkbox"/> 6 - 10 yr <input type="checkbox"/>		Maintenance Needs:    Erosion Control at Bridges <input type="checkbox"/> Urgent <input type="checkbox"/> 1 year <input checked="" type="checkbox"/> 2 year

Figure 9 Retaining Walls at All Quadrants, Note Minor Erosion

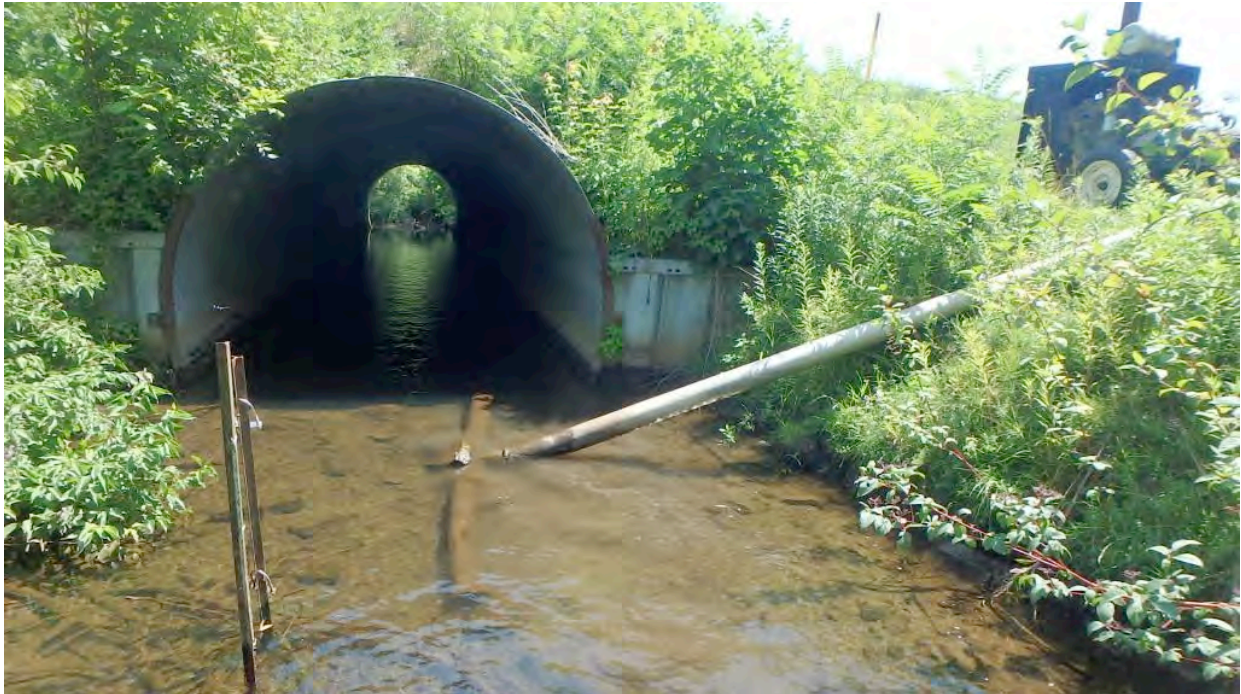
Figure 10 Irrigation Pipe in Waterway

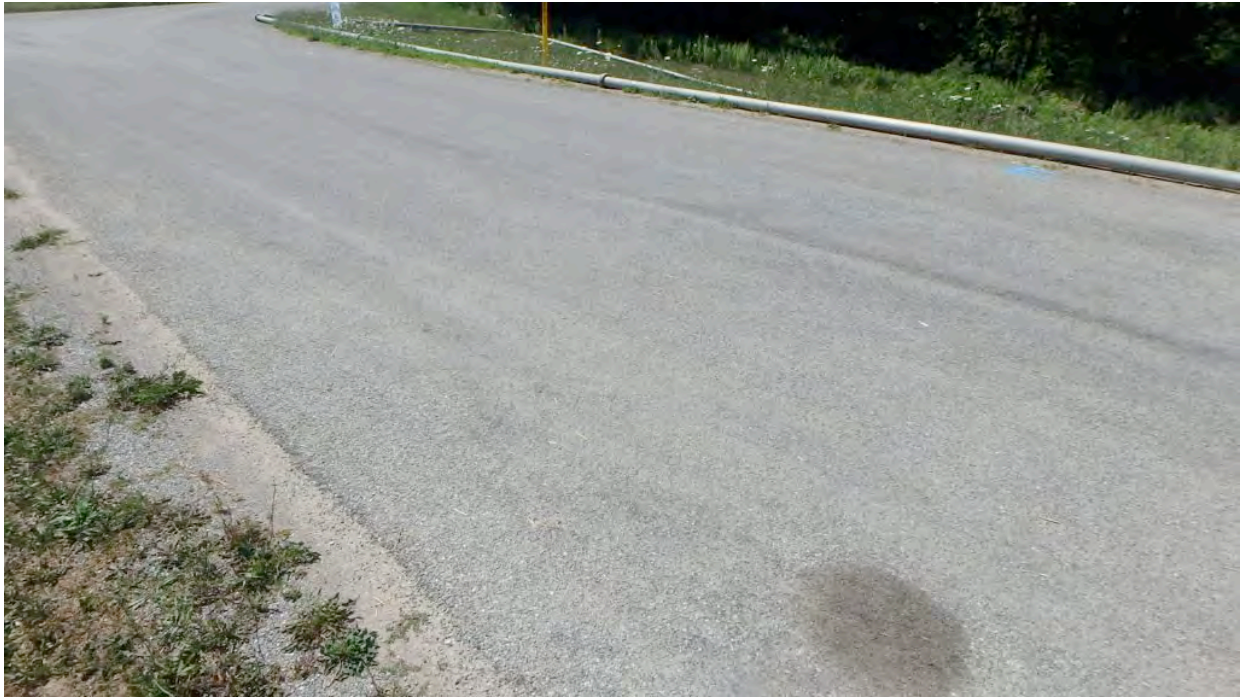
Figure 11      Wearing Surface

Element Group:		1600 Approaches				Length:		
Element Name:		1601 Wearing Surface (Approaches)				Width:		
Location:		Top of Fill				Height:		
Material:		Tar and Chip				Count:		1
Element Type:						Total Quantity:		1 Each
Environment:		Severe				Limited Inspection:		
Protection System:		None				Perform. Deficiencies		
Condition	Units	Exc.	Good	Fair	Poor			
Data:	Each	0	1	0	0			
Comments:								
No signs, no barriers. Tar and chip surface.								
Recommended Work:				Rehab <input type="checkbox"/>		Replace <input type="checkbox"/>		
Timing:				Urgent <input type="checkbox"/>		< 1yr <input type="checkbox"/>		
				1 - 5 yr <input type="checkbox"/>		6 - 10 yr <input type="checkbox"/>		
Maintenance Needs:				<input type="checkbox"/>		Urgent <input type="checkbox"/>		
				<input type="checkbox"/>		1 year <input type="checkbox"/>		
				<input type="checkbox"/>		2 year <input type="checkbox"/>
