TISDALE ROAD CULVERT

Site Number 000201

TISDALE ROAD, DELHI

Ontario Structure Inspection Manual - Inspection Form

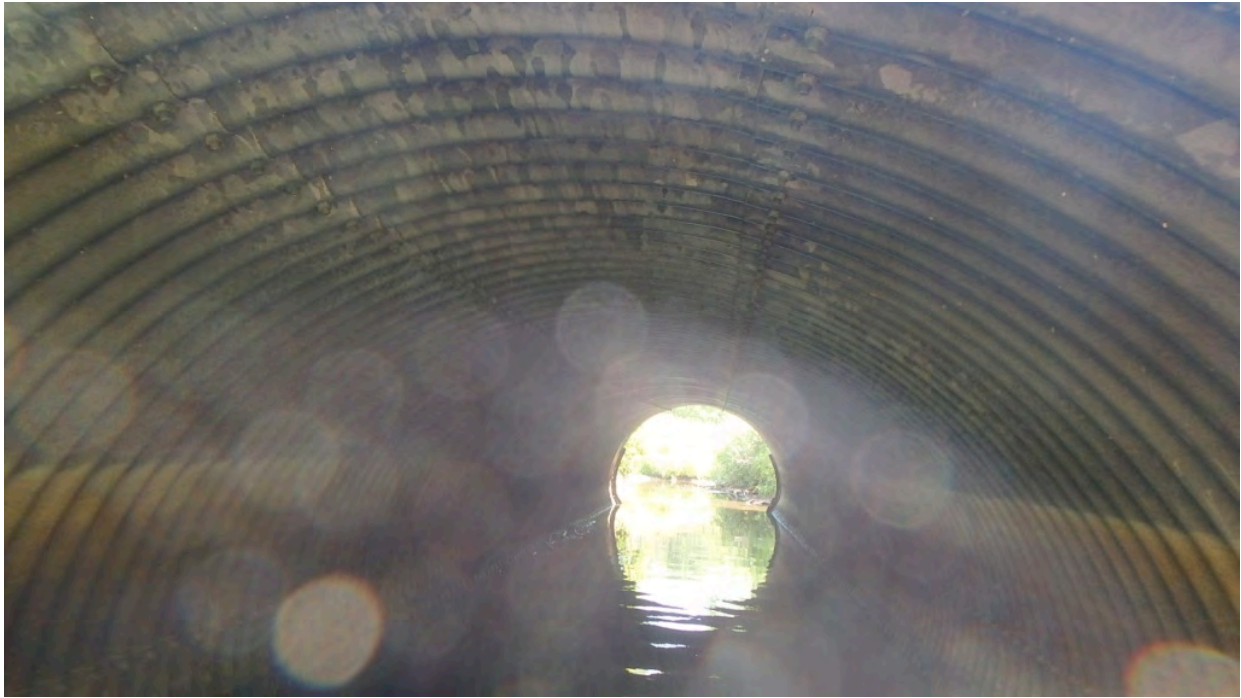
Figure 7 Barrel

Element Group:		1200 Culverts				Length:	17.3
Element Name:		1203 Barrels				Width:	3.7
Location:						Height:	
Material:		5 Corrugated Steel				Count:	1
Element Type:						Total Quantity:	64 sq.m
Environment:		Moderate				Limited Inspection:	
Protection System:		None				Perform. Deficiencies	
Condition	Units	Exc.	Good	Fair	Poor		
Data:	sq.m	0	59	0	5		
Comments: Rust area 300mm wide, 10 - 15m long on South side. 60% average section loss. Similar rust area 2.0m x 300mm area on North side also.							
Recommended Work: Rehab <input type="checkbox"/> Replace <input type="checkbox"/>					Maintenance Needs:		
Timing: Urgent <input type="checkbox"/> < 1yr <input type="checkbox"/> 1 - 5 yr <input type="checkbox"/> 6 - 10 yr <input type="checkbox"/>					<input type="checkbox"/> Urgent <input type="checkbox"/> 1 year <input type="checkbox"/> 2 year

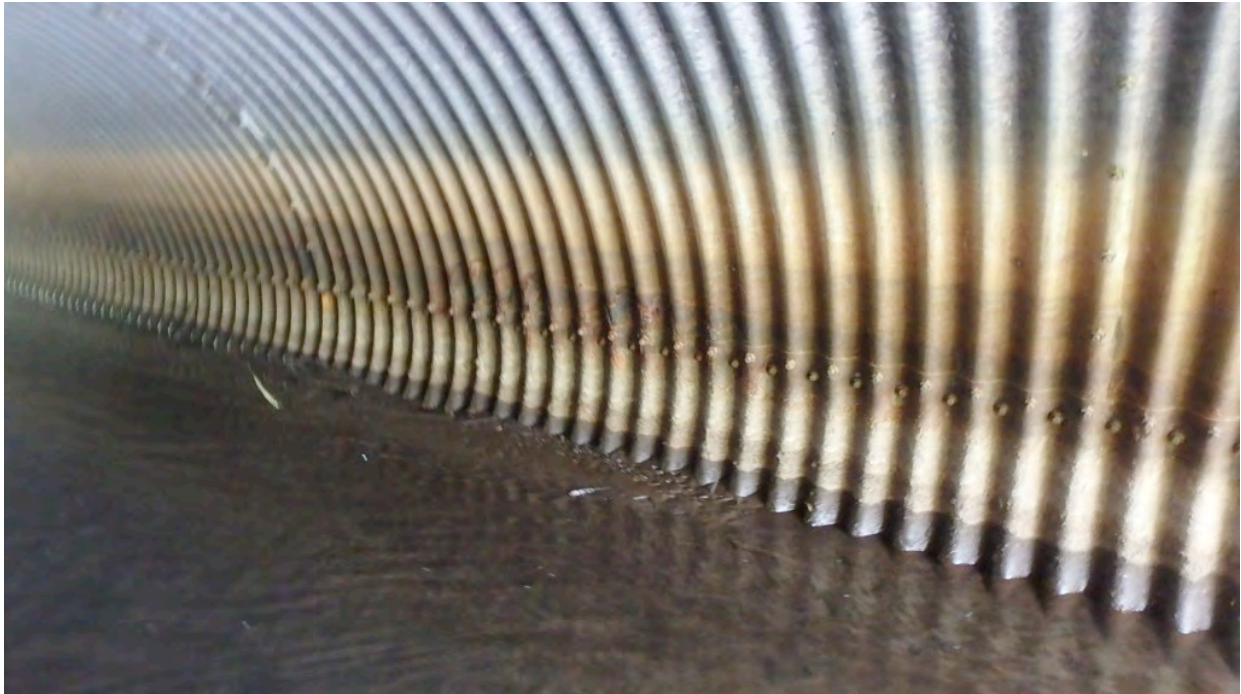
Figure 8 Corrosion at North Wall

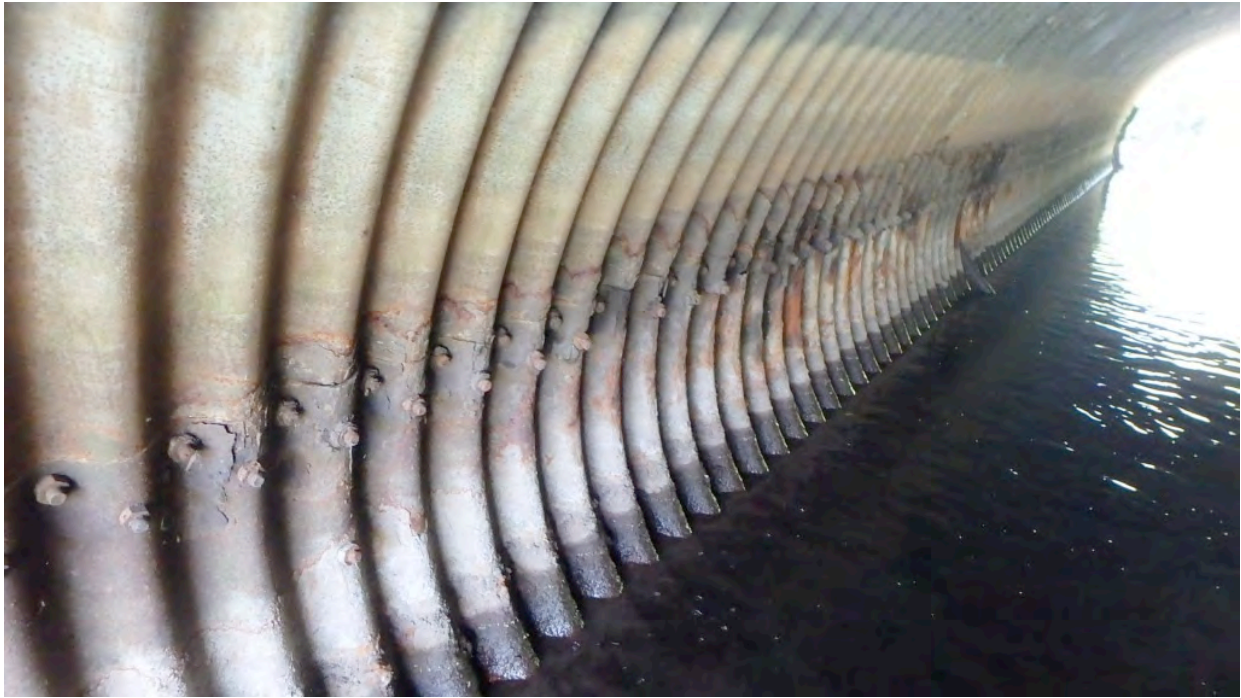
Figure 9 Corrosion at South Wall

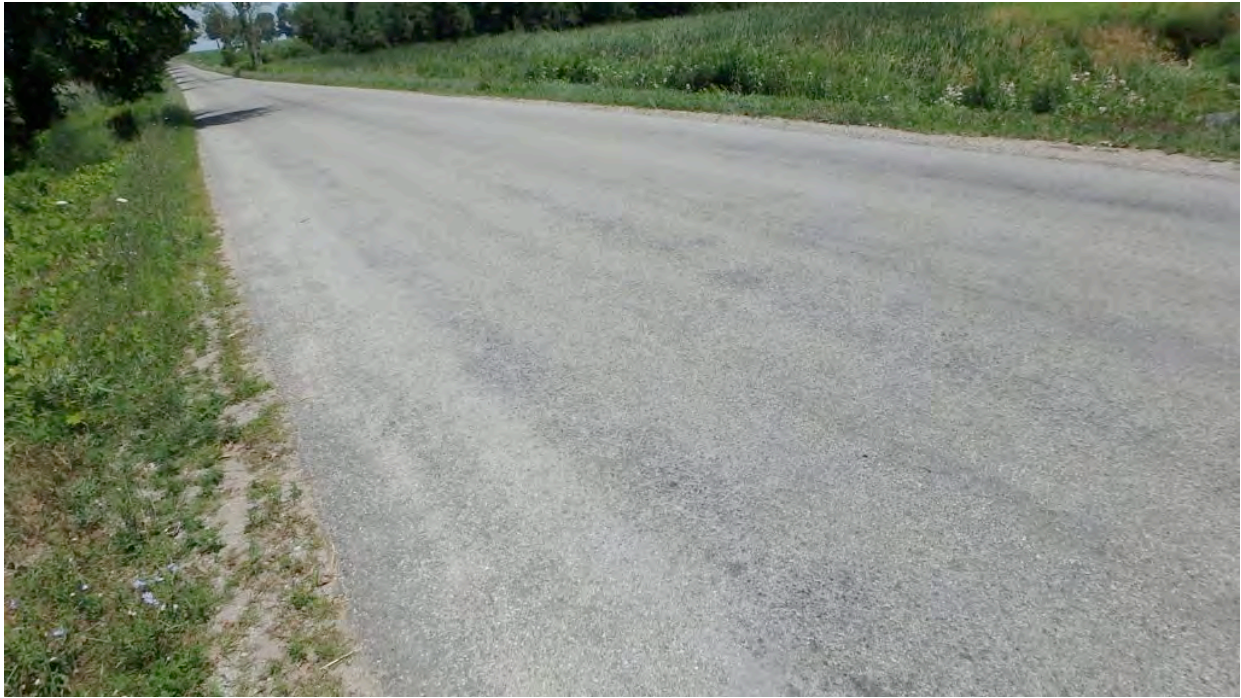
Figure 11 Wearing Surface

Element Group:		1600 Approaches				Length:	
Element Name:		1601 Wearing Surface (Approaches)				Width:	
Location:		Top of Fill				Height:	
Material:		Tar and Chip				Count:	1
Element Type:						Total Quantity:	1 Each
Environment:		Moderate				Limited Inspection:	
Protection System:		None				Perform. Deficiencies	
Condition	Units	Exc.	Good	Fair	Poor		
Data:	Each	0	1	0	0		
Comments: Road slopes - good. No signs, no barriers.							
Recommended Work: Rehab <input type="checkbox"/> Replace <input type="checkbox"/>					Maintenance Needs:		
Timing: Urgent <input type="checkbox"/> < 1yr <input type="checkbox"/> 1 - 5 yr <input type="checkbox"/> 6 - 10 yr <input type="checkbox"/>					<input type="checkbox"/> Urgent <input type="checkbox"/> 1 year <input type="checkbox"/> 2 year
