LOT 3, CONCESSION 9-10 N. WALSINGHAM

Site Number 000302

Ontario Structure Inspection Manual - Inspection Form

Field Inspection Information:	
Date of Inspection:	July 26, 2016
Type of Inspection:	<input checked="" type="checkbox"/> OSIM <input type="checkbox"/> Enhanced OSIM
Inspector:	Matt Alderson, G. Douglas Vallee Ltd.
Others in Party:	N/A
Access Equipment Used:	Hammer, Binoculars, Measuring Tape, Camera, etc.
Weather:	Sunny
Temperature:	25 °C

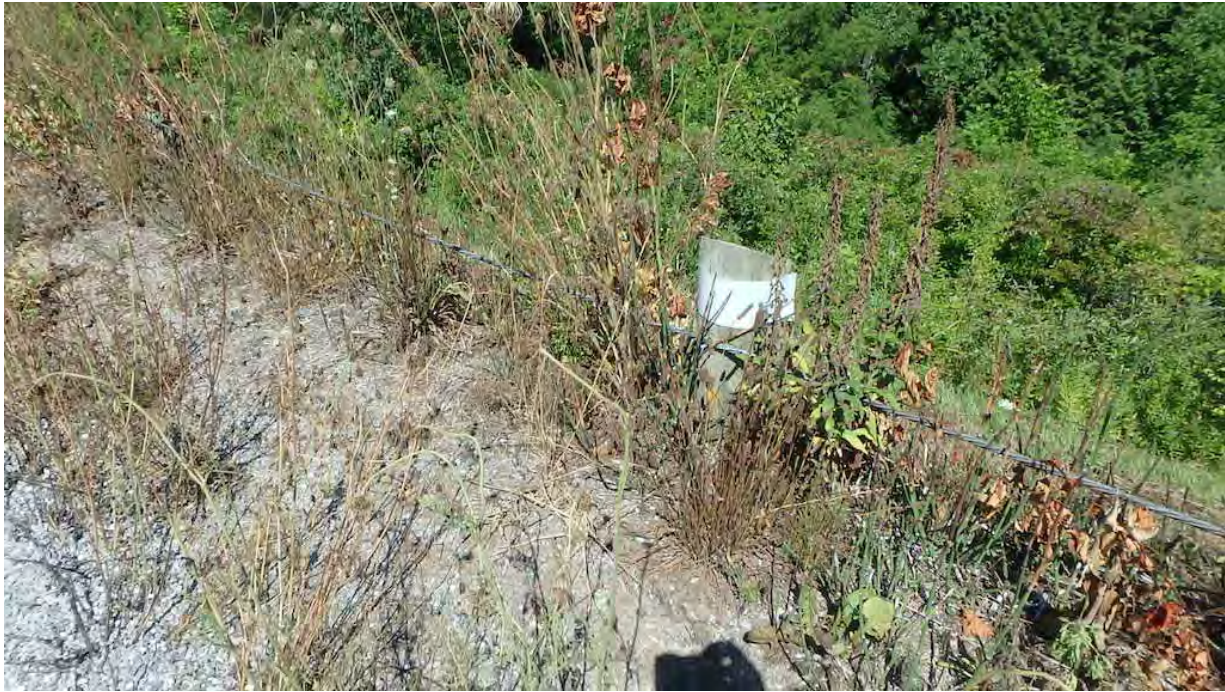
Element Group:	400 Barriers					Length:	100
Element Name:	403 Posts					Width:	
Location:						Height:	
Material:	18	Wood				Count:	2
Element Type:						Total Quantity:	200 m
Environment:	Severe					Limited Inspection:	
Protection System:	Unknown					Perform. Deficiencies	
Condition Data:	Units	Exc.	Good	Fair	Poor		
	m	0	0	100	100		
Comments: North guiderail leaning outward. Single cable guiderail at North. Three cable guiderail at South has loose cables. Posts are rotting.							
Recommended Work:				Rehab <input type="checkbox"/>		Replace <input checked="" type="checkbox"/>	
Timing:				Urgent <input type="checkbox"/>		< 1yr <input type="checkbox"/>	
				1 - 5 yr <input checked="" type="checkbox"/>		6 - 10 yr <input type="checkbox"/>	
				Maintenance Needs:			
				Erosion Control at Bridges			
				Urgent <input type="checkbox"/>			
				1 year <input checked="" type="checkbox"/>			
				2 year <input type="checkbox"/>

Figure 5 Single Cable Guiderail at North

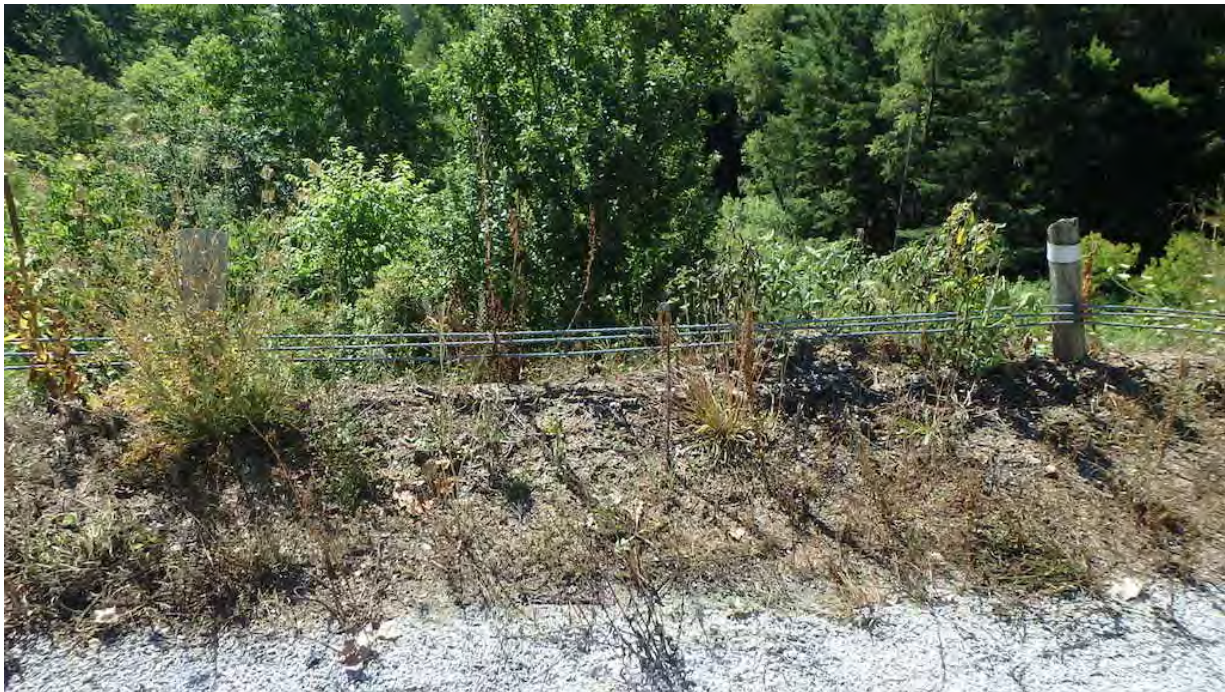
Figure 6 Three Cable Guiderail at South, Loose Cables
