**LOT 1 CONCESSION 3 HOUGHTON**

Site Number 002024

**LOWER SIDE ROAD, HOUGHTON**

**Ontario Structure Inspection Manual - Inspection Form**

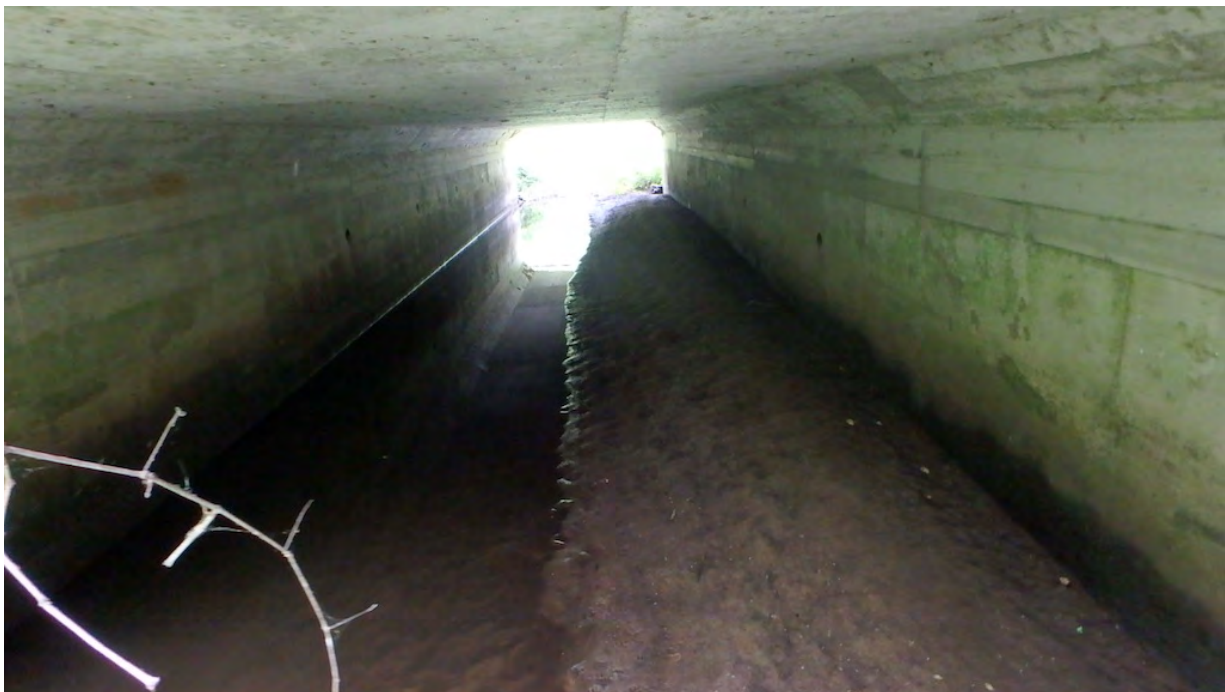
Figure 8 Barrel, Note Buildup of Material Along East Wall

Bridge Cleaning

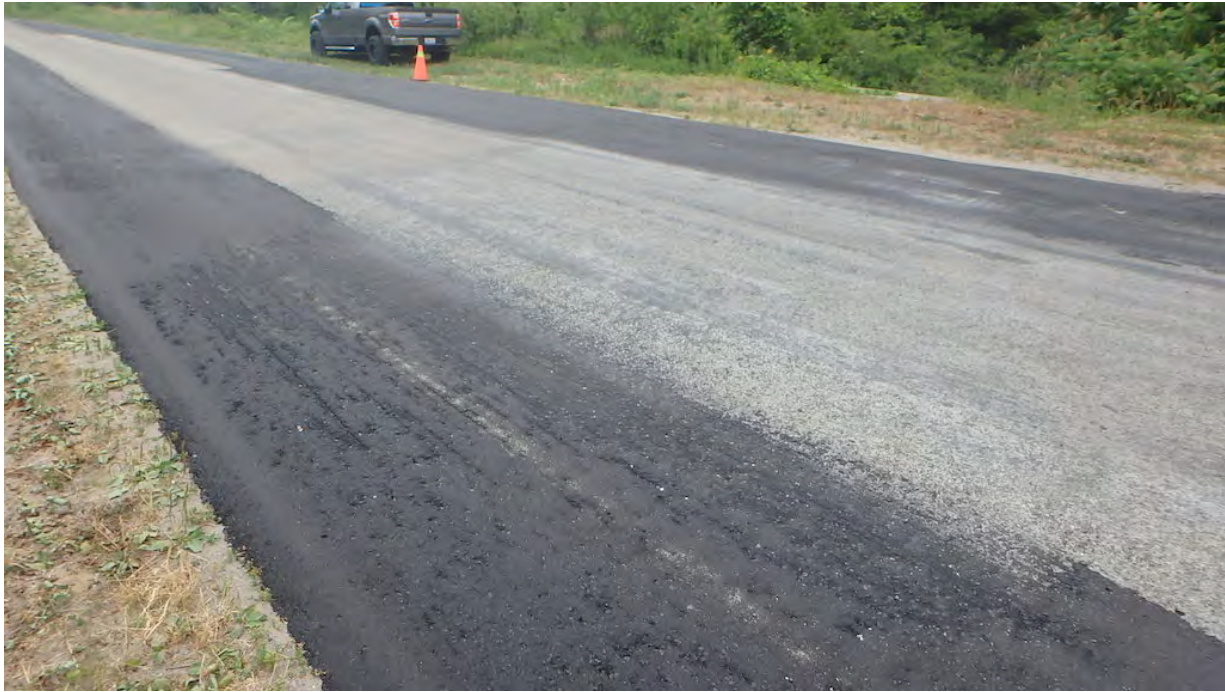
Figure 11      Wearing Surface, Patched

Investigation Notes: Wearing Surface - Rout and Seal, Bridge Cleaning - Bridge Surface Repair
