LOT 1-2 CONCESSION 5 HOUGHTON

Site Number 002030

LOWER SIDE ROAD, HOUGHTON

Ontario Structure Inspection Manual - Inspection Form

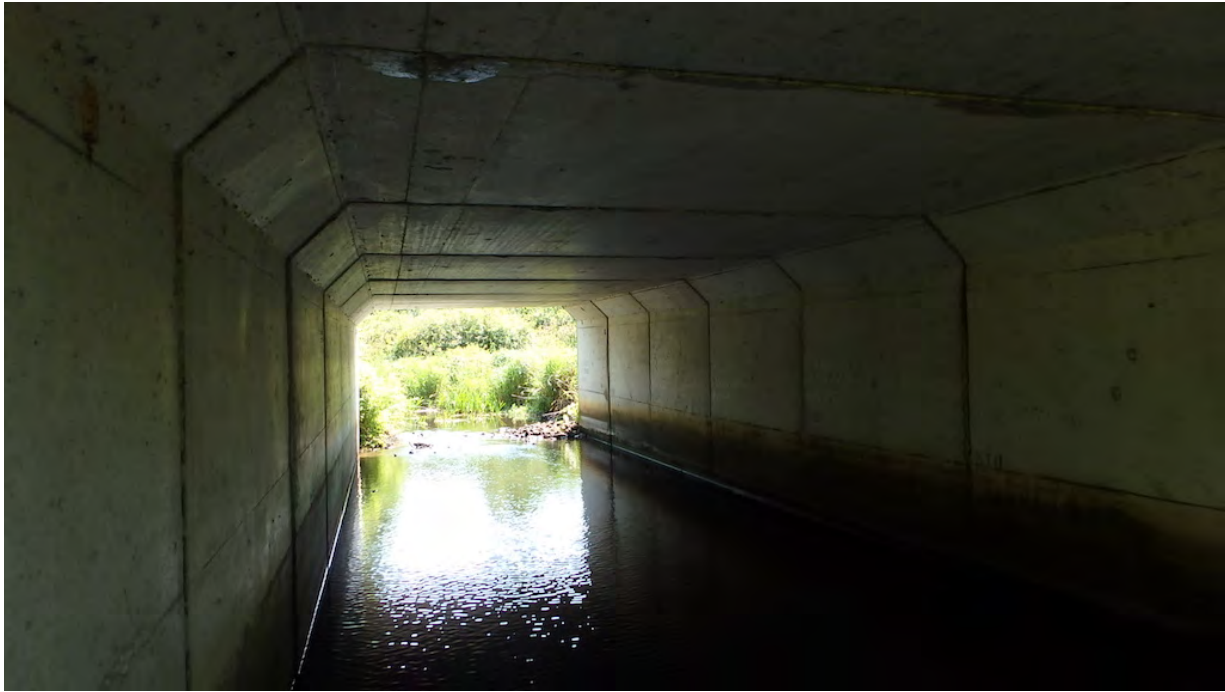
Figure 7 Barrel, Looking South

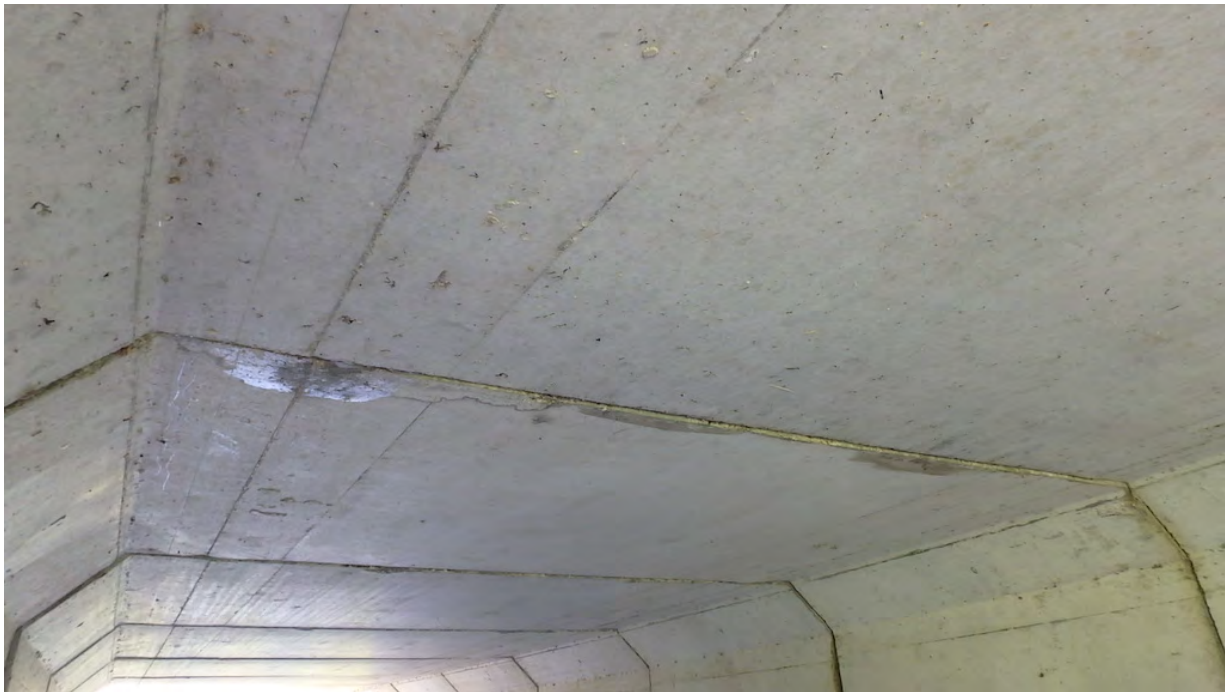
Figure 8 Staining on Soffit

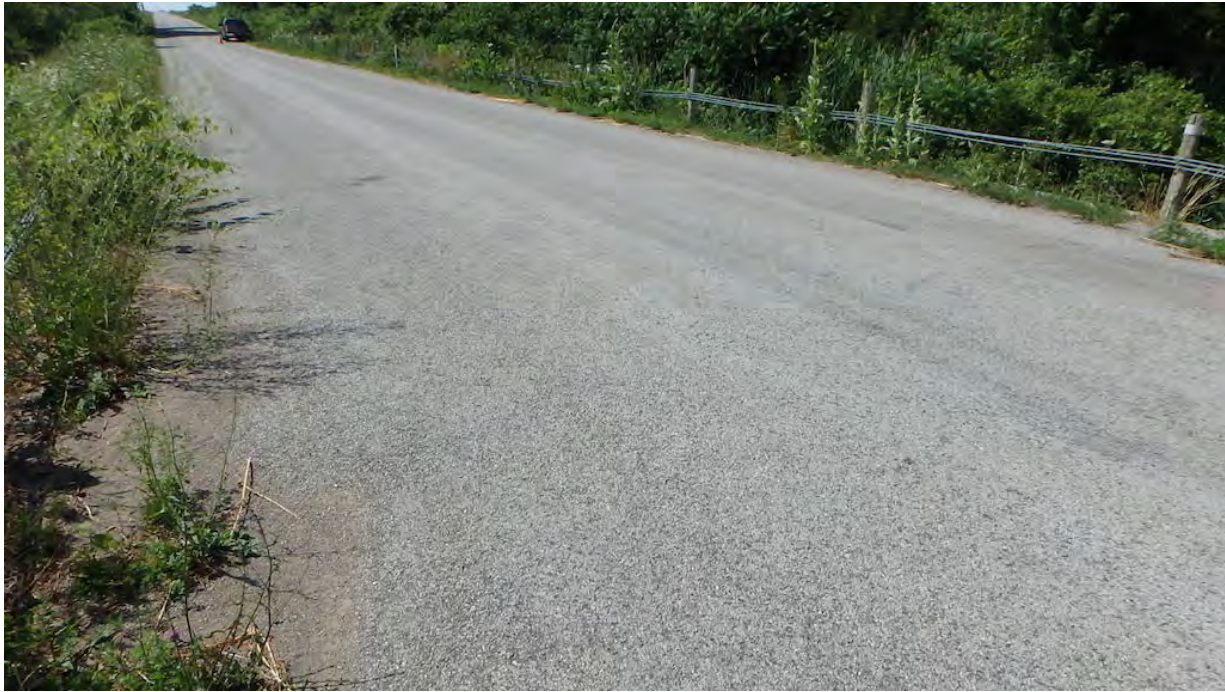
Figure 9 Minor Settlement at Structure Edges

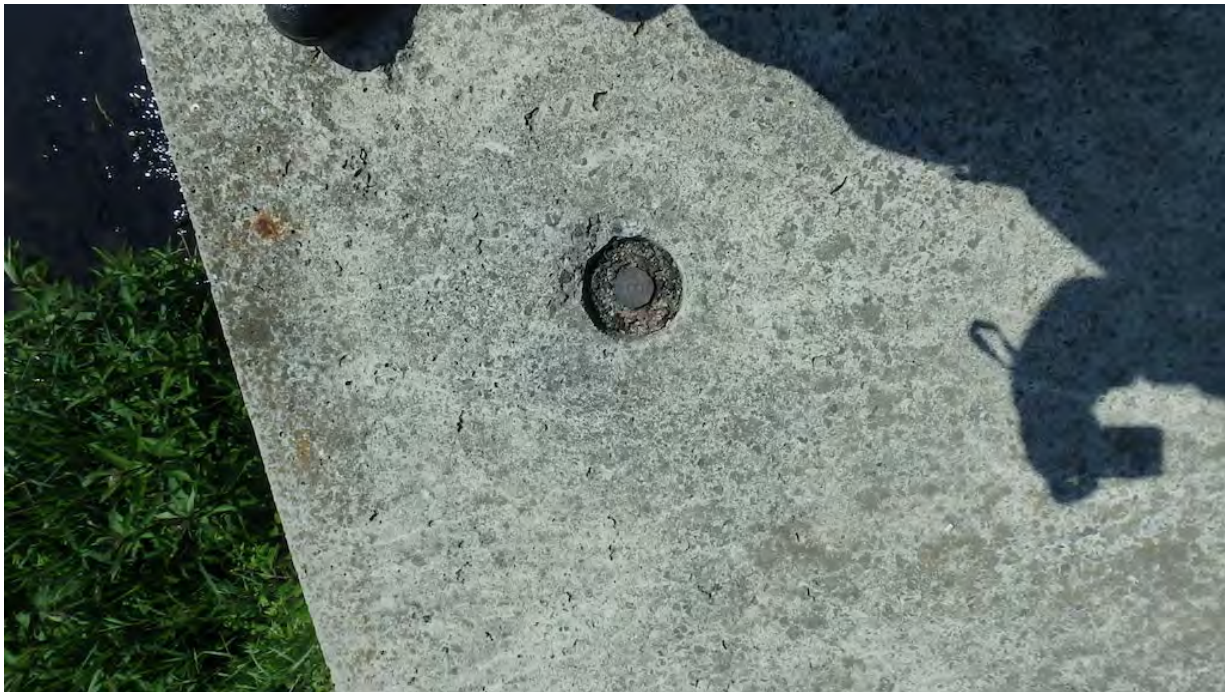
Figure 10 Lifting Lug on Culvert Top

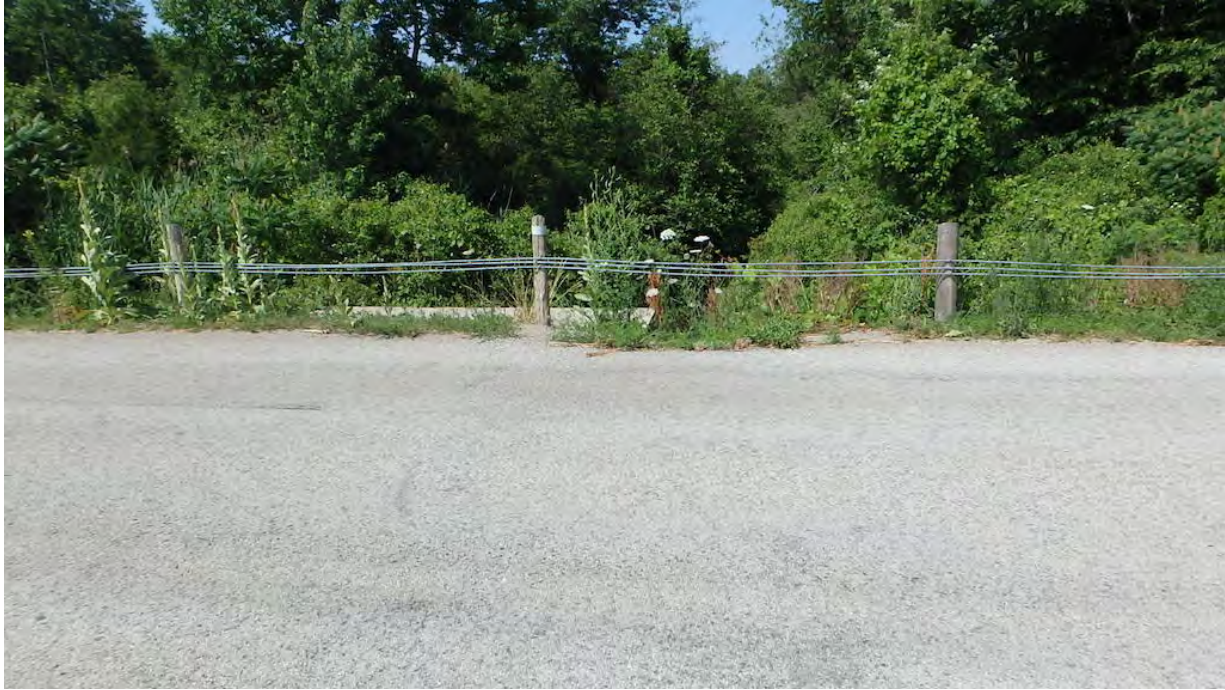
Element Group:	400 Barriers					Length:	93.6
Element Name:	402 Railing System					Width:	
Location:						Height:	
Material:	Steel Cable					Count:	2
Element Type:						Total Quantity:	187.2 m
Environment:	Severe					Limited Inspection:	
Protection System:	Unknown					Perform. Deficiencies	
Condition	Units	Exc.	Good	Fair	Poor		
Data:	m	0	0	100	87.2		
Comments: Cables loose, one (1) broken/rotted post noted on southwest near culvert inlet. Many cracked and rotted posts. Guiderail is overgrown.							
Recommended Work: Rehab <input type="checkbox"/> Replace <input type="checkbox"/>					Maintenance Needs: Bridge Railing System Maintenance		
Timing: Urgent <input type="checkbox"/> < 1yr <input type="checkbox"/> 1 - 5 yr <input type="checkbox"/> 6 - 10 yr <input type="checkbox"/>					<input type="checkbox"/> Urgent <input type="checkbox"/> 1 year <input checked="" type="checkbox"/> 2 year

Figure 11 Loose Guiderail Cables
