LOT 12-13 N.L.R. HOUGHTON

Site Number 002031

5TH CONCESSION ROAD, HOUGHTON

Ontario Structure Inspection Manual - Inspection Form

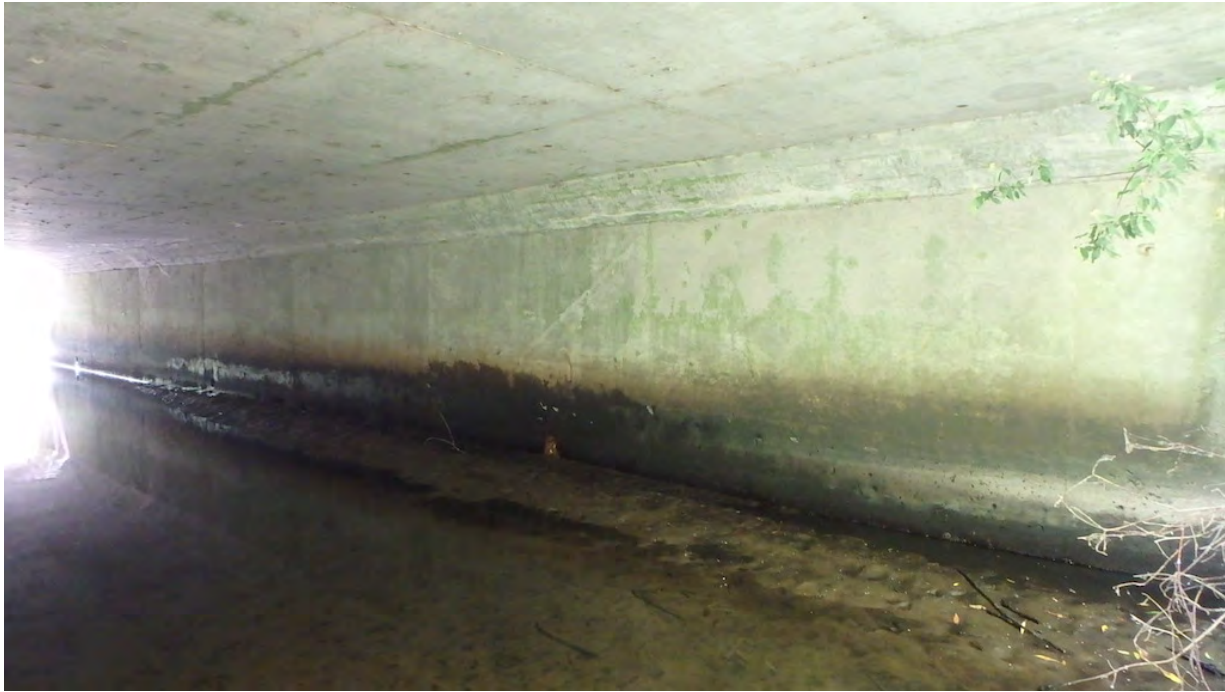
Figure 7 North Barrel Wall, Note Staining

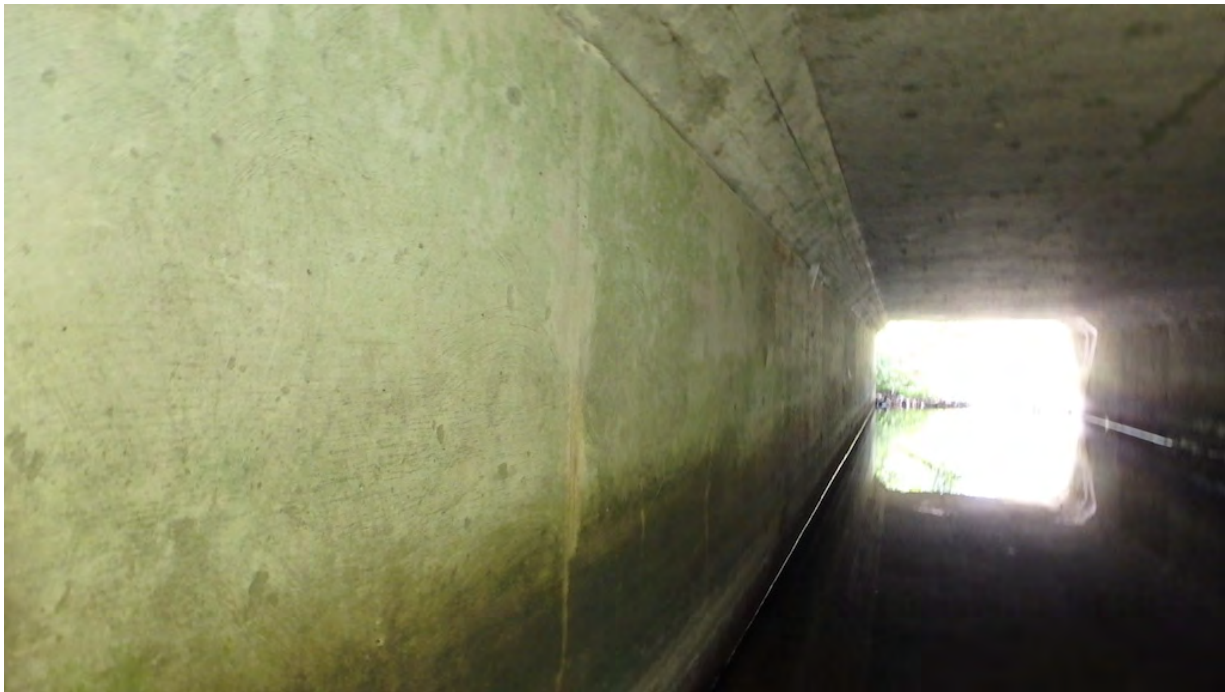
Figure 8 South Barrel Wall, Narrow Vertical Cracks

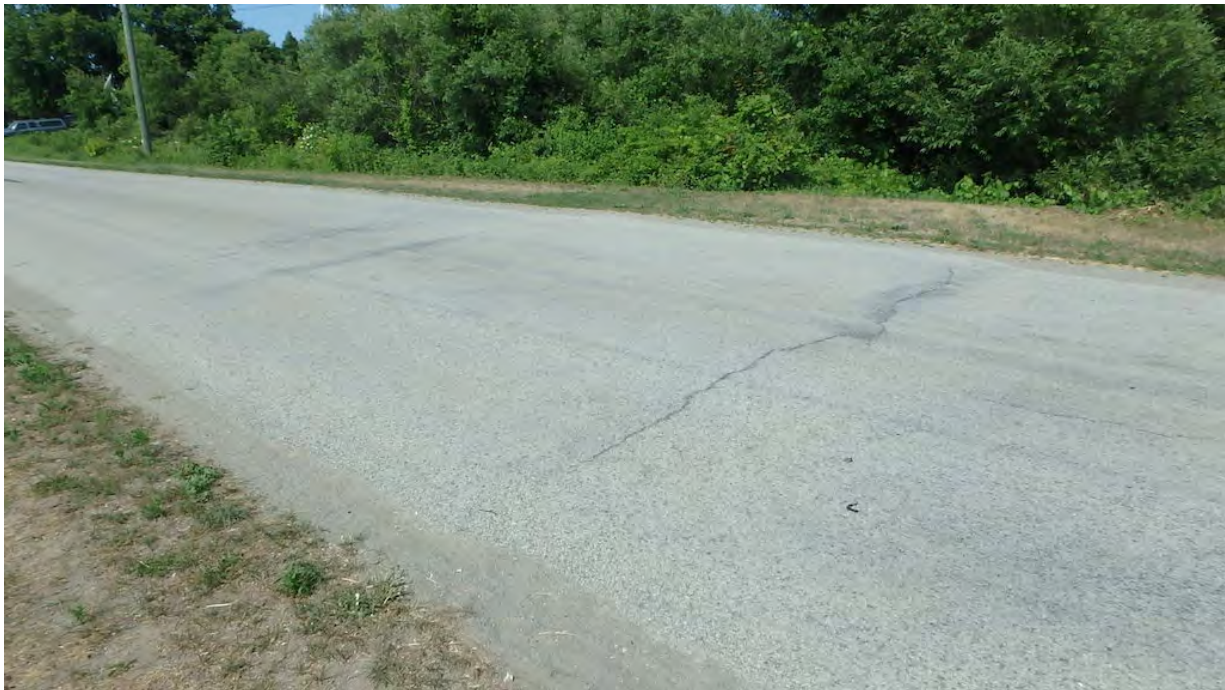
Figure 10 Settlement at Structure Edges
