**7<sup>TH</sup> CONCESSION ROAD CULVERT**

Site Number 002034

**LOWER SIDE ROAD, HOUGHTON**

**Ontario Structure Inspection Manual - Inspection Form**

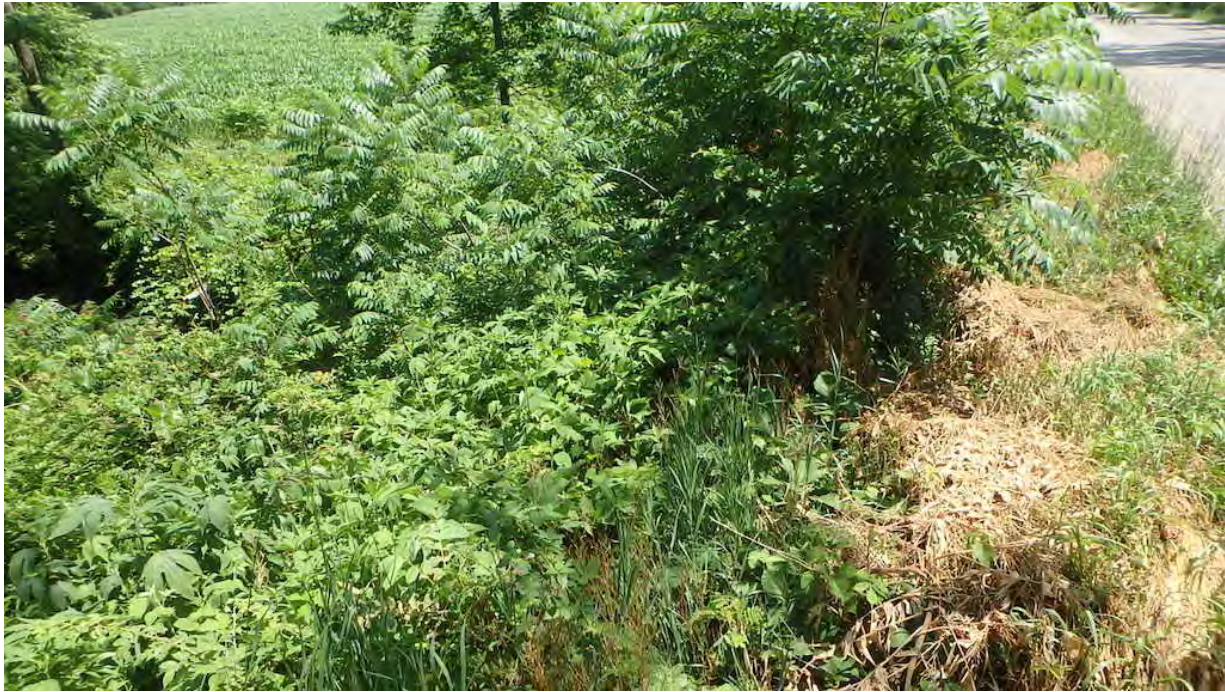
Figure 3 Inlet – Culvert Top

Element Group:		1200 Culverts				Length:	4.9
Element Name:		1201 Inlet Components				Width:	0.3
Location:						Height:	1.9
Material:		4 Cast-in-place Concrete				Count:	1
Element Type:						Total Quantity:	2.6 sq.m
Environment:		Moderate				Limited Inspection:	<b>X</b>
Protection System:		Unknown				Perform. Deficiencies	
Condition Data:	Units	Exc.	Good	Fair	Poor		
	sq.m	0	2.6	0	0		
Comments: Slopes stable. Minor crack at northeast corner (2014) Limited inspection due to overgrown 2016.							
Recommended Work: Rehab <input type="checkbox"/> Replace <input type="checkbox"/>				Maintenance Needs:			
Timing: Urgent <input type="checkbox"/> < 1yr <input type="checkbox"/> 1 - 5 yr <input type="checkbox"/> 6 - 10 yr <input type="checkbox"/>				<input type="checkbox"/> Urgent <input type="checkbox"/> 1 year <input type="checkbox"/> 2 year

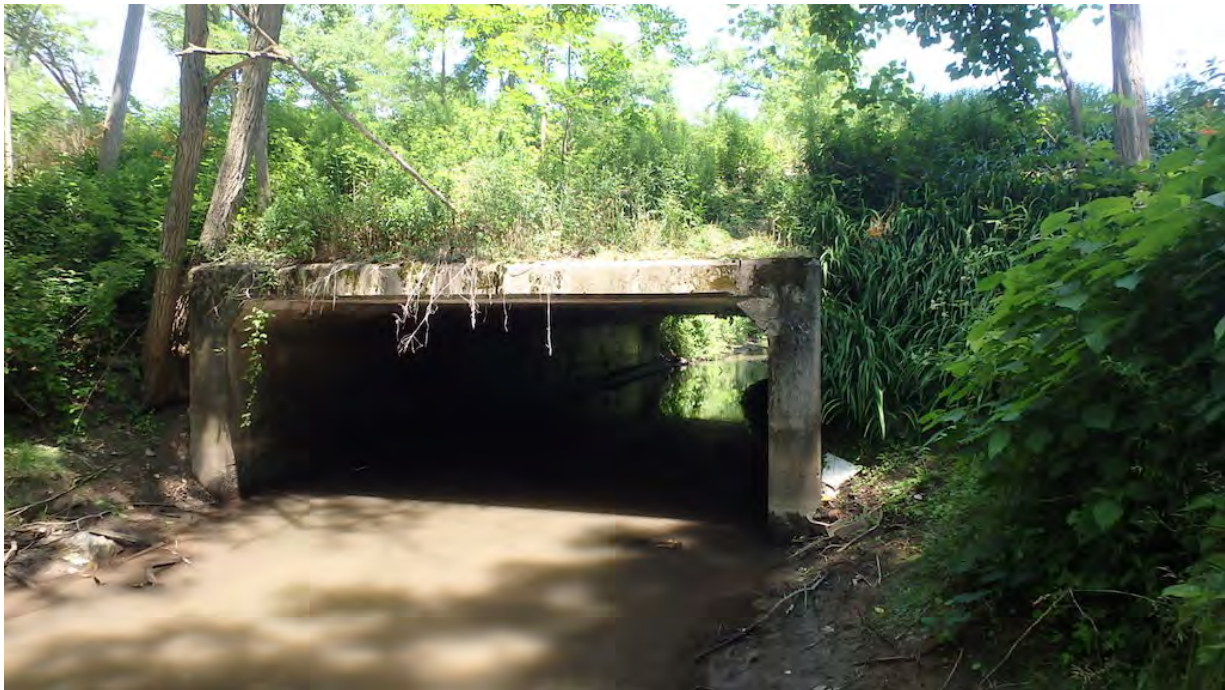
Figure 4 South Profile, Outlet

Element Group:		1200 Culverts				Length:		4.9
Element Name:		1202 Outlet Components				Width:		0.3
Location:						Height:		1.9
Material:		4 Cast-in-place Concrete				Count:		1
Element Type:						Total Quantity:		2.6 sq.m
Environment:		Moderate				Limited Inspection:		
Protection System:		Unknown				Perform. Deficiencies		
Condition Data:	Units	Exc.	Good	Fair	Poor			
	sq.m	0	2.3	0.3	0			
Comments:								
Slopes stable. Minor spalling on southeast face.								
Recommended Work:				Rehab <input type="checkbox"/>		Replace <input type="checkbox"/>		
Timing:				Urgent <input type="checkbox"/>		< 1yr <input type="checkbox"/>		
				1 - 5 yr <input type="checkbox"/>		6 - 10 yr <input type="checkbox"/>		
Maintenance Needs:				Repair of Bridge Concrete				
				<input type="checkbox"/> Urgent		<input checked="" type="checkbox"/> 1 year		
				<input type="checkbox"/> 2 year

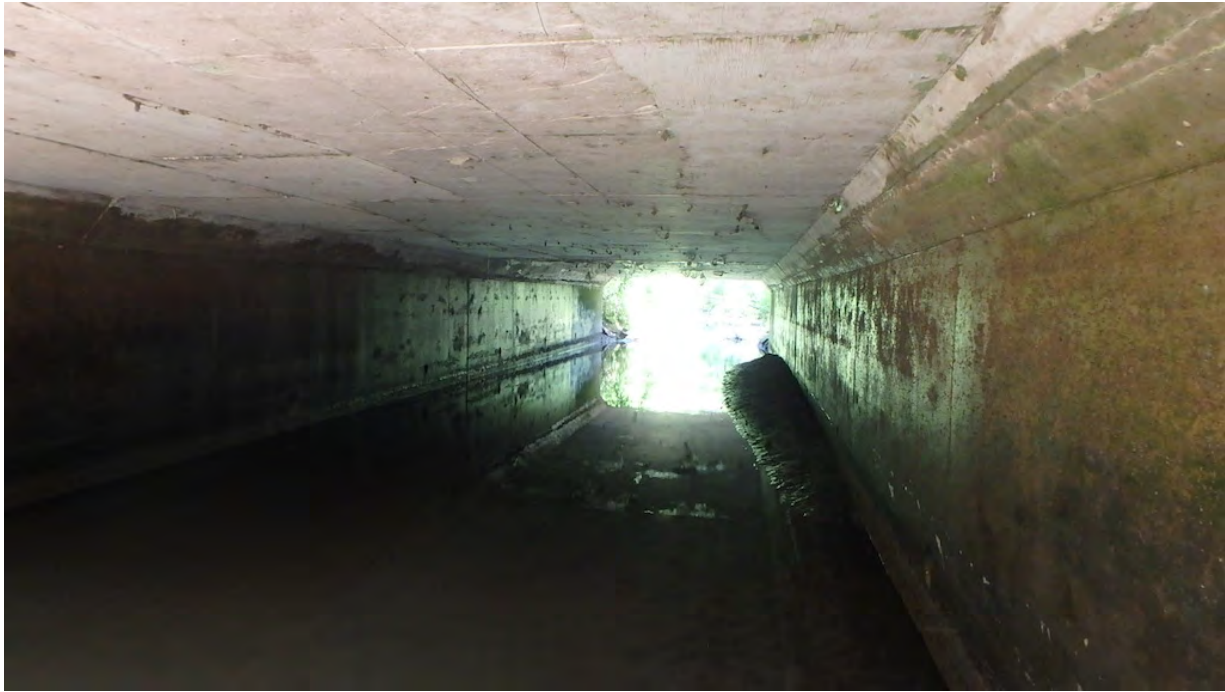
Figure 7 Barrel

Element Group:		1200 Culverts				Length:	23
Element Name:		1203 Barrels				Width:	4.9
Location:		Inside				Height:	1.9
Material:		4 Cast-in-place Concrete				Count:	1
Element Type:						Total Quantity:	200.1 sq.m
Environment:		Benign				Limited Inspection:	
Protection System:		Unknown				Perform. Deficiencies	
Condition Data:	Units	Exc.	Good	Fair	Poor		
	sq.m	0	200	0.1	0		
Comments: Top of deck not visible. Minor popout with exposed rebar. Staining & leakage evident.							
Recommended Work: Rehab <input type="checkbox"/> Replace <input type="checkbox"/>				Maintenance Needs:			
Timing: Urgent <input type="checkbox"/> < 1yr <input type="checkbox"/> 1 - 5 yr <input type="checkbox"/> 6 - 10 yr <input type="checkbox"/>				<input type="checkbox"/> Urgent <input type="checkbox"/> 1 year <input type="checkbox"/> 2 year

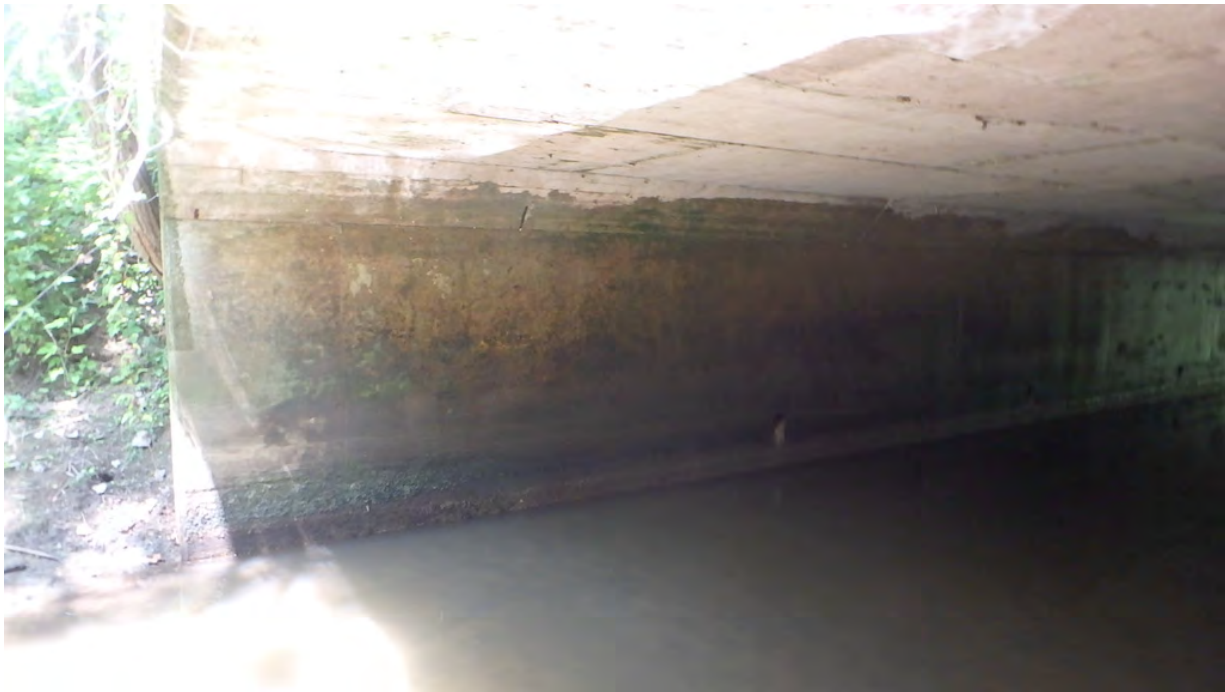
Figure 8 Staining and Wetness on Wall

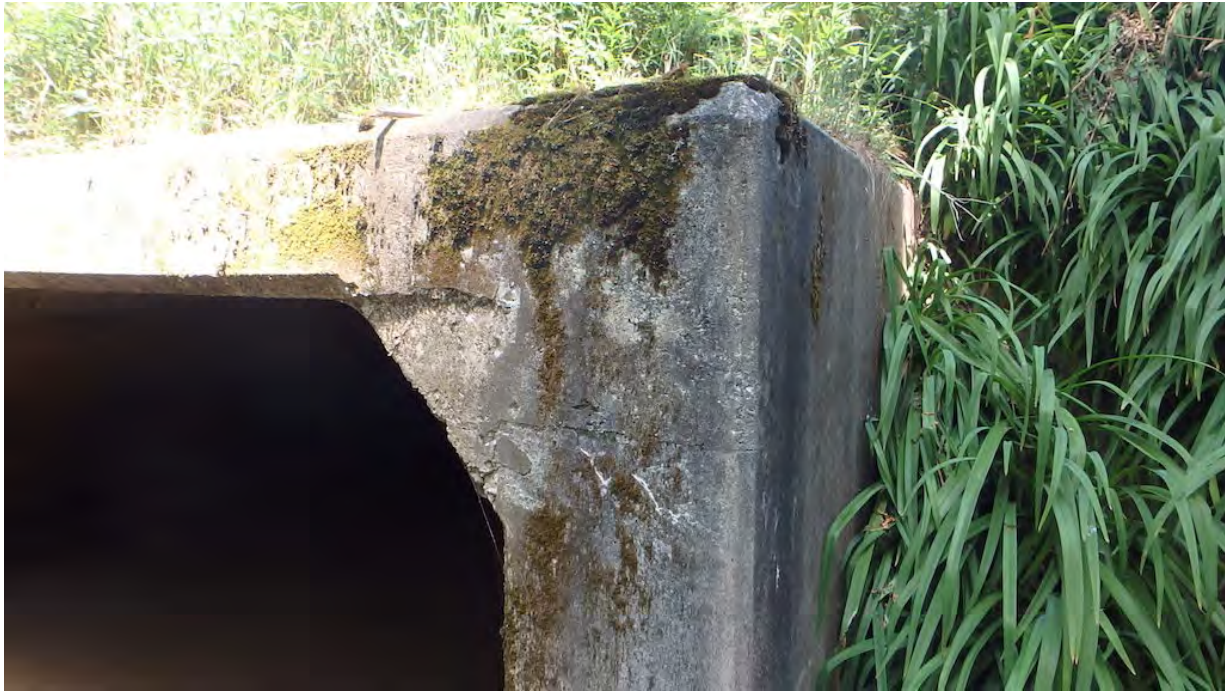
Figure 9 Minor Scale and Construction Joint Deterioration

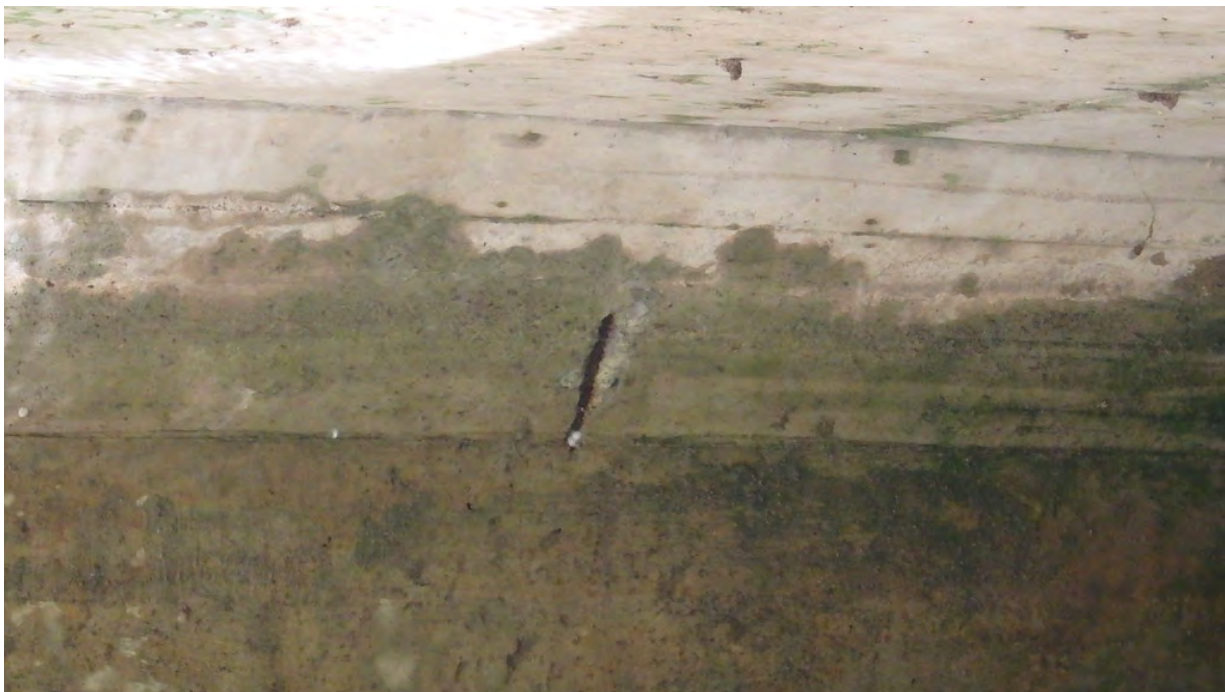
Figure 10 Popout with Exposed Rebar
