LOT 2 CONCESSION 6-7 HOUGHTON

Site Number 002035

7TH CONCESSION ROAD, HOUGHTON

Ontario Structure Inspection Manual - Inspection Form

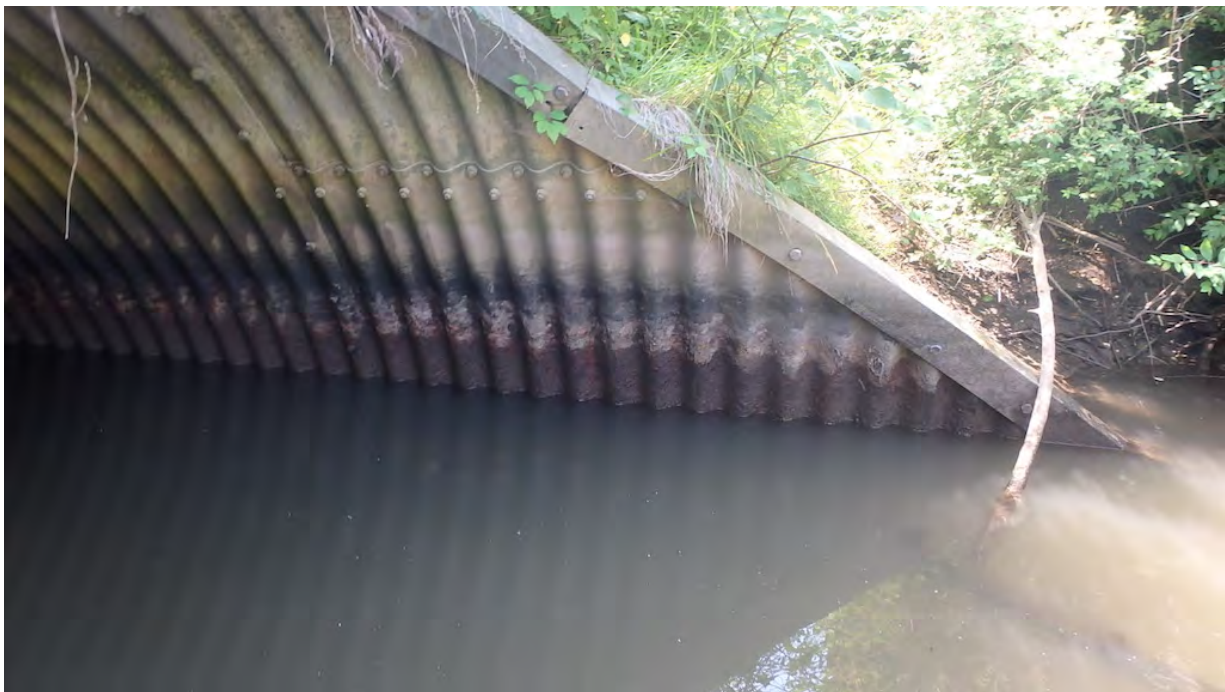
Figure 8 Corrosion at Waterline

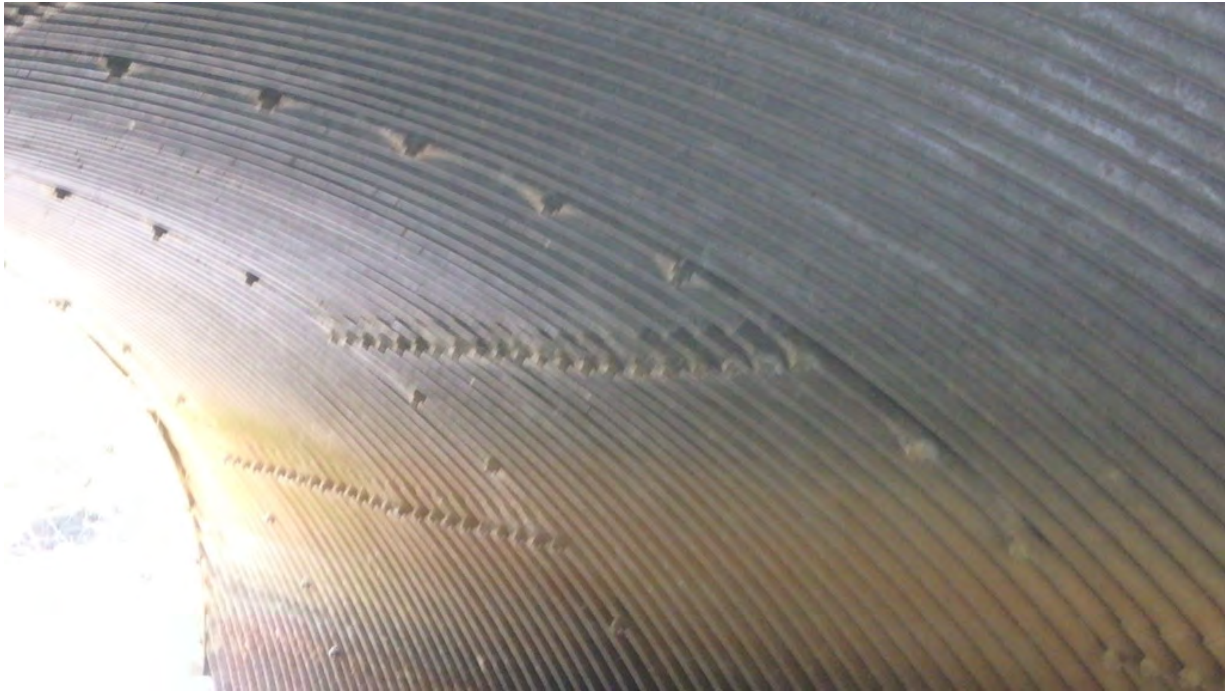
Figure 9 Deformation at Multiplate Joint

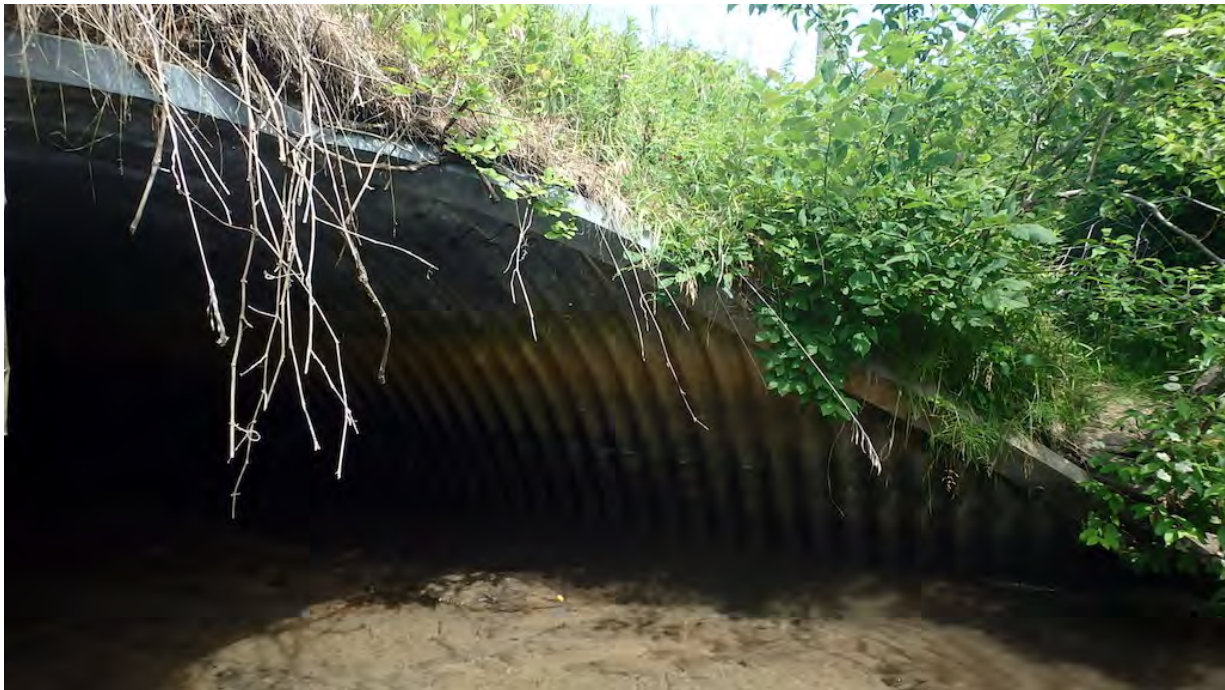
Figure 10 Wingwall, Note Corrosion

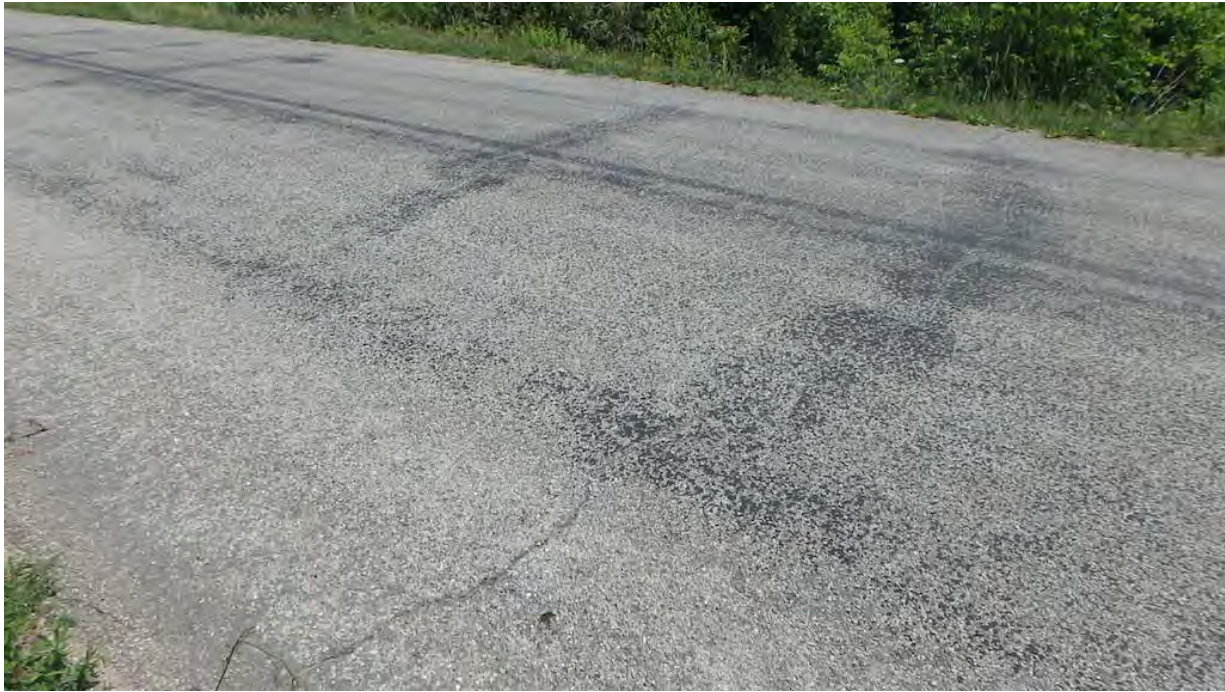
Figure 11 Transverse Cracks and Polishing of Wearing Surface
