JAMES BERRY DRAIN, LOT 2 CONCESSION A-1

Site Number 002106

1ST CONCESSION ROAD, SOUTH WALSINGHAM

Ontario Structure Inspection Manual - Inspection Form

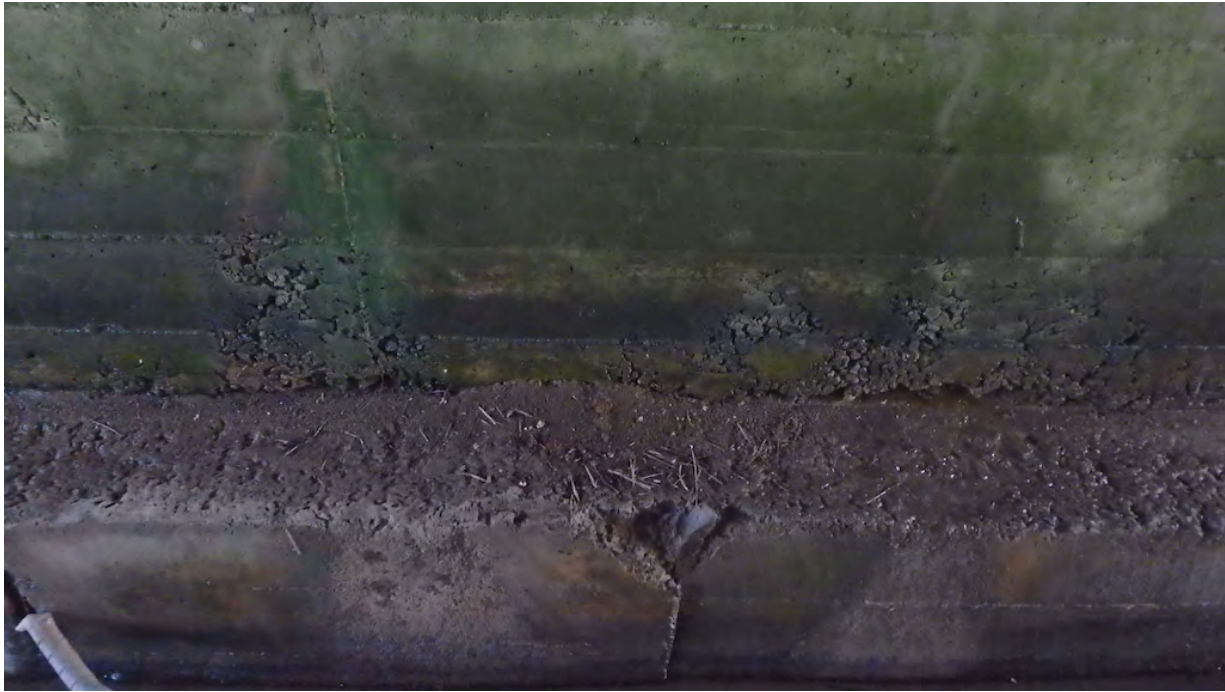
Figure 9 Honeycombing on Footing and Walls

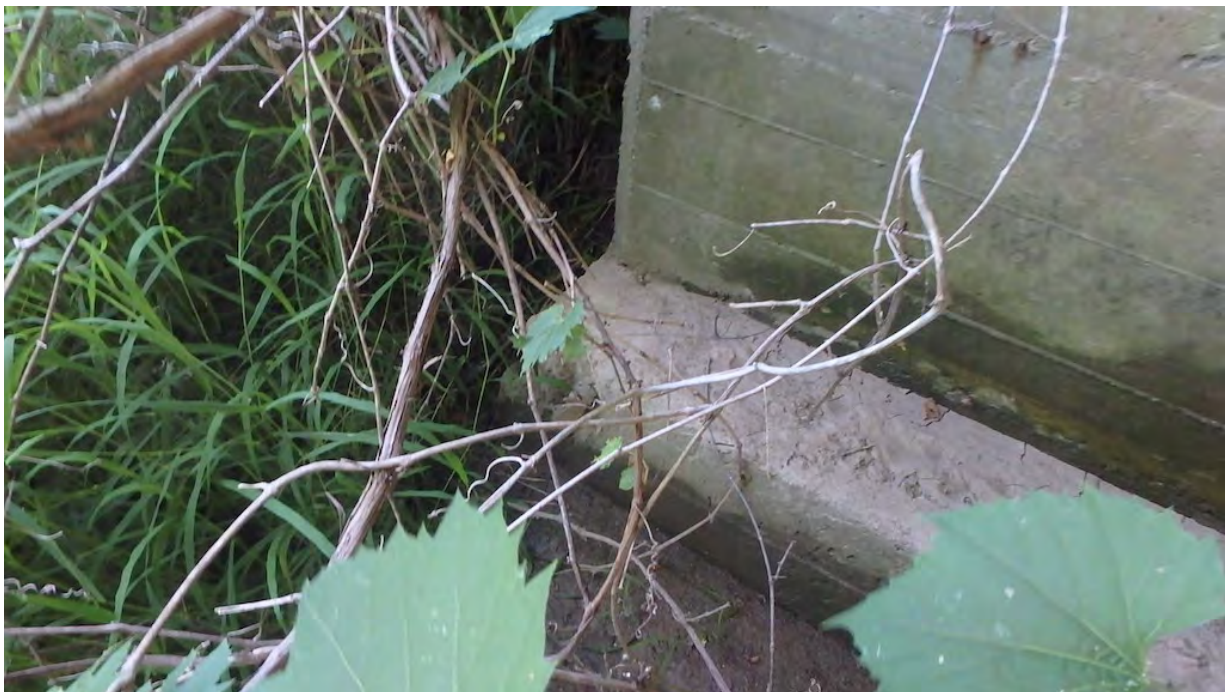
Figure 10 Spall on Footing at Southwest Corner

Element Group:	1300 Foundations	Length:	2.5										
Element Name:	1301 Foundation (below ground level)	Width:	1										
Location:		Height:	1										
Material:		Count:	2										
Element Type:	Spread	Total Quantity:	5 m										
Environment:	Benign	Limited Inspection:											
Protection System:	Unknown	Perform. Deficiencies											
Condition Data:	<table border="1" style="width: 100%; border-collapse: collapse;"> <tr> <th style="width: 10%;">Units</th> <th style="width: 10%;">Exc.</th> <th style="width: 10%;">Good</th> <th style="width: 10%;">Fair</th> <th style="width: 10%;">Poor</th> </tr> <tr> <td>m</td> <td style="text-align: center;">0</td> <td style="text-align: center;">5</td> <td style="text-align: center;">0</td> <td style="text-align: center;">0</td> </tr> </table>	Units	Exc.	Good	Fair	Poor	m	0	5	0	0		
Units	Exc.	Good	Fair	Poor									
m	0	5	0	0									
Comments: The footings are visible throughout - the waterbed is 0.6m below top of footings. Minor deterioration and standing water on footings (2014). Minor deterioration at joint between wall and footing.													
Recommended Work: Rehab <input type="checkbox"/> Replace <input type="checkbox"/> Timing: Urgent <input type="checkbox"/> < 1yr <input type="checkbox"/> 1 - 5 yr <input type="checkbox"/> 6 - 10 yr <input type="checkbox"/>		Maintenance Needs: Repair of Bridge Concrete <input type="checkbox"/> Urgent <input type="checkbox"/> 1 year <input checked="" type="checkbox"/> 2 year

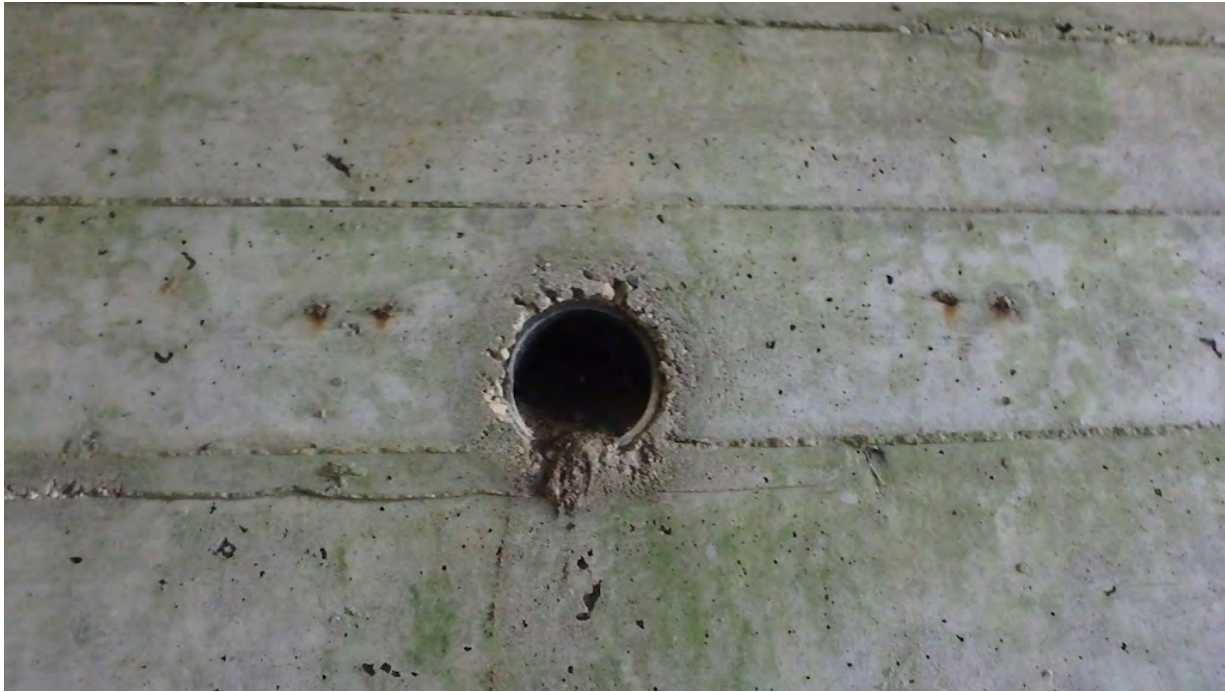
Figure 11 Weeping Holes Plugged with Debris
