LOT CONCESSION A-1, S. WALSINGHAM

Site Number 002107

Ontario Structure Inspection Manual - Inspection Form

Field Inspection Information:		
Date of Inspection:	July 6, 2016	Type of Inspection: <input checked="" type="checkbox"/> OSIM <input type="checkbox"/> Enhanced OSIM
Inspector:	Matt Alderson, G. Douglas Vallee Ltd.	
Others in Party:	N/A	
Access Equipment Used:	Hammer, Binoculars, Measuring Tape, Camera, etc.	
Weather:	Sunny	
Temperature:	25 °C

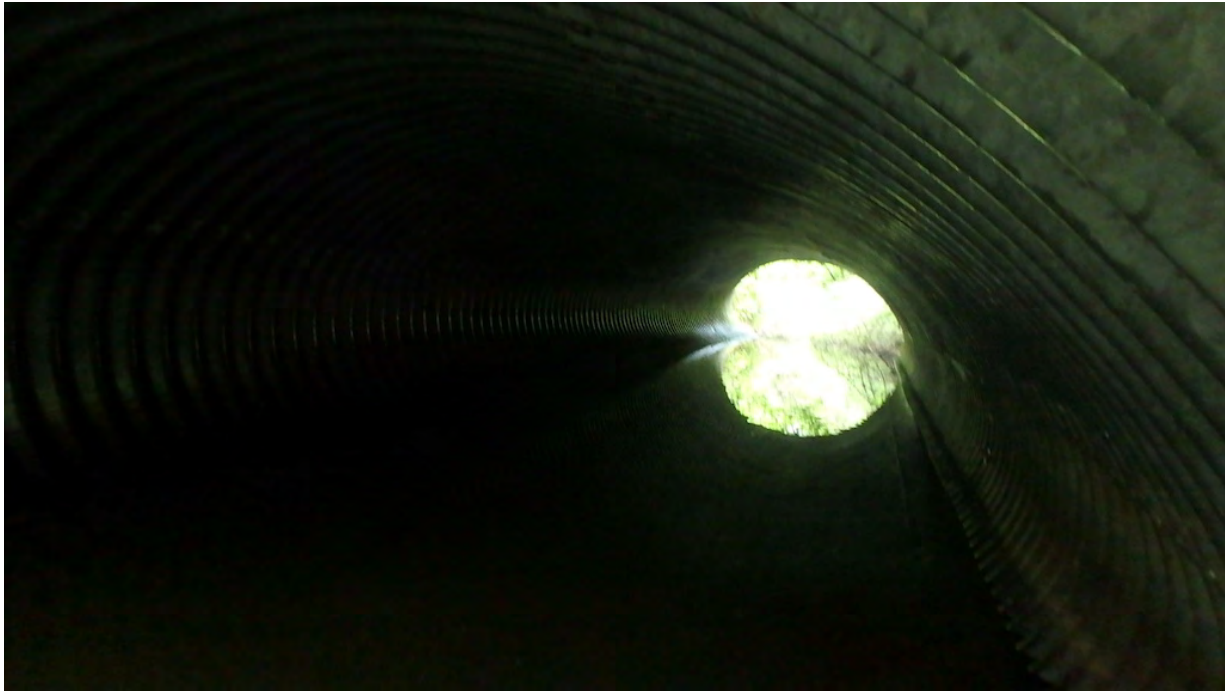
Figure 3 Barrel

Element Group:		1200 Culverts				Length:	
Element Name:		1203 Barrels				Width:	
Location:						Height:	
Material:		5 Corrugated Steel				Count:	1
Element Type:						Total Quantity:	1 Each
Environment:		Moderate				Limited Inspection:	
Protection System:		Hot Dip Galvanized				Perform. Deficiencies	
Condition	Units	Exc.	Good	Fair	Poor		
Data:	Each	0	1	0	0		
Comments: Galvanizing is good. Minor surface corrosion at waterline.							
Recommended Work: Rehab <input type="checkbox"/> Replace <input type="checkbox"/>					Maintenance Needs:		
Timing: Urgent <input type="checkbox"/> < 1yr <input type="checkbox"/> 1 - 5 yr <input type="checkbox"/> 6 - 10 yr <input type="checkbox"/>					<input type="checkbox"/> Urgent <input type="checkbox"/> 1 year <input type="checkbox"/> 2 year

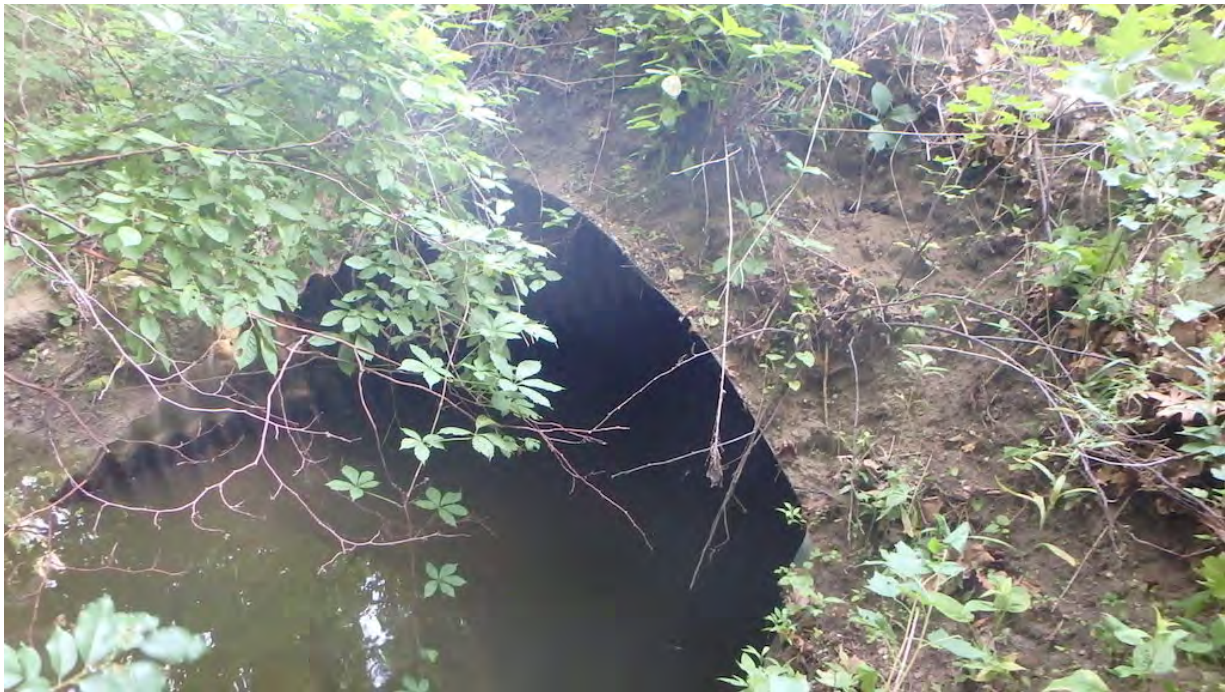
Figure 4 South Profile, Outlet

Element Group:	1200 Culverts					Length:	
Element Name:	1202 Outlet Components					Width:	
Location:						Height:	
Material:	10 Other					Count:	1
Element Type:						Total Quantity:	1 Each
Environment:	Moderate					Limited Inspection:	
Protection System:	Unknown					Perform. Deficiencies	
Condition Data:	Units Each	Exc. 0	Good 0	Fair 1	Poor 0		
Comments: Slope protection is failing at outlet. Erosion at southwest quadrant. Overgrown.							
Recommended Work: Rehab <input type="checkbox"/> Replace <input type="checkbox"/>					Maintenance Needs: Erosion Control at Bridges		
Timing: Urgent <input type="checkbox"/> < 1yr <input type="checkbox"/> 1 - 5 yr <input type="checkbox"/> 6 - 10 yr <input type="checkbox"/>					<input type="checkbox"/> Urgent <input checked="" type="checkbox"/> 1 year <input type="checkbox"/> 2 year

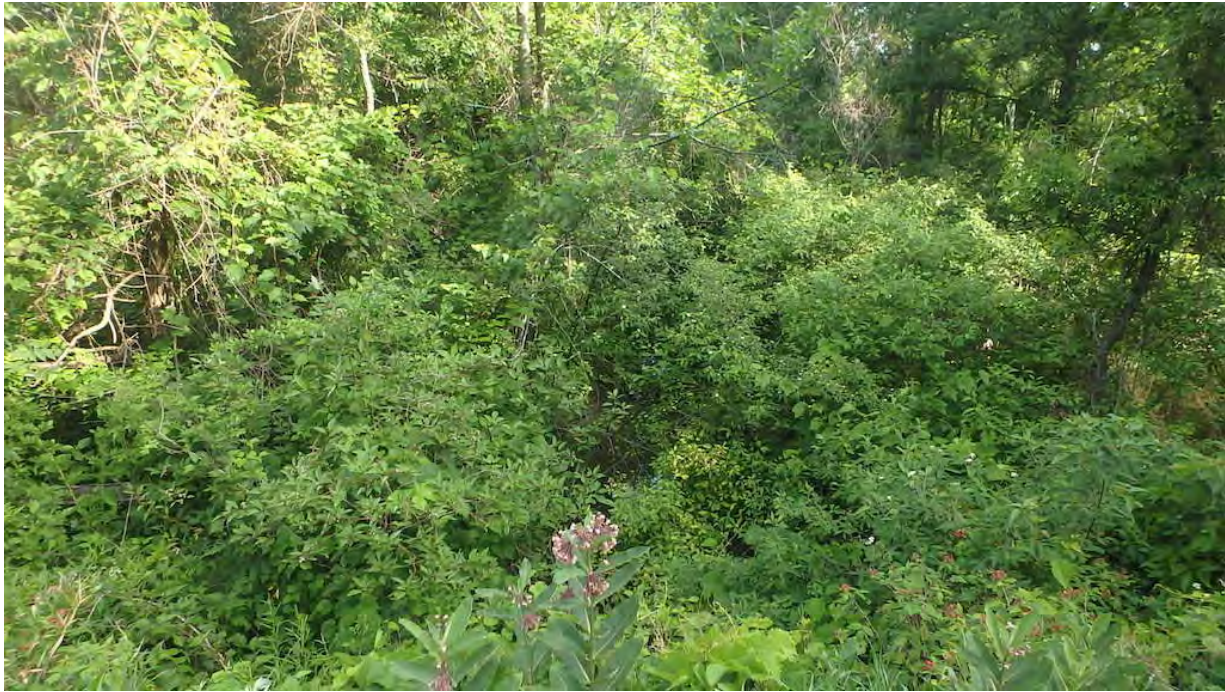
Figure 5 Upstream

Element Group:		1200 Culverts				Length:	
Element Name:		1201 Inlet Components				Width:	
Location:						Height:	
Material:		10 Other				Count:	1
Element Type:						Total Quantity:	1 Each
Environment:		Moderate				Limited Inspection:	
Protection System:		Unknown				Perform. Deficiencies	
Condition	Units	Exc.	Good	Fair	Poor		
Data:	Each	0	1	0	0	Flooding/channel blockage	
Comments: Clear vegetation. Overgrown.							
Recommended Work: Rehab <input type="checkbox"/> Replace <input type="checkbox"/>					Maintenance Needs:		
Timing: Urgent <input type="checkbox"/> < 1yr <input type="checkbox"/> 1 - 5 yr <input type="checkbox"/> 6 - 10 yr <input type="checkbox"/>					<input type="checkbox"/> Urgent <input type="checkbox"/> 1 year <input type="checkbox"/> 2 year

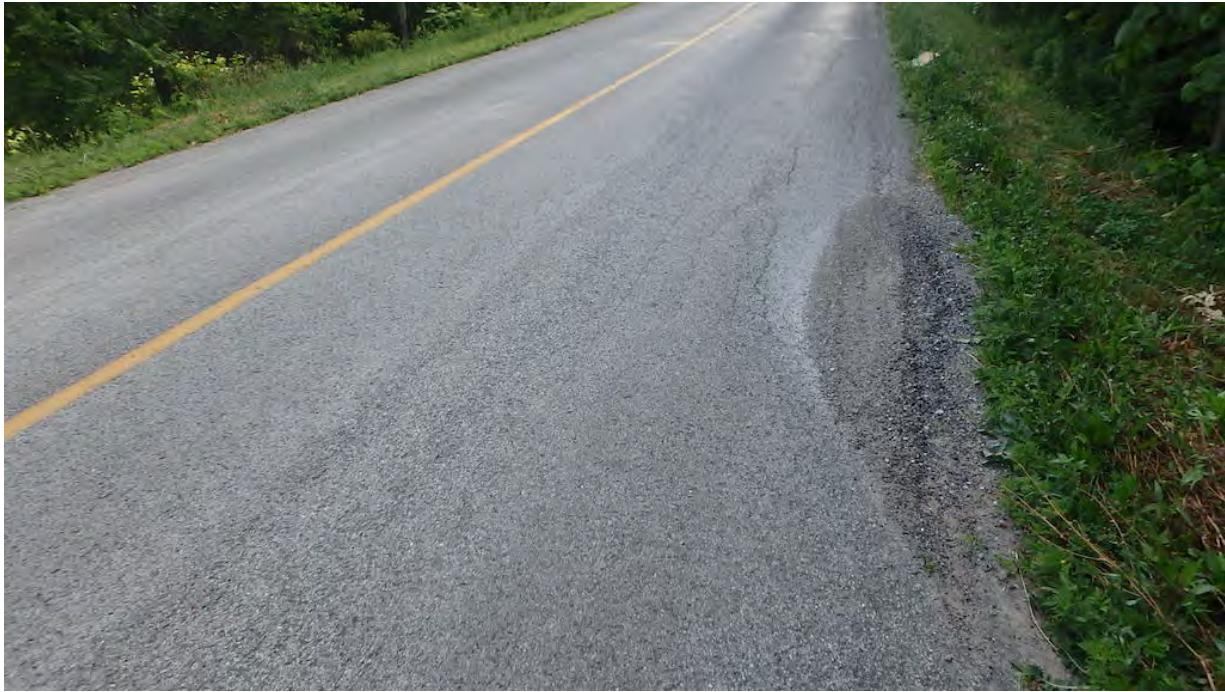
Element Group:		1600 Approaches				Length:	30
Element Name:		1601 Wearing Surface (Approaches)				Width:	8
Location:		Top of Pipe				Height:	
Material:						Count:	1
Element Type:						Total Quantity:	240 sq.m
Environment:		Severe				Limited Inspection:	
Protection System:		Unknown				Perform. Deficiencies	
Condition	Units	Exc.	Good	Fair	Poor		
Data:	sq.m	0	239	1	0		
Comments: Surface is cracking at edges near culvert ends (minor).							
Recommended Work: Rehab <input type="checkbox"/> Replace <input type="checkbox"/>					Maintenance Needs:		
Timing: Urgent <input type="checkbox"/> < 1yr <input type="checkbox"/> 1 - 5 yr <input type="checkbox"/> 6 - 10 yr <input type="checkbox"/>					<input type="checkbox"/> Urgent <input type="checkbox"/> 1 year <input type="checkbox"/> 2 year

Figure 7 Minor Settlement and Cracking at Road Edges
