LOT 8 CONCESSION A-B OVERFLOW

Site Number 002113

CONCESSION A ROAD, SOUTH WALSINGHAM

Ontario Structure Inspection Manual - Inspection Form

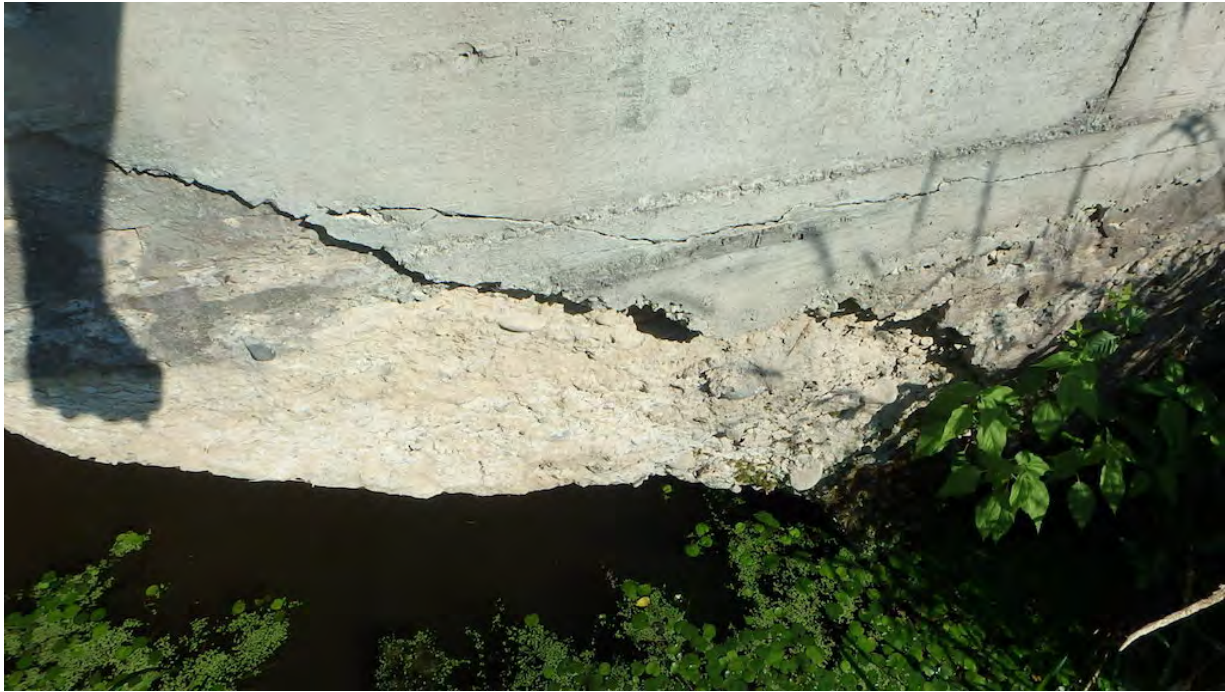
Figure 7 Deterioration of Fascia

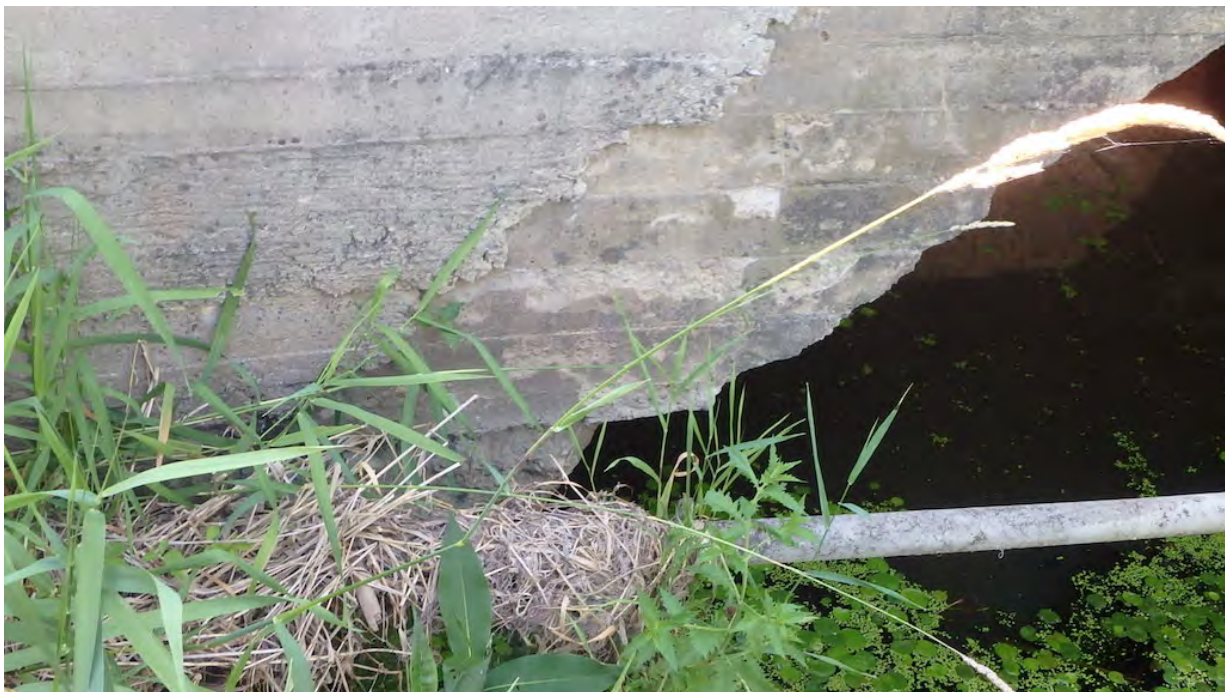
Element Group:		900 Abutments				Length:	7.9
Element Name:		903 Wingwalls				Width:	0.25
Location:		Each End				Height:	2.6
Material:		4 Cast-in-place Concrete				Count:	2
Element Type:		Reinforced Concrete				Total Quantity:	10.3 sq.m
Environment:		Moderate				Limited Inspection:	
Protection System:		Unknown				Perform. Deficiencies	
Condition	Units	Exc.	Good	Fair	Poor	Load carrying capacity	
Data:	sq.m	0	0	10.3	0		
Comments: 0.4m above road.							
Recommended Work: Rehab <input checked="" type="checkbox"/> Replace <input type="checkbox"/>				Maintenance Needs: Repair of Bridge Concrete			
Timing: Urgent <input type="checkbox"/> < 1yr <input type="checkbox"/> 1 - 5 yr <input checked="" type="checkbox"/> 6 - 10 yr <input type="checkbox"/>				<input type="checkbox"/> Urgent <input type="checkbox"/> 1 year <input checked="" type="checkbox"/> 2 year

Figure 8 Deterioration of Wingwall

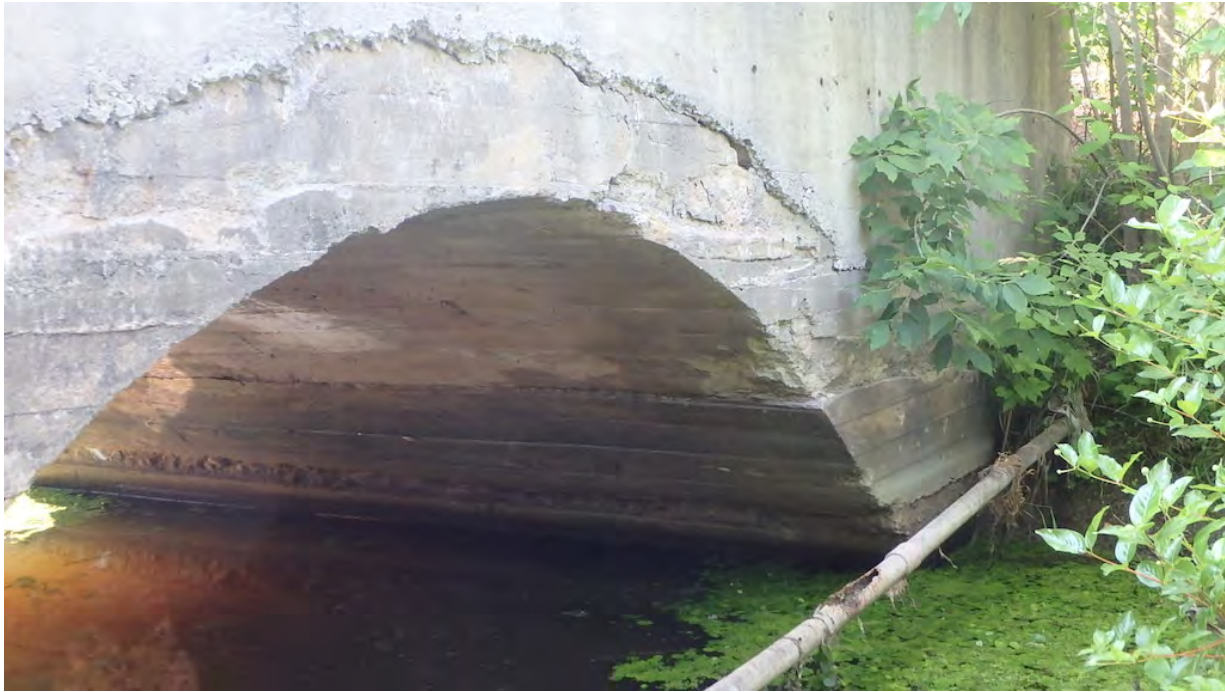
Element Group:		1200 Culverts				Length:	4.8
Element Name:		1203 Barrels				Width:	4.3
Location:						Height:	2
Material:		4 Cast-in-place Concrete				Count:	1
Element Type:		Arch				Total Quantity:	41.3 sq.m
Environment:		Moderate				Limited Inspection:	
Protection System:		Unknown				Perform. Deficiencies	
Condition	Units	Exc.	Good	Fair	Poor	Load carrying capacity	
Data:	sq.m	0	0	20.6	20.6		
Comments: Large cracking at midspan. Poor concrete at end. Recommend replacement. Exposed rebar on soffit.							
Recommended Work: Rehab <input type="checkbox"/> Replace <input checked="" type="checkbox"/>				Maintenance Needs: Repair of Bridge Concrete			
Timing: Urgent <input type="checkbox"/> < 1yr <input type="checkbox"/> 1 - 5 yr <input checked="" type="checkbox"/> 6 - 10 yr <input type="checkbox"/>				<input type="checkbox"/> Urgent <input checked="" type="checkbox"/> 1 year <input type="checkbox"/> 2 year

Figure 9 Transverse Crack Along Soffit
