**LOT 9 CONCESSION A-B OVERFLOW**

Site Number 002114

**CONCESSION A ROAD, SOUTH WALSINGHAM**

**Ontario Structure Inspection Manual - Inspection Form**

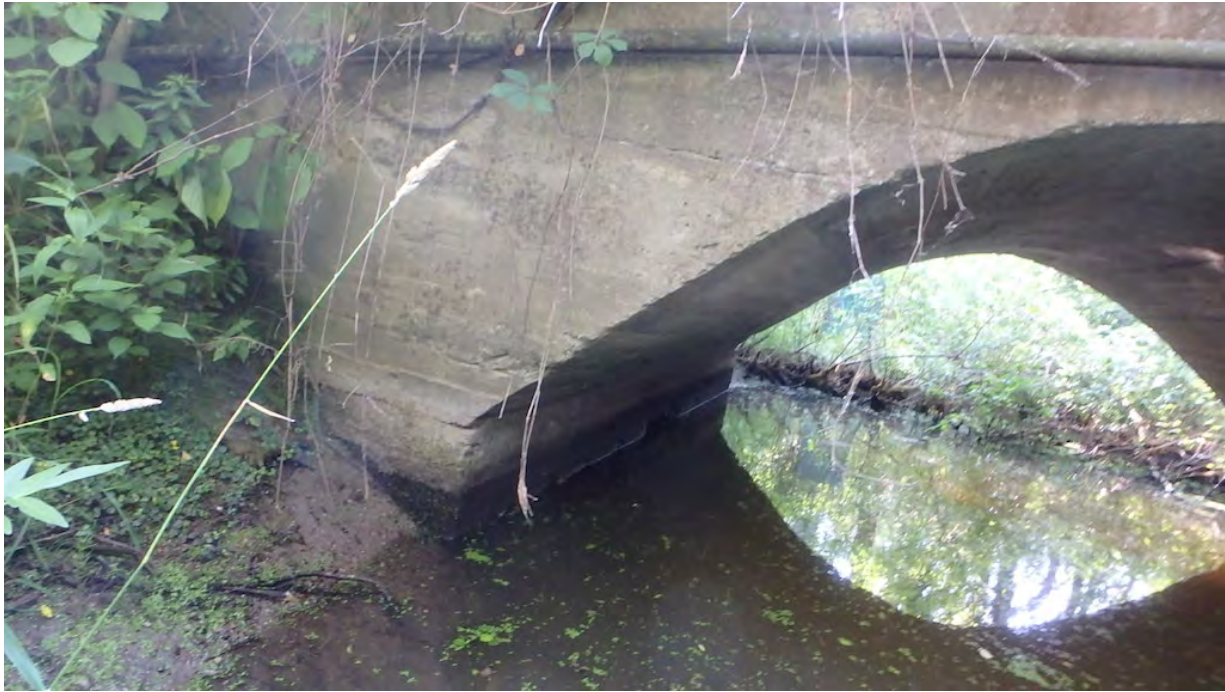
Element Group:		900 Abutments				Length:	4
Element Name:		903 Wingwalls				Width:	
Location:		Culvert Ends				Height:	2.6
Material:		4 Cast-in-place Concrete				Count:	4
Element Type:		Reinforced Concrete				Total Quantity:	41.6 sq.m
Environment:		Moderate				Limited Inspection:	
Protection System:		Unknown				Perform. Deficiencies	
Condition Data:	Units sq.m	Exc. 0	Good 0	Fair 40	Poor 1.6		
Comments: Cracking and spalls.							
Recommended Work: Rehab <input checked="" type="checkbox"/> Replace <input type="checkbox"/>					Maintenance Needs:		
Timing: Urgent <input type="checkbox"/> < 1yr <input type="checkbox"/> 1 - 5 yr <input type="checkbox"/> 6 - 10 yr <input checked="" type="checkbox"/>					<input type="checkbox"/> Urgent <input type="checkbox"/> 1 year <input type="checkbox"/> 2 year

Figure 7 Deterioration of Walls

Overall Structure Notes:			
Recommended Work on Structure:	<input type="checkbox"/> None	<input type="checkbox"/> Minor Rehab.	<input checked="" type="checkbox"/> Replace
	<input type="checkbox"/> Maintenance	<input type="checkbox"/> Major Rehab.	
Timing of Recommended Work:	<input checked="" type="checkbox"/> 1 to 5 years	<input type="checkbox"/> 6 to 10 years	
Overall Comments:	Culvert is in-que for replacement along with adjacent structures.		
Date of next Inspection:	July 5, 2018

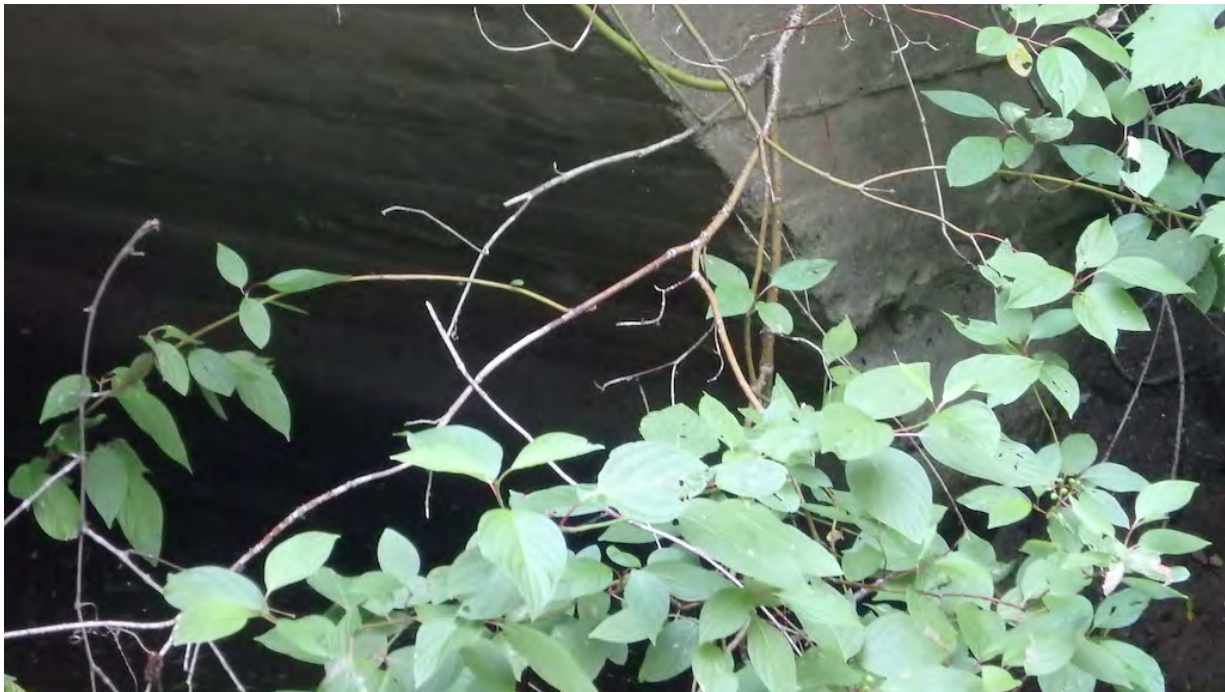
Figure 8 Deterioration of Corners
