LOT 23 CONCESSION 2-3, SOUTH WALSINGHAM

Site Number 002119

3RD CONCESSION ROAD, SOUTH WALSINGHAM

Ontario Structure Inspection Manual - Inspection Form

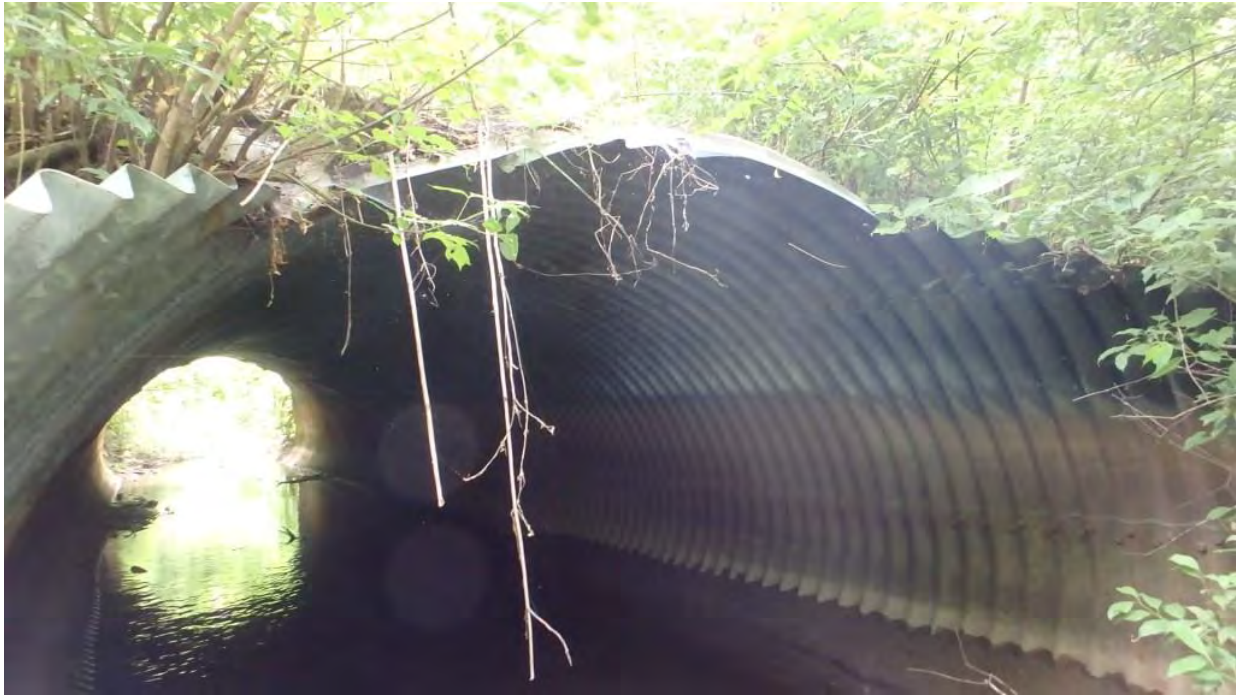
Figure 3 North Profile, Inlet

Element Group:		1200 Culverts				Length:	
Element Name:		1201 Inlet Components				Width:	
Location:		North End				Height:	
Material:						Count:	1
Element Type:						Total Quantity:	1 Each
Environment:						Limited Inspection:	
Protection System:		Unknown				Perform. Deficiencies	
Condition	Units	Exc.	Good	Fair	Poor		
Data:	Each	0	0	1	0		
Comments:							
Corrosion on SE wingwall. Overgrown. Impact damage to top flange at inlet.							
Recommended Work:					Maintenance Needs:		
Rehab <input checked="" type="checkbox"/> Replace <input type="checkbox"/>					<input type="checkbox"/> Urgent <input type="checkbox"/> 1 year <input type="checkbox"/> 2 year		
Timing: Urgent <input type="checkbox"/> < 1yr <input type="checkbox"/> 1 - 5 yr <input type="checkbox"/> 6 - 10 yr <input checked="" type="checkbox"/>

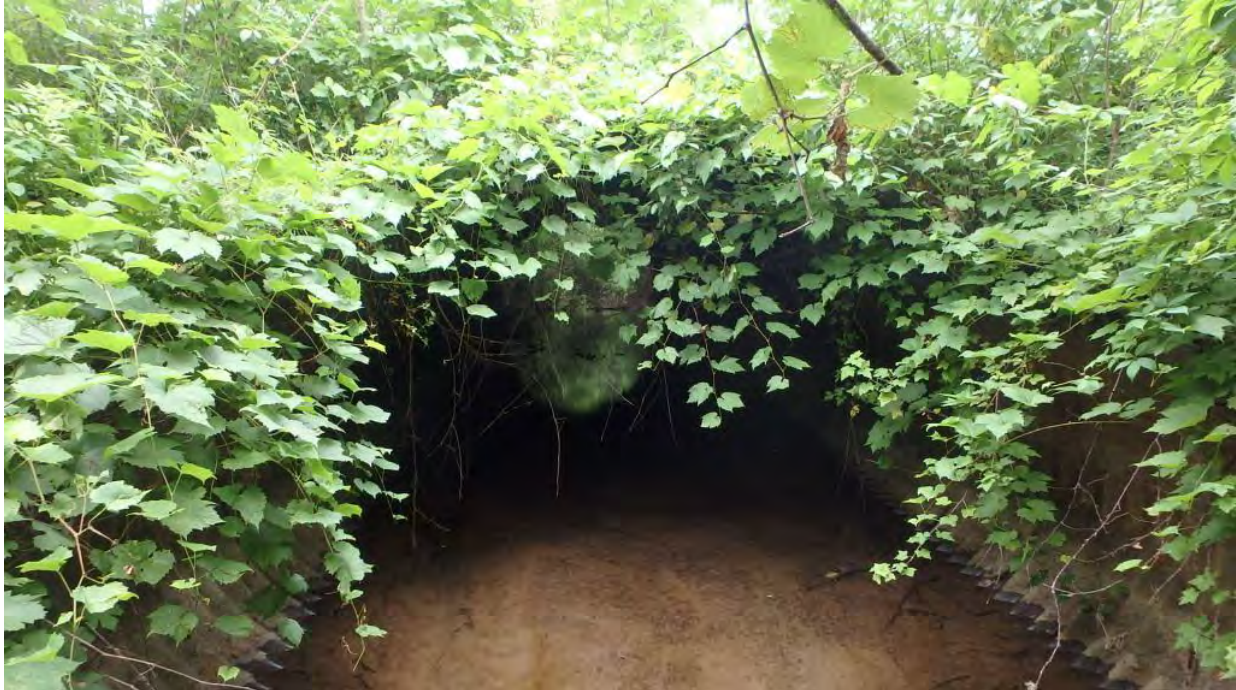
Figure 4 South Profile, Outlet

Element Group:		1200 Culverts				Length:		
Element Name:		1202 Outlet Components				Width:		
Location:		South End				Height:		
Material:						Count:		1
Element Type:						Total Quantity:		1 Each
Environment:						Limited Inspection:		
Protection System:		Unknown				Perform. Deficiencies		
Condition Data:	Units	Exc.	Good	Fair	Poor			
	Each	0	0	1	0			
Comments:								
Recommended Work:				Rehab <input type="checkbox"/>		Replace <input type="checkbox"/>		
Timing:				Urgent <input type="checkbox"/>		< 1yr <input type="checkbox"/>		
				1 - 5 yr <input type="checkbox"/>		6 - 10 yr <input type="checkbox"/>		
				Maintenance Needs:		<input type="checkbox"/> Urgent <input type="checkbox"/> 1 year <input type="checkbox"/> 2 year

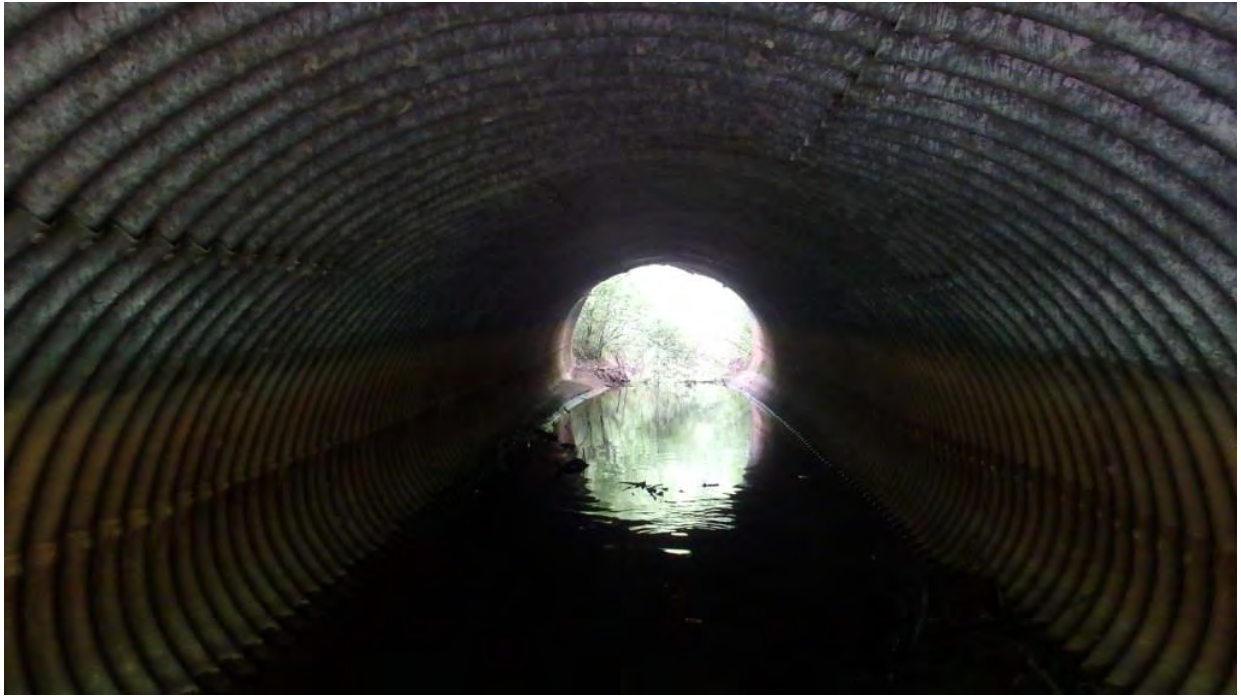
Figure 7 Barrel, Looking North

Element Group:		1200 Culverts				Length:	20
Element Name:		1203 Barrels				Width:	3.9
Location:		Inside Barrel				Height:	3.14
Material:						Count:	1
Element Type:		Pipe Arch				Total Quantity:	244.9 sq.m
Environment:		Severe				Limited Inspection:	
Protection System:		Unknown				Perform. Deficiencies	
Condition	Units	Exc.	Good	Fair	Poor		
Data:	sq.m	0	0	244.9	0		
Comments:							
Several plates are deforming and plate joints buckling. Should be monitored. Surface corrosion at water level and significant corrosion on SE wingwall.							
Recommended Work:					Maintenance Needs:		
Rehab <input checked="" type="checkbox"/> Replace <input type="checkbox"/>					<input type="checkbox"/> Urgent <input type="checkbox"/> 1 year <input type="checkbox"/> 2 year		
Timing: Urgent <input type="checkbox"/> < 1yr <input type="checkbox"/> 1 - 5 yr <input type="checkbox"/> 6 - 10 yr <input checked="" type="checkbox"/>

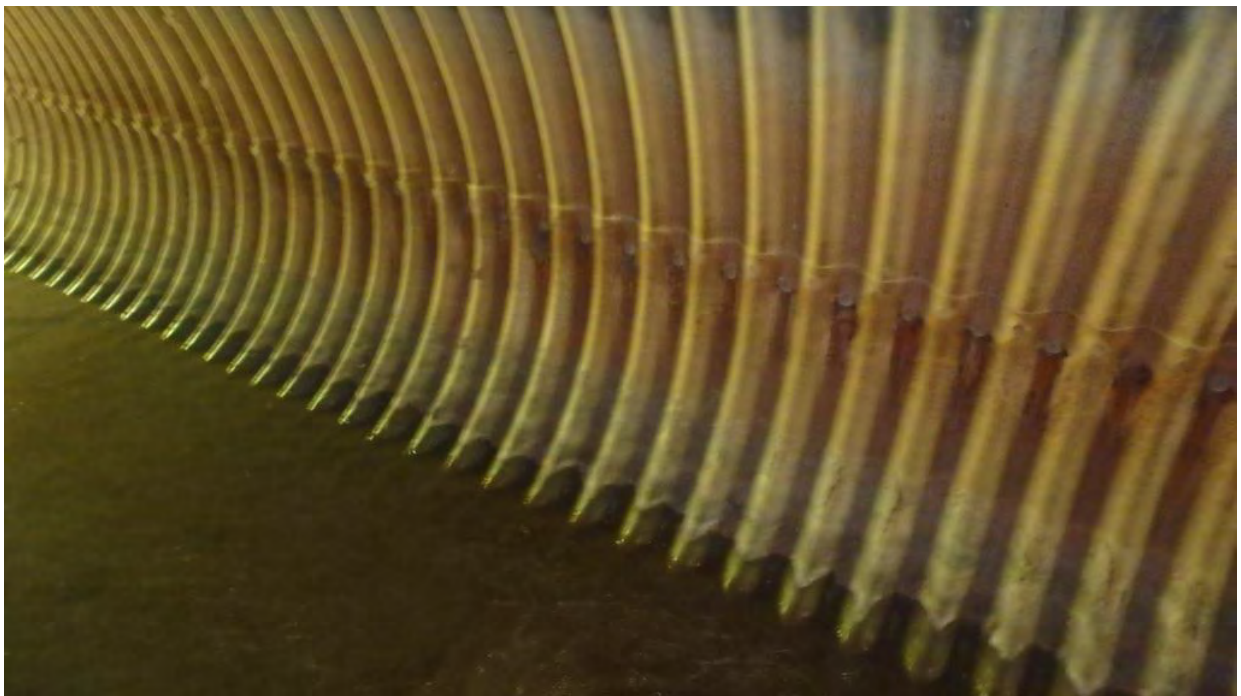
Figure 8 Corrosion at Waterline

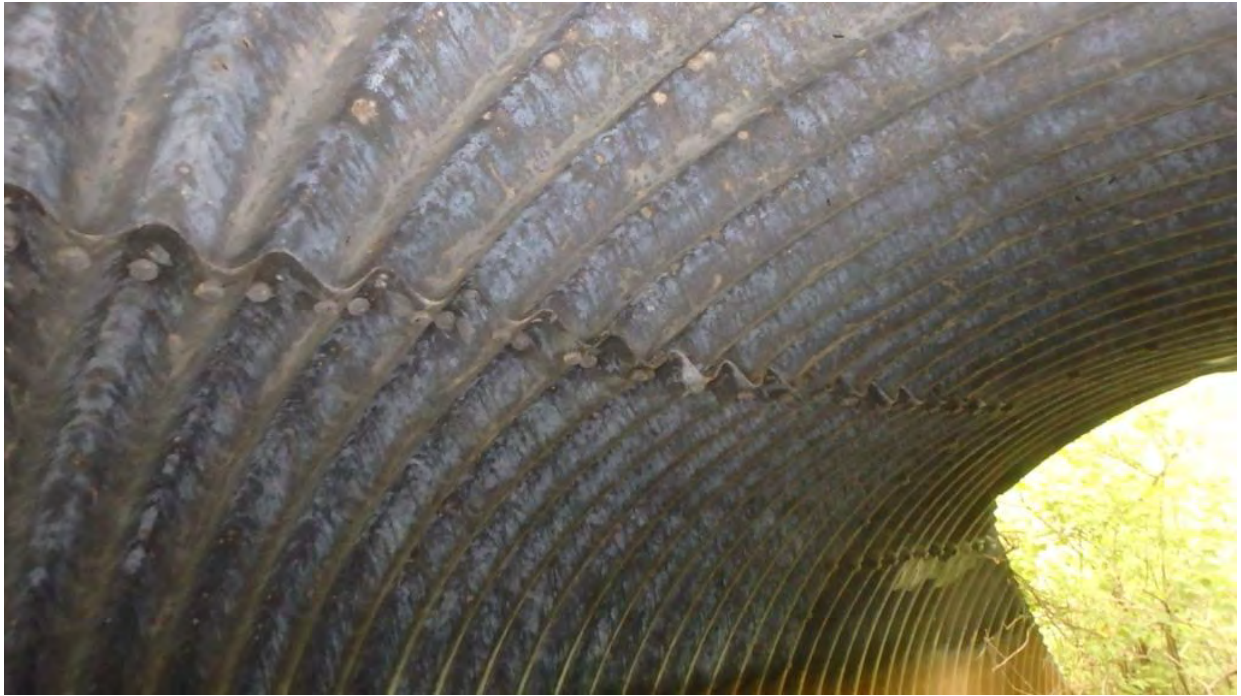
Figure 9 Deflection at Joint

Additional Investigation Required:	Priority		
	None	Normal	Urgent
Material Condition Survey			
<input checked="" type="checkbox"/> Detailed Deck Condition Survey:		X	
<input checked="" type="checkbox"/> Non-destructive Delamination Survey of Asphalt-Covered Deck:	X		
<input checked="" type="checkbox"/> Concrete Substructure Condition Survey:	X		
<input checked="" type="checkbox"/> Detailed Coating Condition Survey:	X		
<input checked="" type="checkbox"/> Detailed Timber Investigation	X		
<input checked="" type="checkbox"/> Post-Tensioned Strand Investigation	X		
Underwater Investigation:	X		
Fatigue Investigation:	X		
Seismic Investigation:	X		
Structure Evaluation:		X	
Monitoring			
<input checked="" type="checkbox"/> Monitoring of Deformations, Settlements and Movements:		X	
<input checked="" type="checkbox"/> Monitoring Crack Widths:	X		
Investigation Notes: Monitor plate deformation.

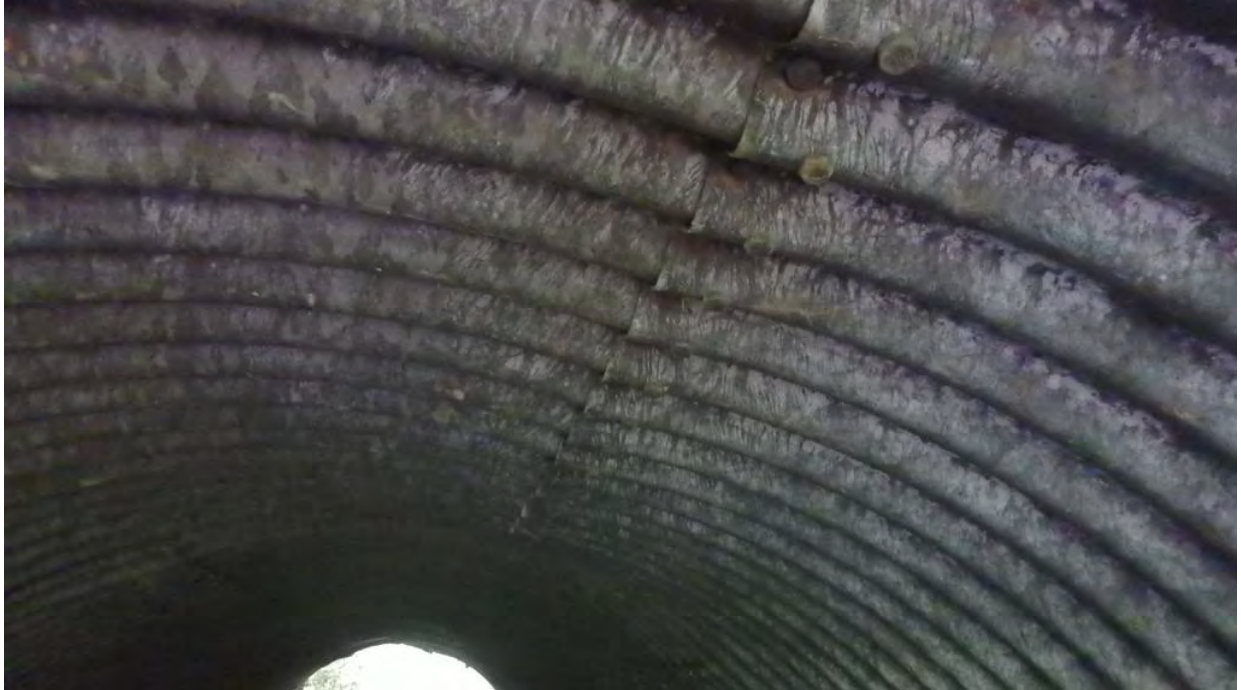
Figure 10 Deflection in Multiplate Joint

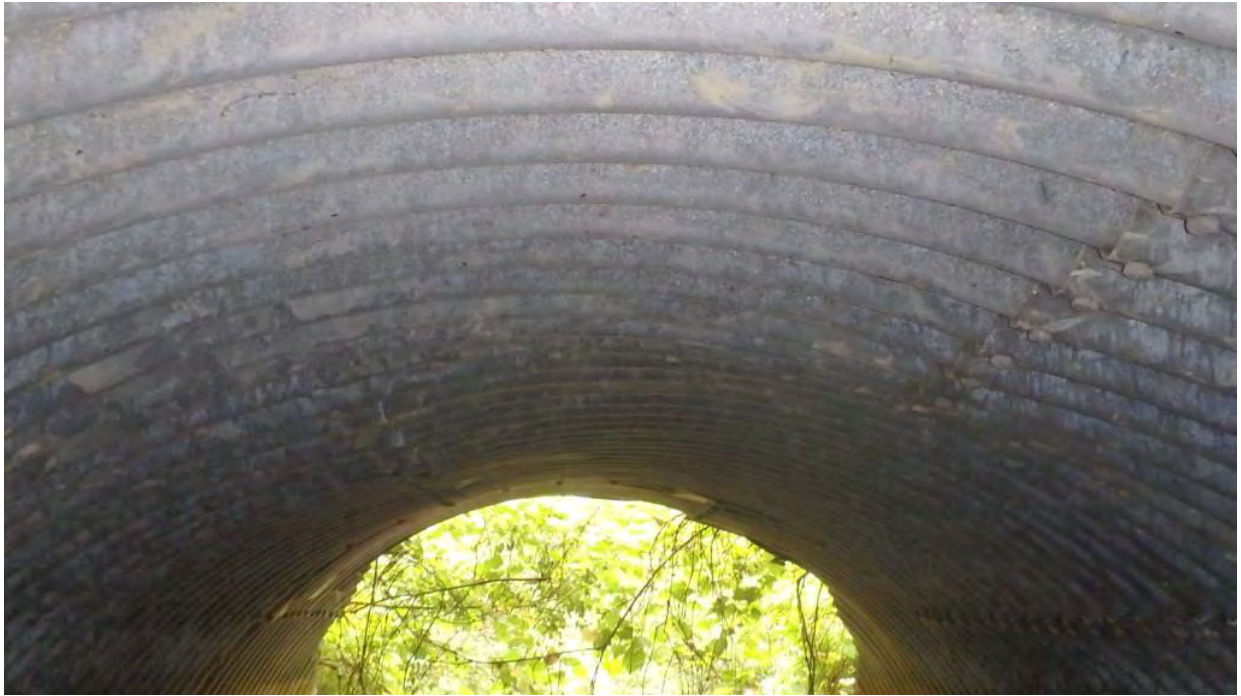
Figure 11 Deflections in Multiplate Joints at North End

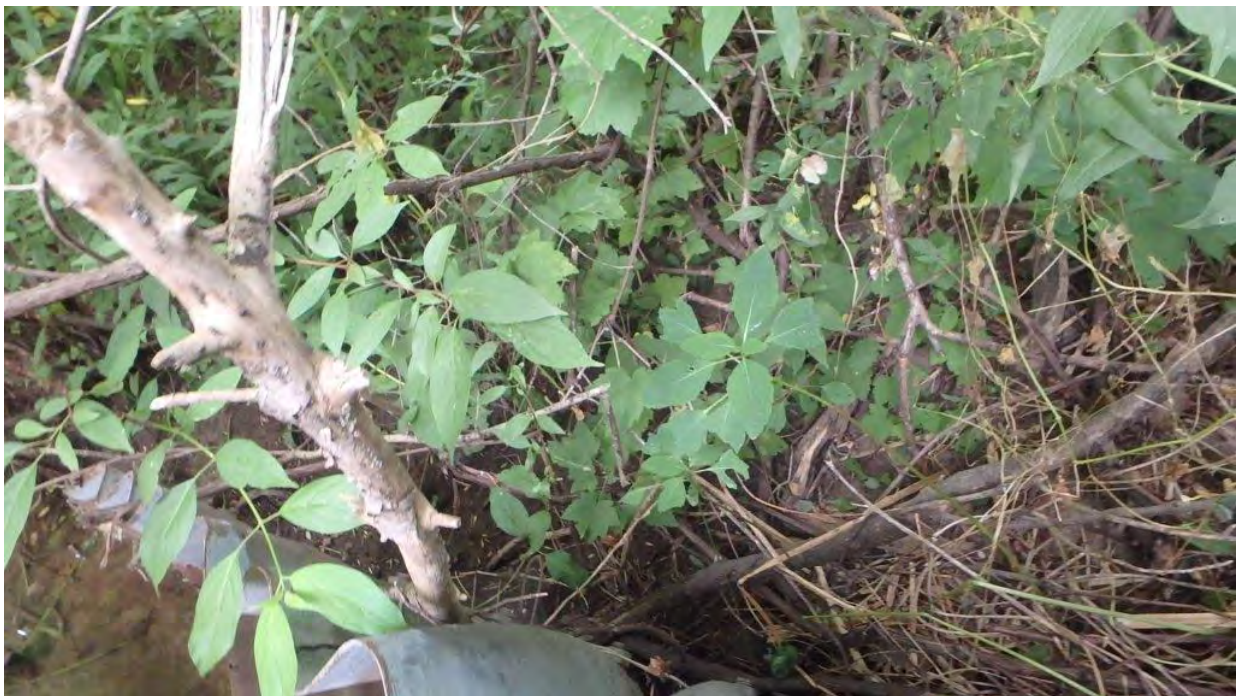
Element Group:		1400 Embankments & Streams				Length:		
Element Name:		1402 Embankments				Width:		
Location:						Height:		
Material:						Count:		1
Element Type:						Total Quantity:		1 Each
Environment:						Limited Inspection:		
Protection System:		Unknown				Perform. Deficiencies		
Condition Data:	Units	Exc.	Good	Fair	Poor			
	Each	0	0.75	0.25	0			
Comments:								
Minor erosion at wingwalls.								
Recommended Work:				Rehab <input type="checkbox"/>		Replace <input type="checkbox"/>		
Timing:				Urgent <input type="checkbox"/>		< 1yr <input type="checkbox"/>		
				1 - 5 yr <input type="checkbox"/>		6 - 10 yr <input type="checkbox"/>		
				Maintenance Needs:		<input type="checkbox"/> Urgent <input type="checkbox"/> 1 year <input type="checkbox"/> 2 year

Figure 12 Erosion at North Quadrants

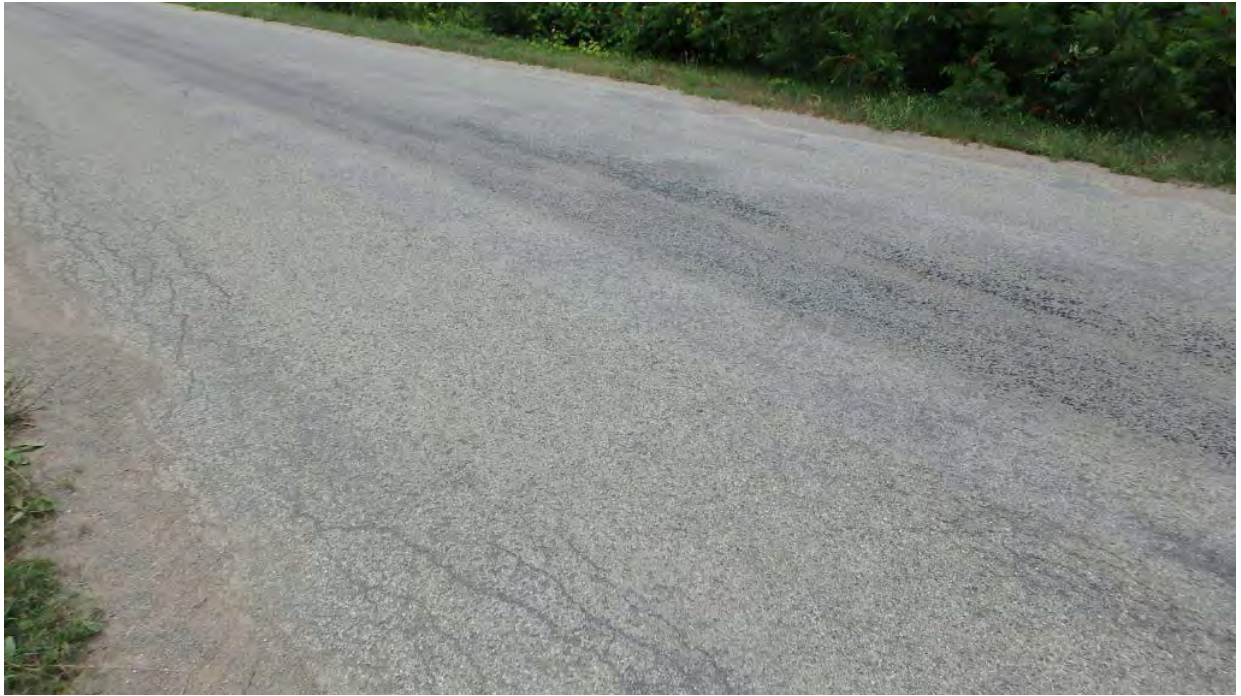
Figure 13 Wearing Surface

Element Group:		1600 Approaches				Length:	
Element Name:		1601 Wearing Surface (Approaches)				Width:	
Location:		Top of Fill				Height:	
Material:						Count:	1
Element Type:						Total Quantity:	1 All
Environment:		Severe				Limited Inspection:	
Protection System:		Unknown				Perform. Deficiencies	
Condition	Units	Exc.	Good	Fair	Poor		
Data:	All	0	0	1	0		
Comments:							
Fill slopes stable. Need hazard markers. Map cracking and rutting on approaches.							
Recommended Work:					Maintenance Needs:		
Rehab <input checked="" type="checkbox"/> Replace <input type="checkbox"/>					<input type="checkbox"/> Urgent <input type="checkbox"/> 1 year <input type="checkbox"/> 2 year		
Timing: Urgent <input type="checkbox"/> < 1yr <input type="checkbox"/> 1 - 5 yr <input type="checkbox"/> 6 - 10 yr <input checked="" type="checkbox"/>
