**LOT 18-19 CONCESSION 4, SOUTH WALSINGHAM**

Site Number 002120

**EAST ¼ LINE ROAD, SOUTH WALSINGHAM**

**Ontario Structure Inspection Manual - Inspection Form**

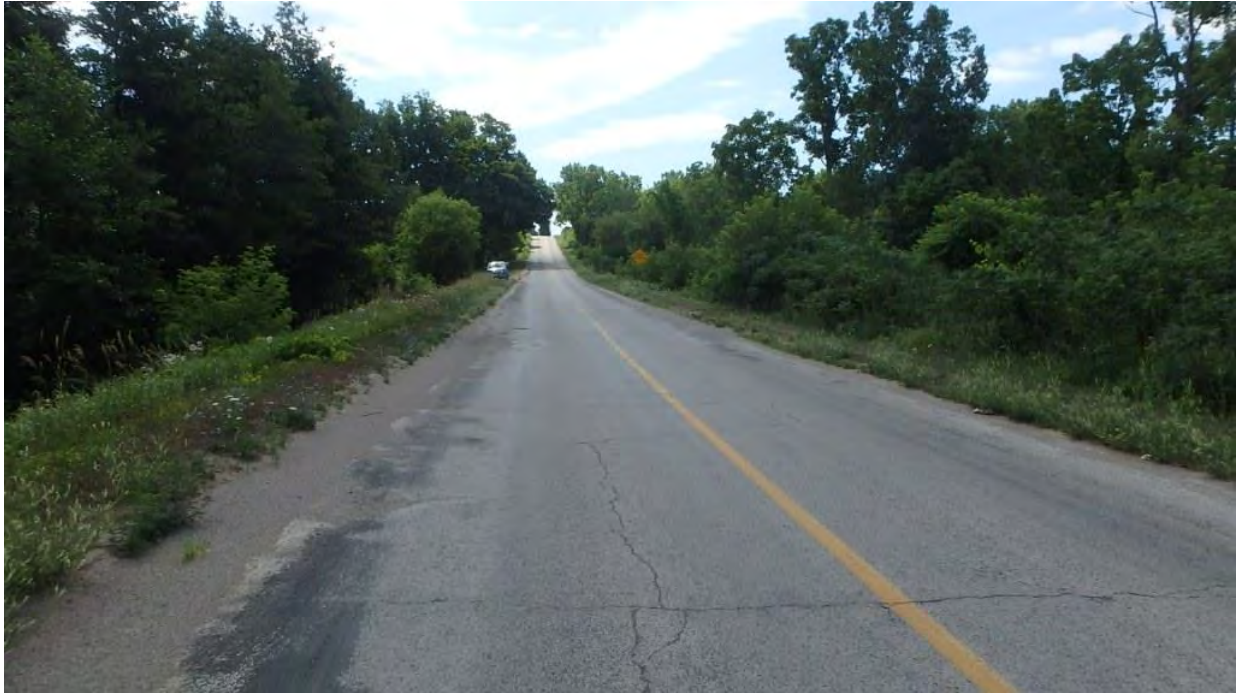
Figure 1 North Approach

| Comments:<br>Surface has rutting and small pothole at edge. Polishing of road surface at edges. Settlement at road edges at culvert. | | | | | | | |

| Recommended Work: Rehab <input type="checkbox"/> Replace <input type="checkbox"/> | | | | Maintenance Needs: Bridge Surface Repair | | | |

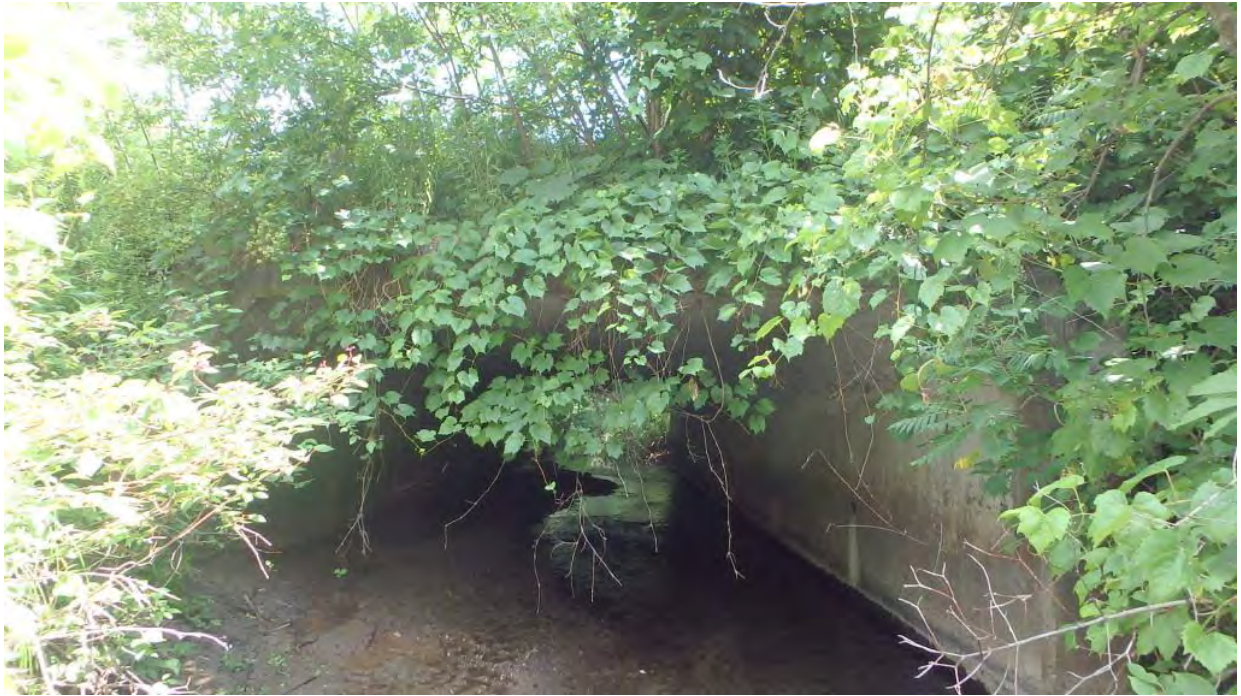
Figure 3 West Profile, Outlet

| Comments:<br>Overgrown vegetation on top of outlet. | | | | | | | |

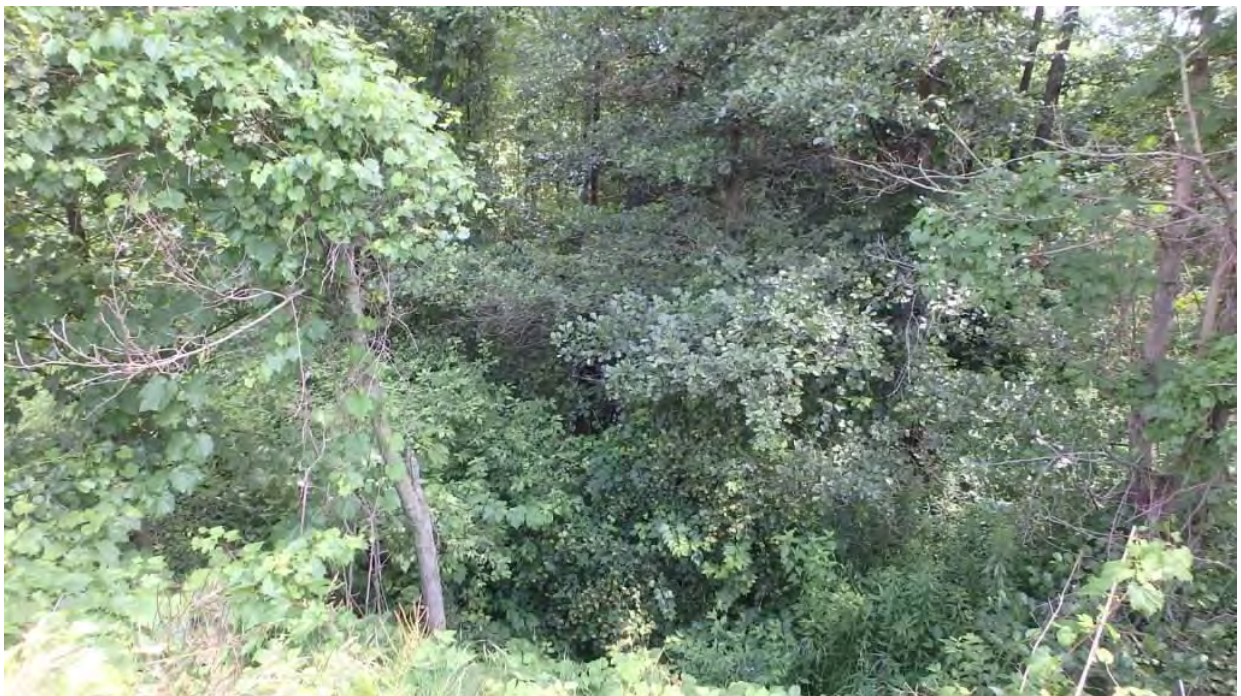
Figure 4 Upstream

| Comments:<br>Vegetation growing at culvert inlet. Minor erosion at quadrants and build up of streambed material along North wall. | | | | | | | |

| Recommended Work:    Rehab <input type="checkbox"/> Replace <input type="checkbox"/> | | | | Maintenance Needs:    Erosion Control at Bridges | | | |

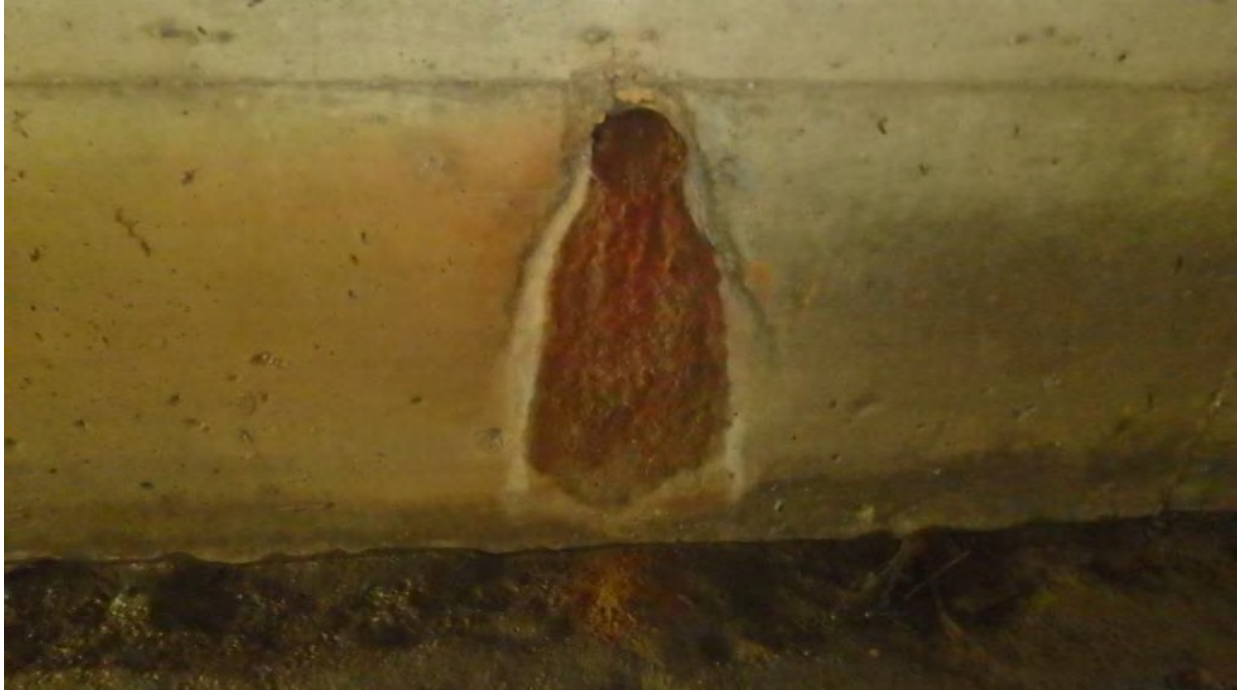
| Comments:<br>Drains present. Exposed reinforcing ties on soffit. Minor deterioration of concrete walls underneath drain outlets. Staining. | | | | | | | |

Figure 10 Weeping Holes Full of Debris

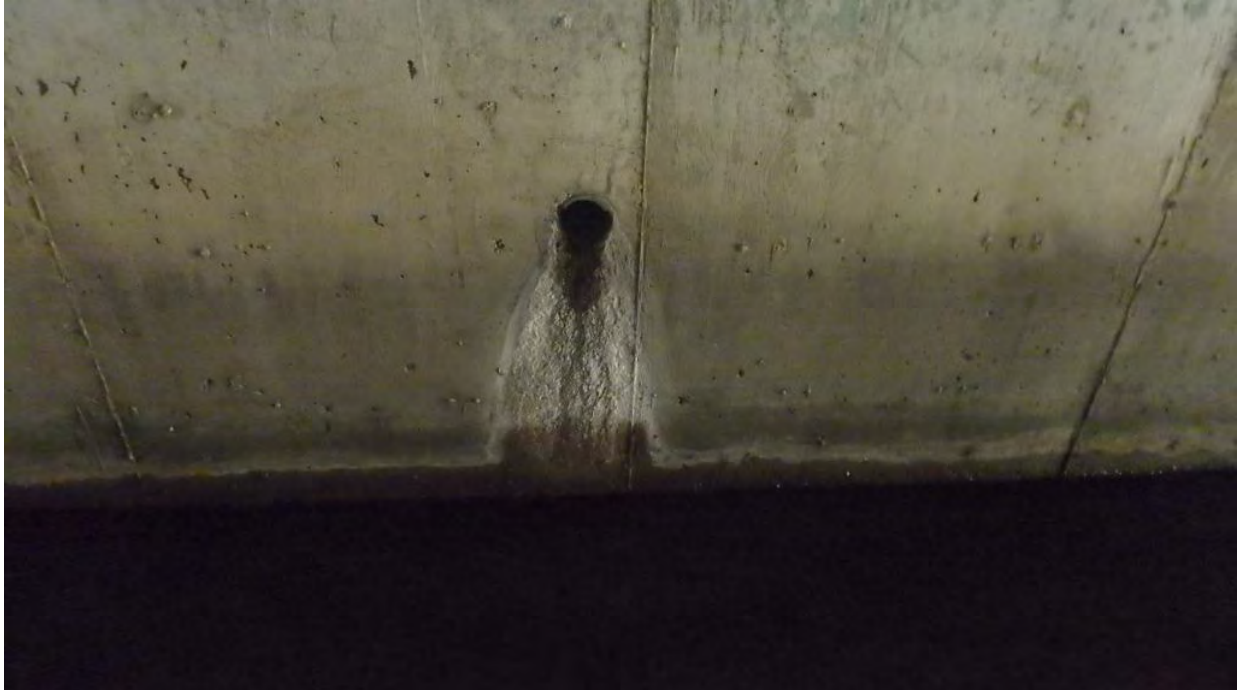
Figure 12 Deterioration at Weeping Holes

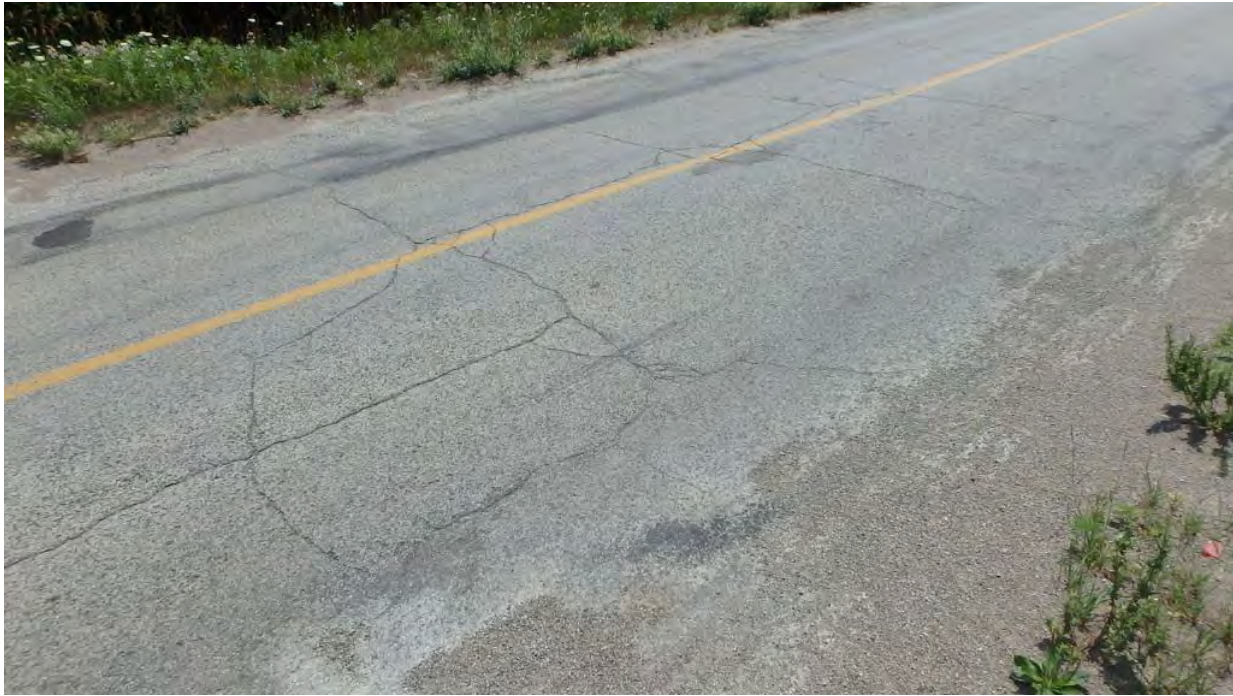
Figure 13 Cracking & Settlement at Road Edges at Culvert
