LOT 14 CONCESSION A-1, SOUTH WALSINGHAM

Site Number 002124

1ST CONCESSION ROAD, SOUTH WALSINGHAM

Ontario Structure Inspection Manual - Inspection Form

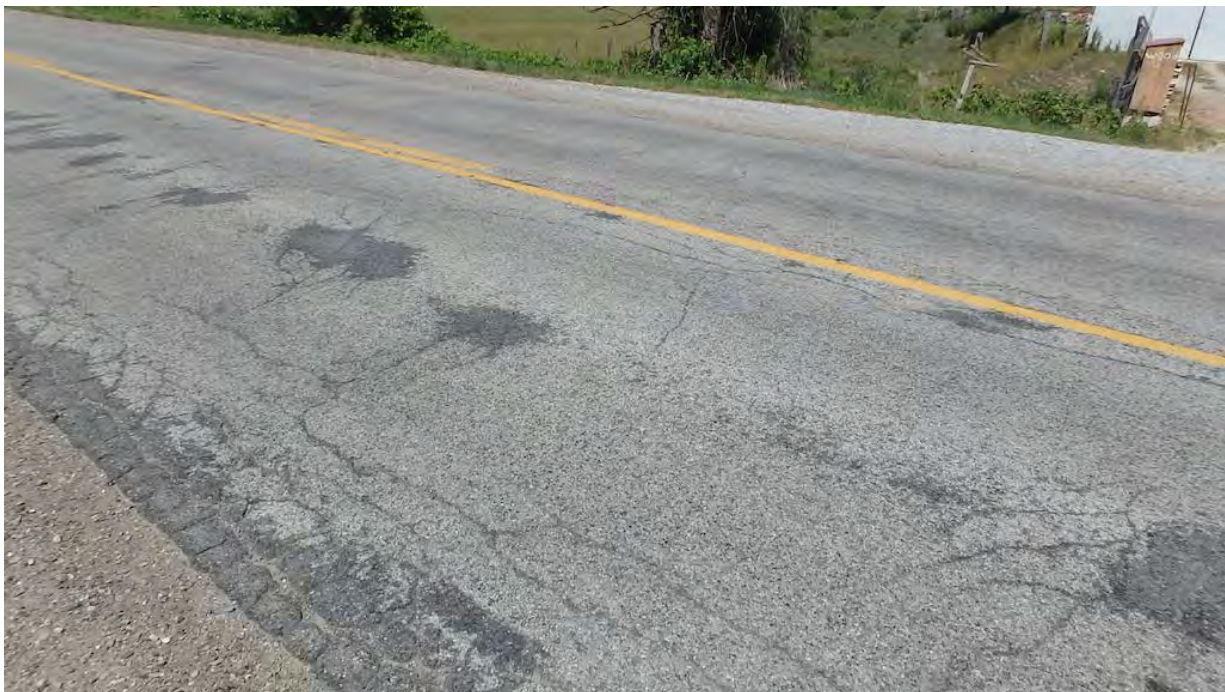
Figure 10 Rutting and Map Cracking on Wearing Surface
