LOT 4 CONCESSION 10-11, N. WALSINGHAM

Site Number 002302

11TH CONCESSION ROAD, NORTH WALSINGHAM

Ontario Structure Inspection Manual - Inspection Form

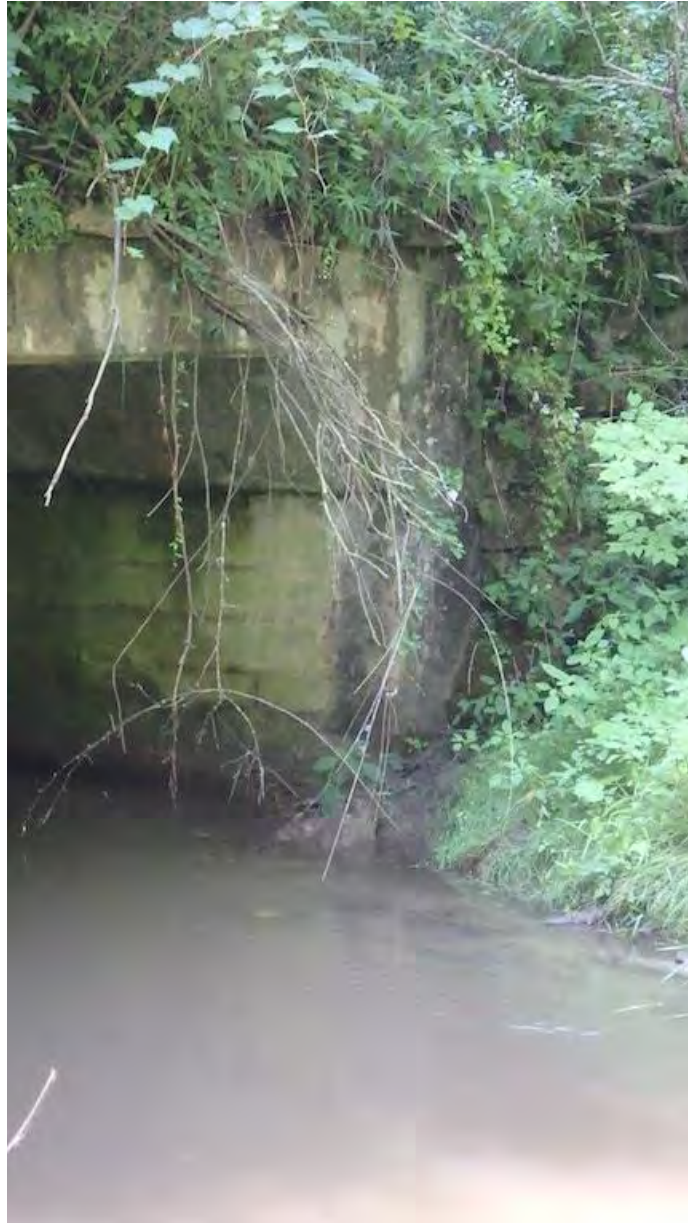
Figure 7 Deterioration at Haunch Construction Joint

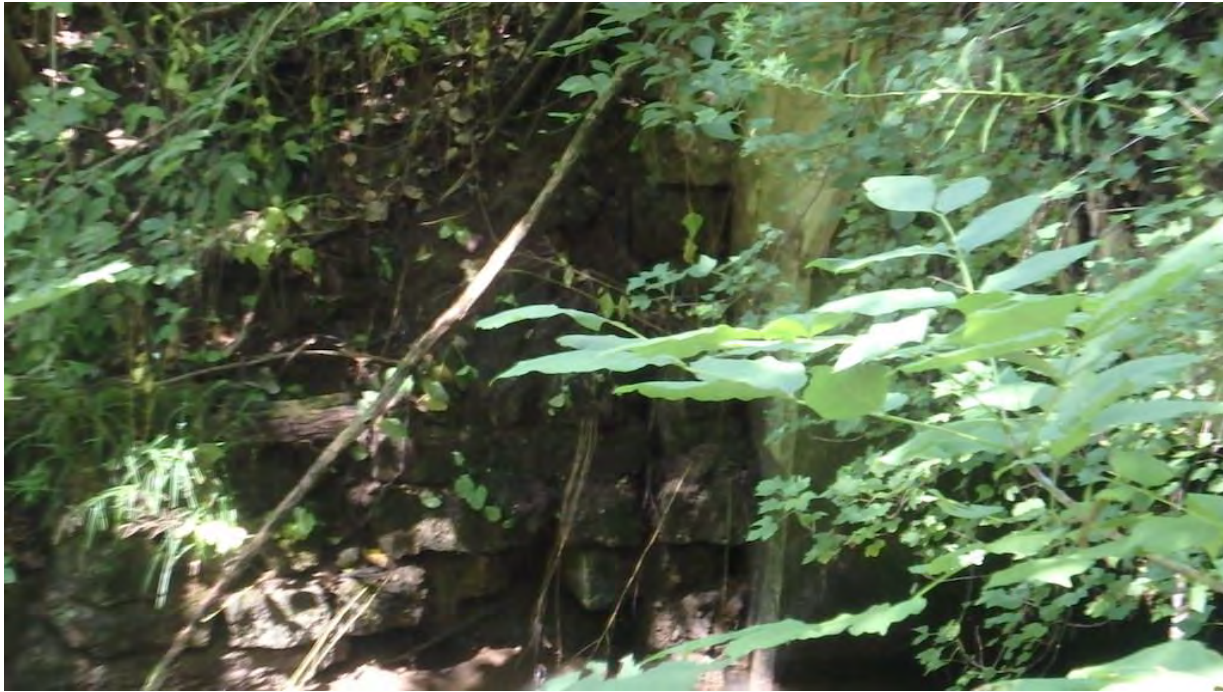
Element Group:		1400 Embankments & Streams				Length:	
Element Name:		1402 Embankments				Width:	
Location:						Height:	
Material:						Count:	4
Element Type:						Total Quantity:	4 Each
Environment:		Moderate				Limited Inspection:	
Protection System:		Unknown				Perform. Deficiencies	
Condition Data:	Units	Exc.	Good	Fair	Poor		
	Each	0	0	4	0		
Comments: Stone retaining walls at quadrants are deteriorating. Erosion evident.							
Recommended Work: Rehab <input type="checkbox"/> Replace <input type="checkbox"/>					Maintenance Needs: Erosion Control at Bridges		
Timing: Urgent <input type="checkbox"/> < 1yr <input type="checkbox"/> 1 - 5 yr <input type="checkbox"/> 6 - 10 yr <input type="checkbox"/>					<input type="checkbox"/> Urgent <input checked="" type="checkbox"/> 1 year <input type="checkbox"/> 2 year

Figure 8 Stone Retaining Wall Deteriorated

Overall Structure Notes:	
Recommended Work on Structure:	<input type="checkbox"/> None <input type="checkbox"/> Minor Rehab. <input type="checkbox"/> Replace <input checked="" type="checkbox"/> Maintenance <input type="checkbox"/> Major Rehab.
Timing of Recommended Work:	<input type="checkbox"/> 1 to 5 years <input type="checkbox"/> 6 to 10 years
Overall Comments:	Repair walls and soffit cracks. Protect Northwest inlet. Erosion control required at quadrant to repair stone retaining walls.
Date of next Inspection:	July 26, 2018
