LOT 15-16 CONCESSION 2 N.T.R. MIDDLETON

Site Number 002423

JACKSON SIDE ROAD, MIDDLETON

Ontario Structure Inspection Manual - Inspection Form

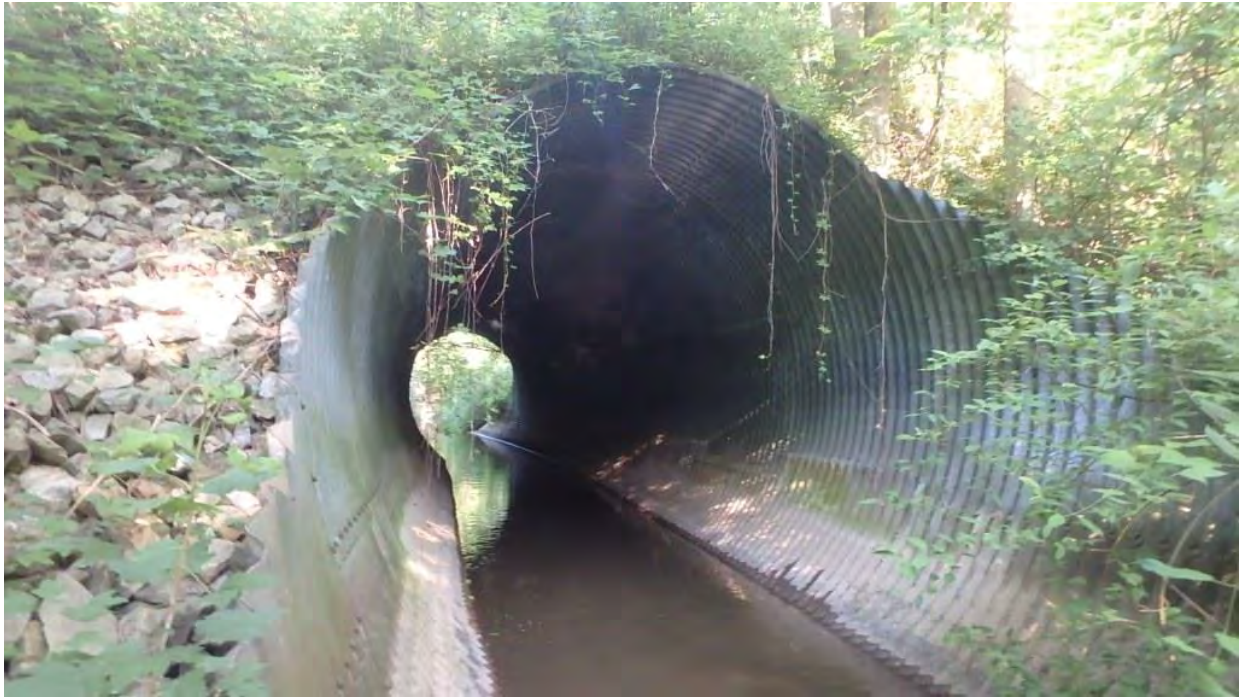
Figure 7 Barrel, Looking West, Note Culvert Out of Alignment

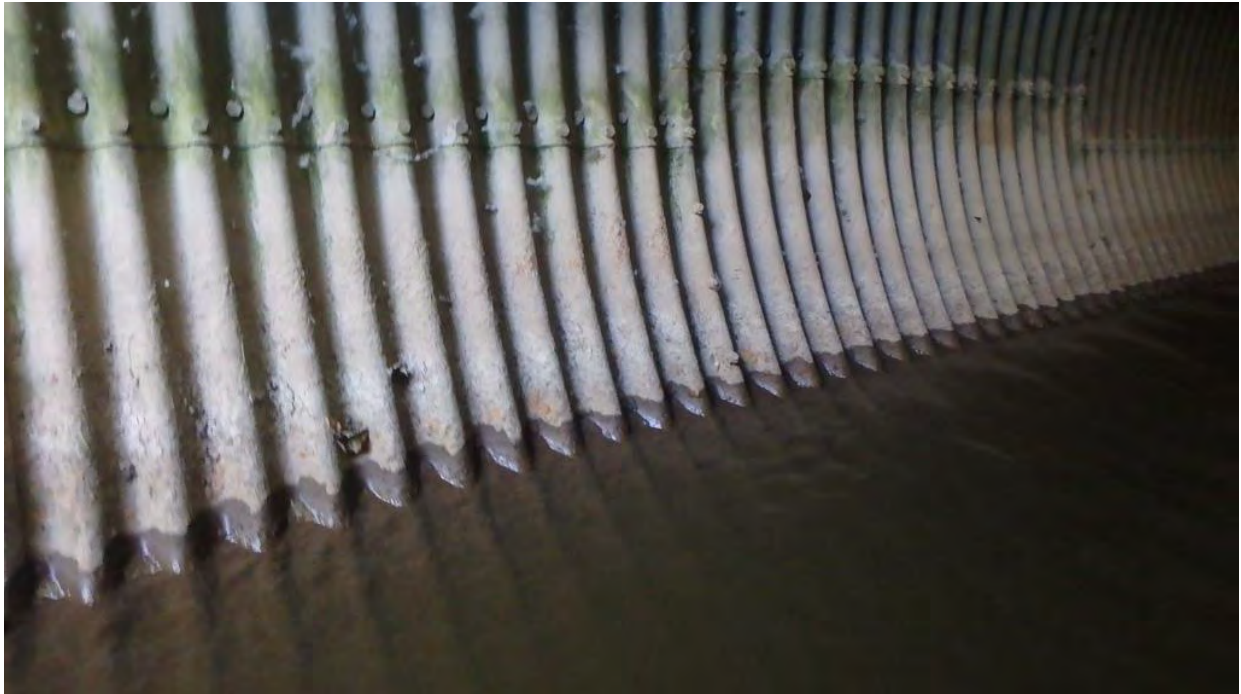
Figure 8 Corrosion and Staining at Water Line

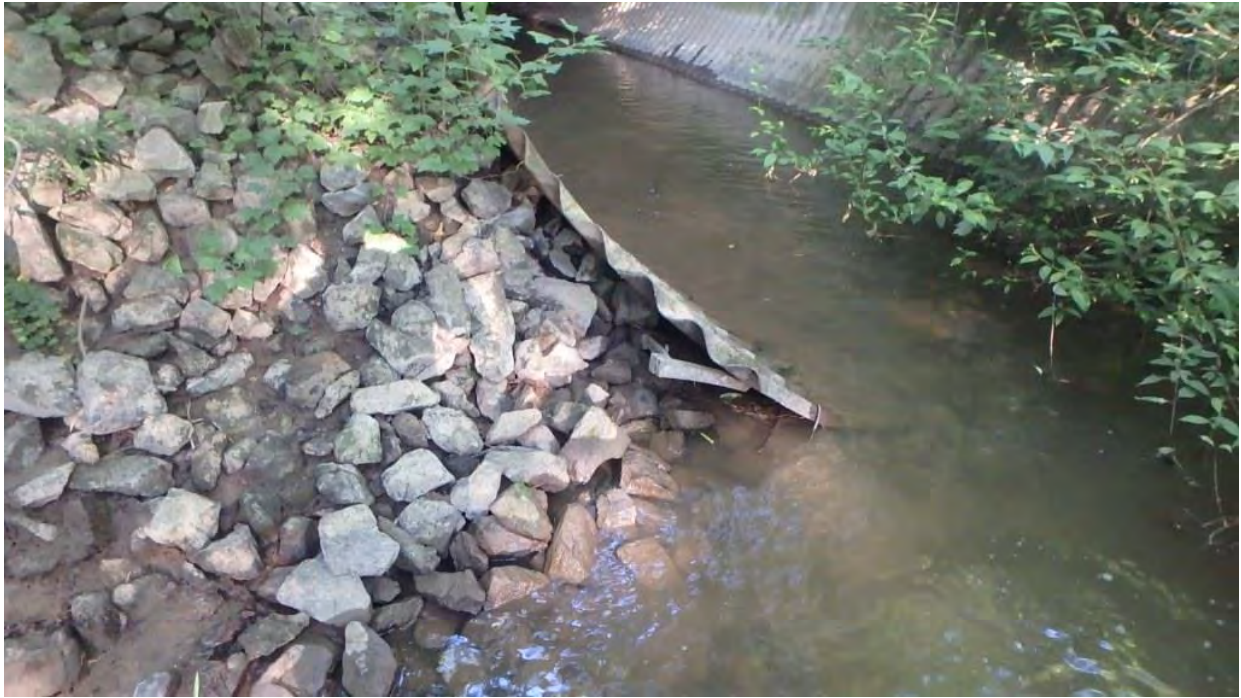
Figure 9 Minor Undermining at All Quadrants

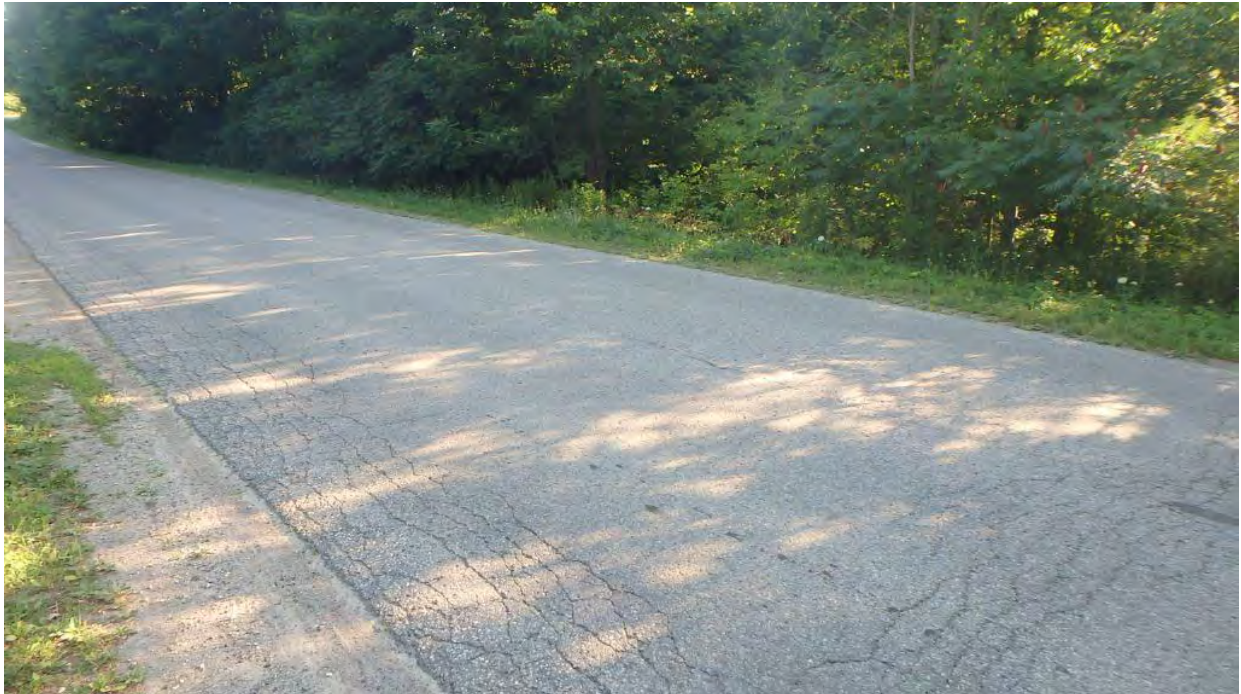
Element Group:		1600 Approaches				Length:		
Element Name:		1601 Wearing Surface (Approaches)				Width:		
Location:		Top of Fill				Height:		
Material:		2 Asphalt				Count:		1
Element Type:						Total Quantity:		1 Each
Environment:		Severe				Limited Inspection:		
Protection System:		None				Perform. Deficiencies		
Condition	Units	Exc.	Good	Fair	Poor			
Data:	Each	0	0	1	0			
Comments:								
Includes: Signs - no signs, Barriers - no barriers. Minor transverse cracks in asphalt and alligator cracks along west edge of road.								
Recommended Work:				Rehab <input type="checkbox"/>		Replace <input type="checkbox"/>		
Timing:				Urgent <input type="checkbox"/>		< 1yr <input type="checkbox"/>		
				1 - 5 yr <input type="checkbox"/>		6 - 10 yr <input type="checkbox"/>		
Maintenance Needs:				Rout and Seal				
				<input type="checkbox"/> Urgent		<input checked="" type="checkbox"/> 1 year		
						<input type="checkbox"/> 2 year

Figure 10 Asphalt Wearing Surface, Note Cracking
