LOT 13 TOWNLINE ROAD

Site Number 002426

MIDDLETON – NORTH WALSINGHAM TOWNLINE ROAD

Ontario Structure Inspection Manual - Inspection Form

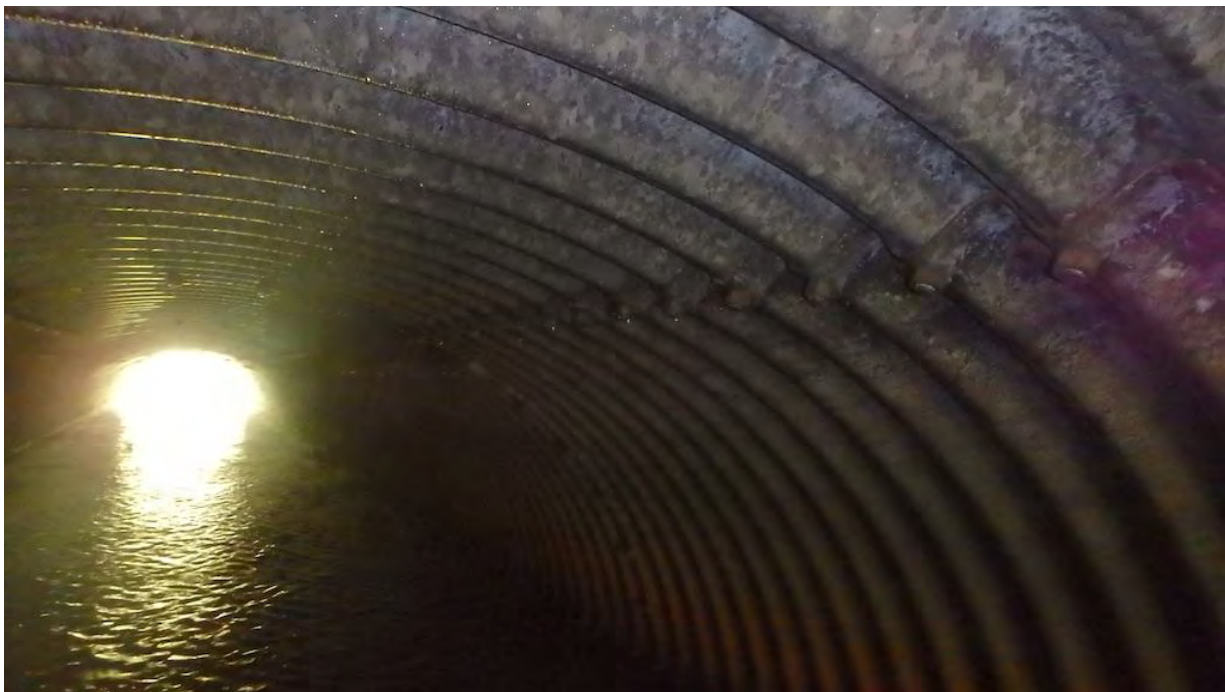
Figure 8 Leaking Multiplate Joints

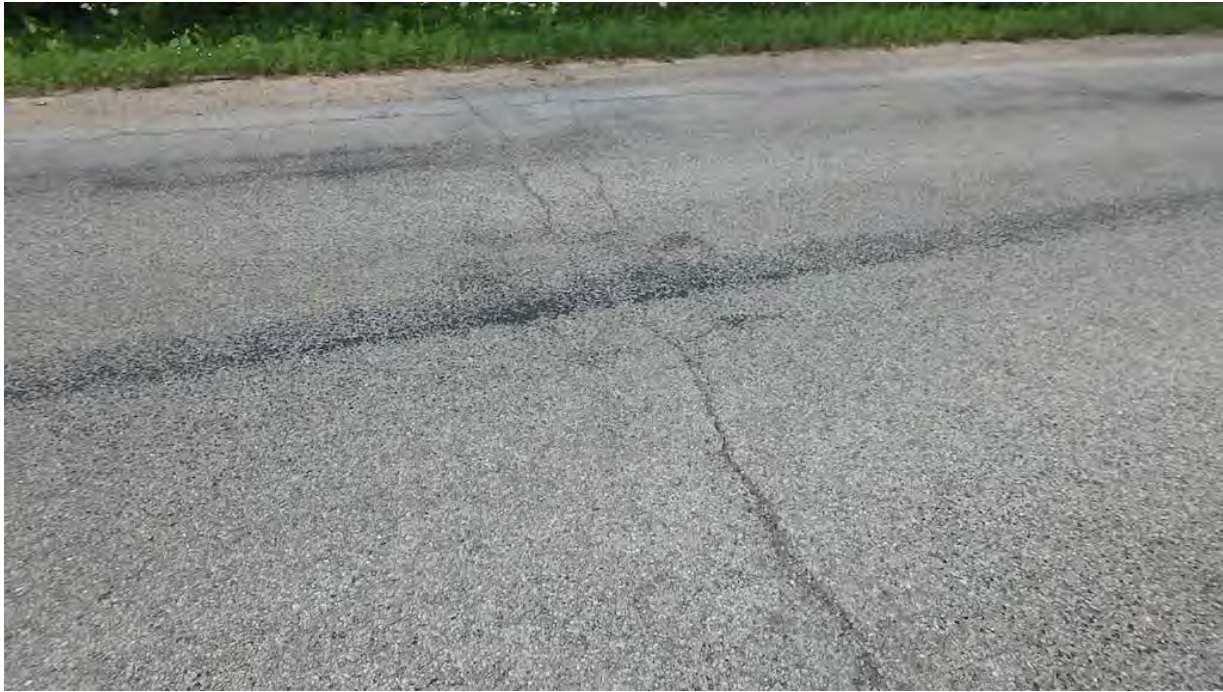
Overall Structure Notes:	
Recommended Work on Structure:	<input type="checkbox"/> None <input type="checkbox"/> Minor Rehab. <input type="checkbox"/> Replace <input checked="" type="checkbox"/> Maintenance <input type="checkbox"/> Major Rehab.
Timing of Recommended Work:	<input type="checkbox"/> 1 to 5 years <input type="checkbox"/> 6 to 10 years
Overall Comments:	Wearing surface has many transverse cracks. Rout and Seal
Date of next Inspection:	July 28, 2018

Figure 9 Transverse Crack in Wearing Surface
