MISENER BRIDGE

Site Number 010032

SCOTCH LINE ROAD (CONCESSION 6), WOODHOUSE

Ontario Structure Inspection Manual - Inspection Form

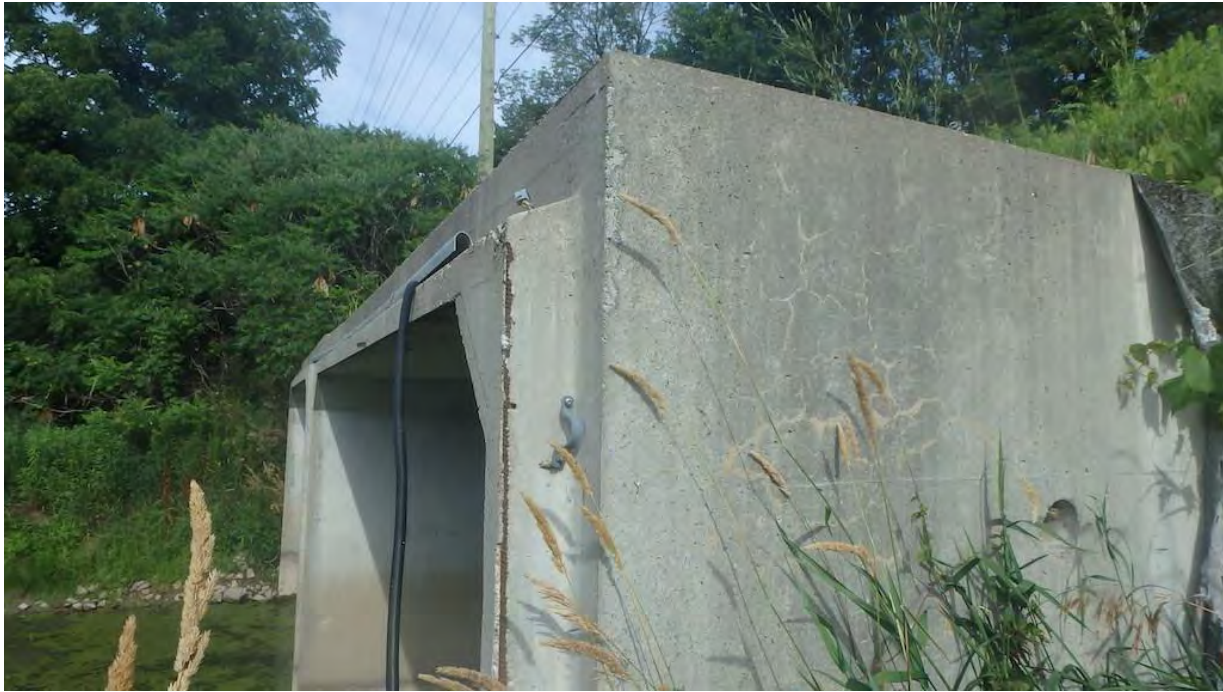
Figure 9 Exposed Rebar and Staining at Southeast Quadrant

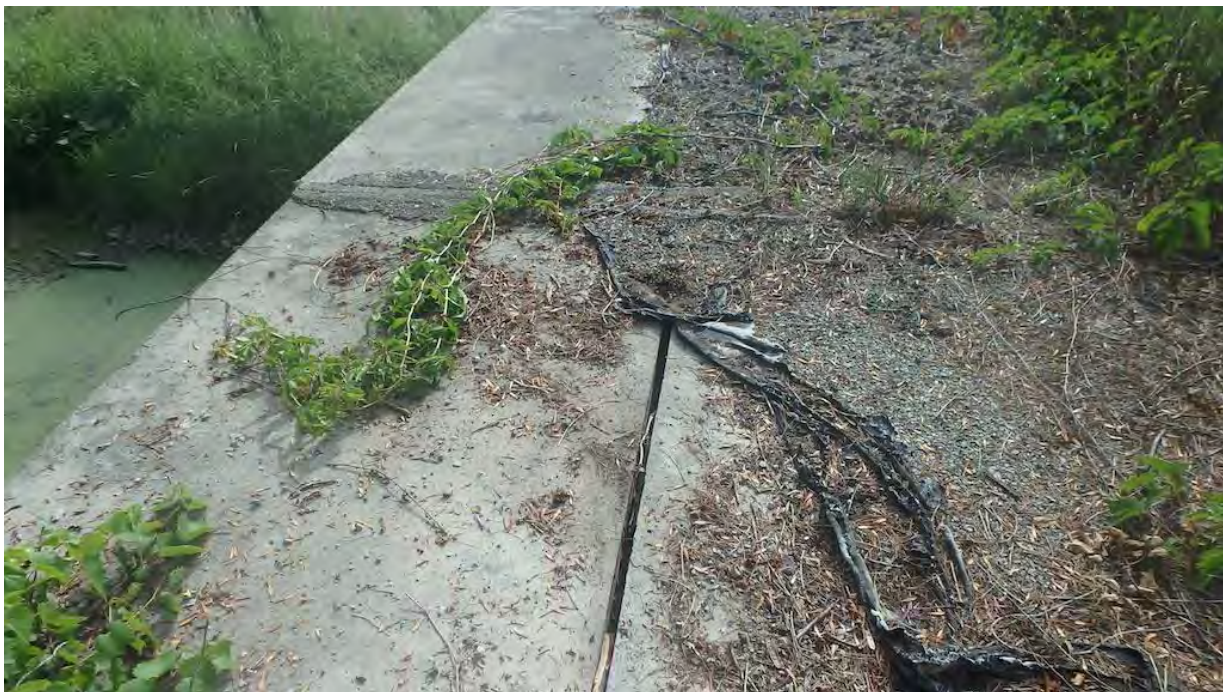
Figure 10 Deterioration of Parking of Joints at Inlet

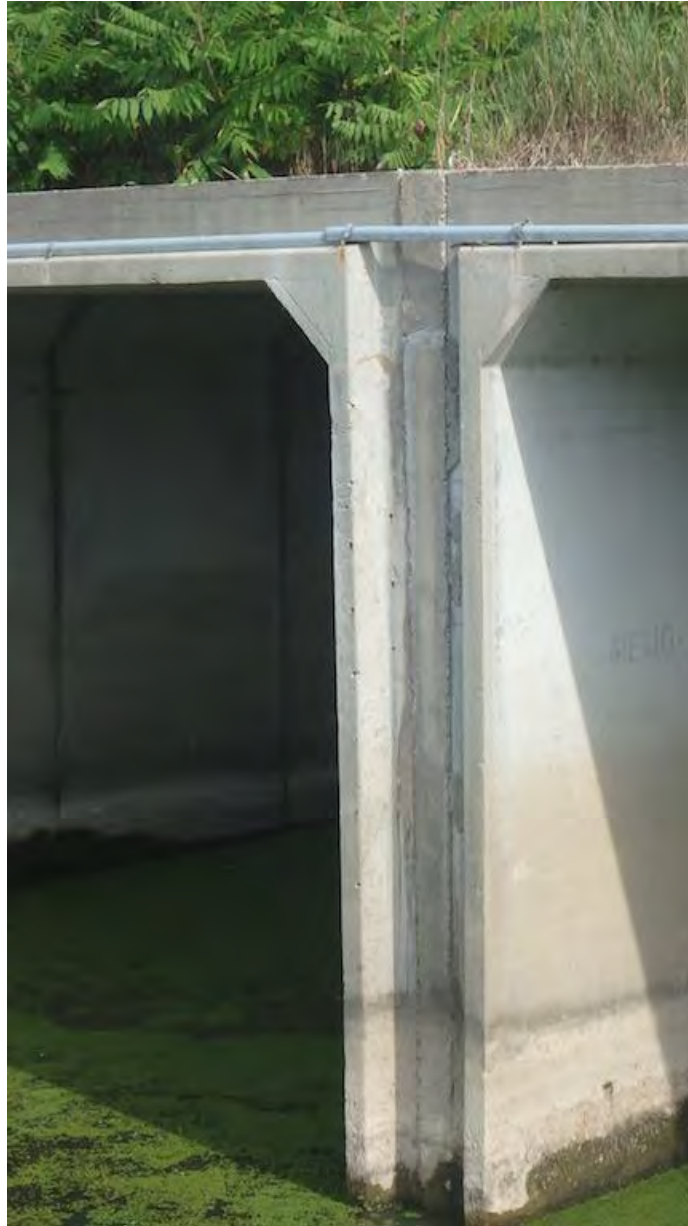
Figure 11 Minor Cracking of Parging Between Outlet Barrels

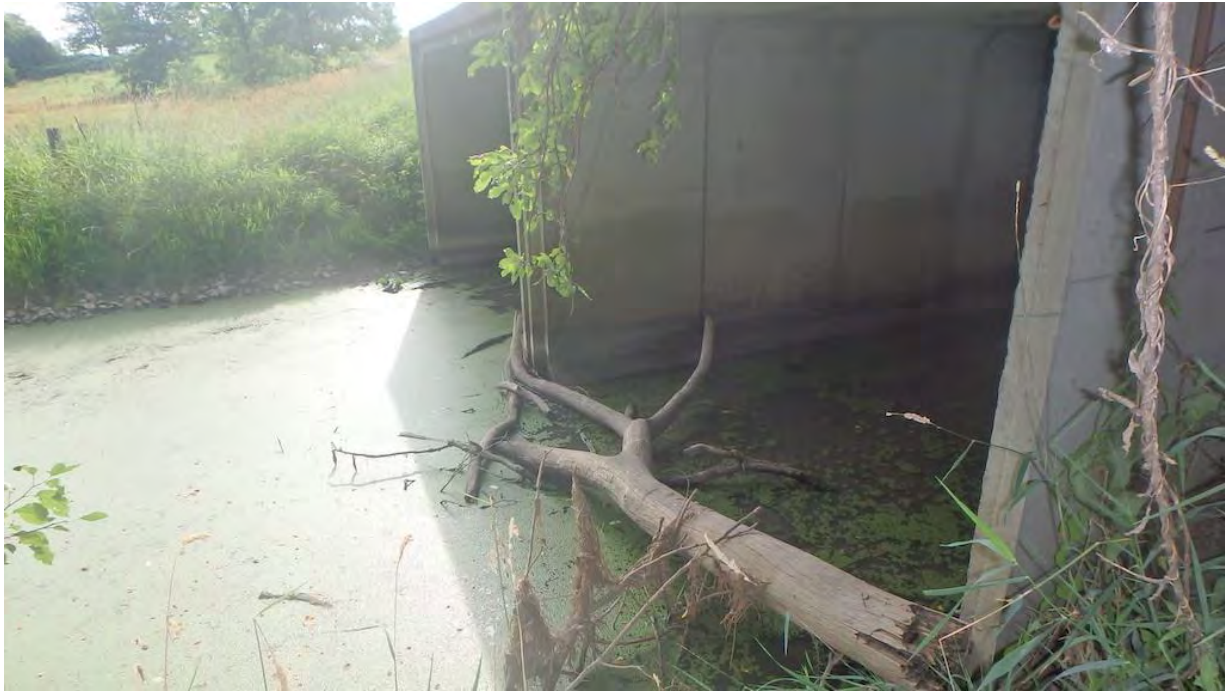
Figure 12 Fallen Tree at West Inlet Barrel
