DUNN BRIDGE

Site Number 010033

SCOTCH LINE ROAD (CONCESSION 6), WOODHOUSE

Ontario Structure Inspection Manual - Inspection Form

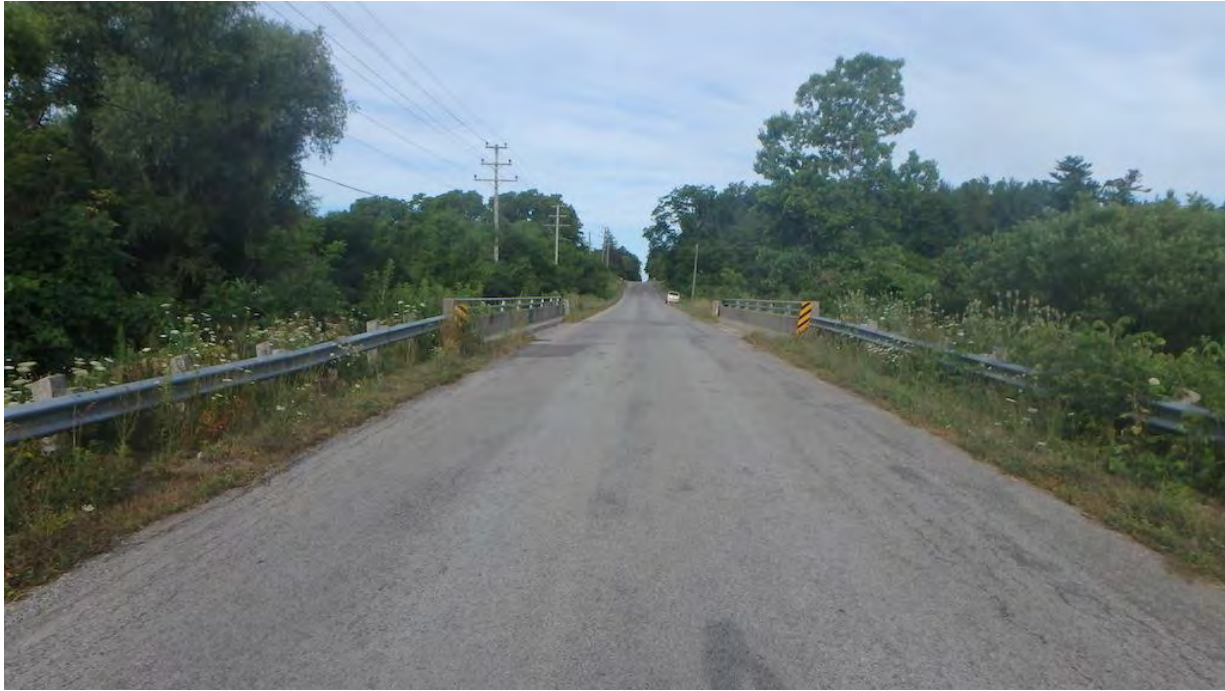
Figure 1 East Approach

| Cold patching and settlement on east approach. | | | | | | | | |

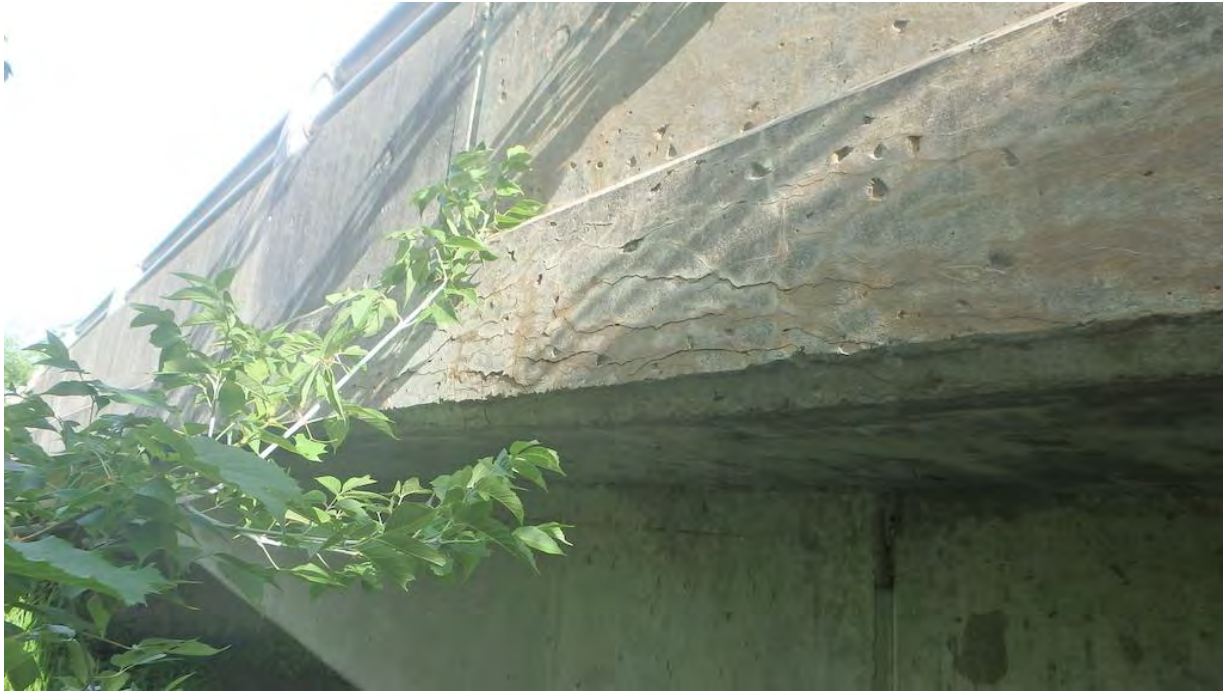
| Comments: Includes: Both walls and underside of deck and wingwalls. Localized areas of deterioration with chlorides on southeast and southwest fascia. Crack on west soffit with visible chlorides. | | | | | | | |

Figure 9 Cracking and Deterioration at Southeast Fascia

| Recommended Work: Rehab <input type="checkbox"/> Replace <input type="checkbox"/> Timing: Urgent <input type="checkbox"/> < 1yr <input type="checkbox"/> 1 - 5 yr <input type="checkbox"/> 6 - 10 yr <input type="checkbox"/> | | | | | Maintenance Needs: Repair of Bridge Concrete <input type="checkbox"/> Urgent <input type="checkbox"/> 1 year <input checked="" type="checkbox"/> 2 year | | |

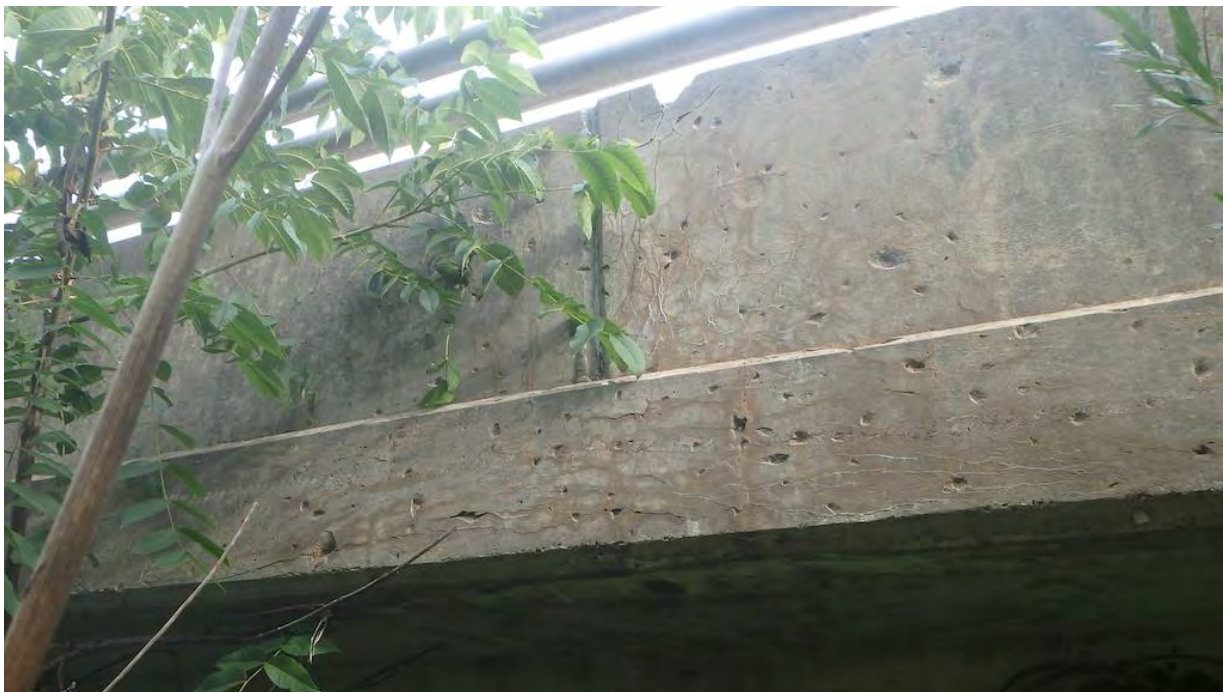
Figure 10 Cracking and Deterioration at Southwest Fascia

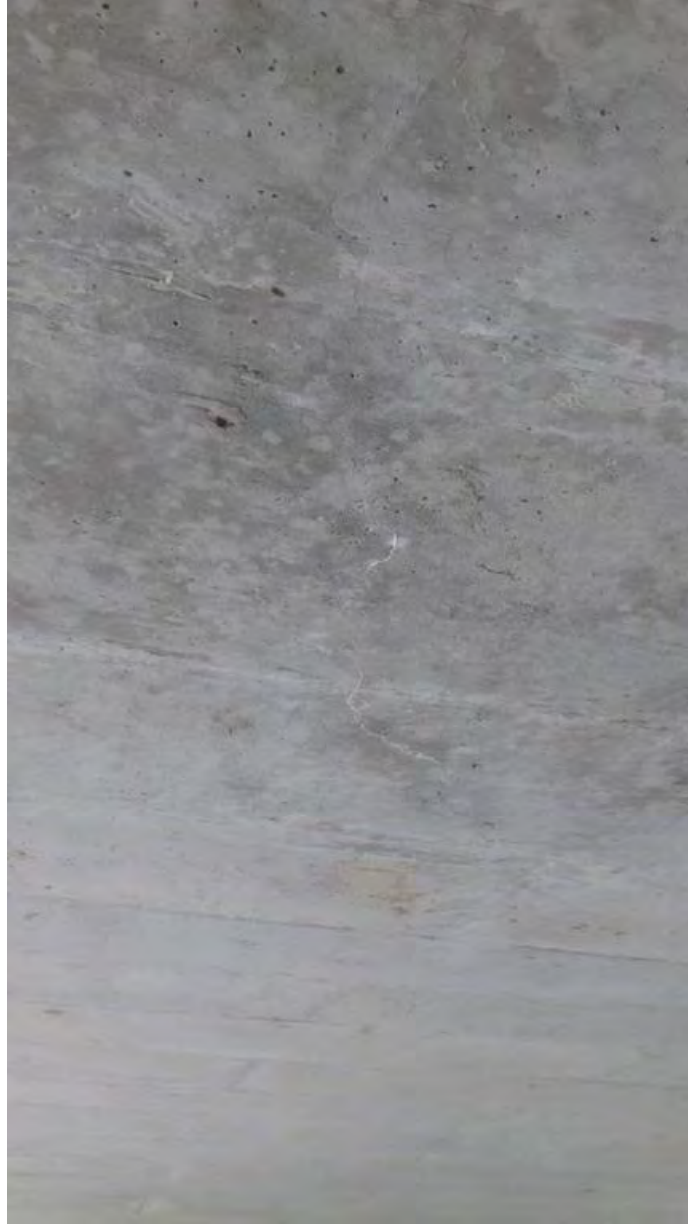
Figure 11 Crack on Soffit with Chloride

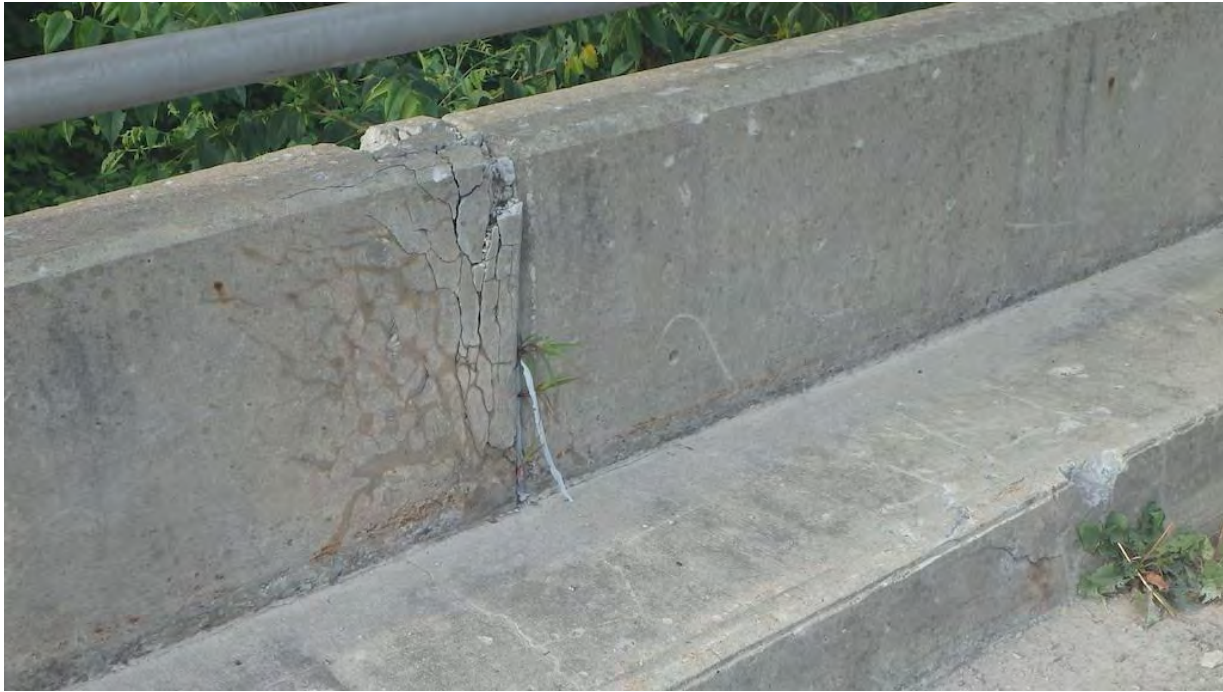
| Cracking and spalling at parapet walls at joints. Cable hanging from north wall not attached. | | | | | | | | |

Figure 12 Spalling at Barrier Joints

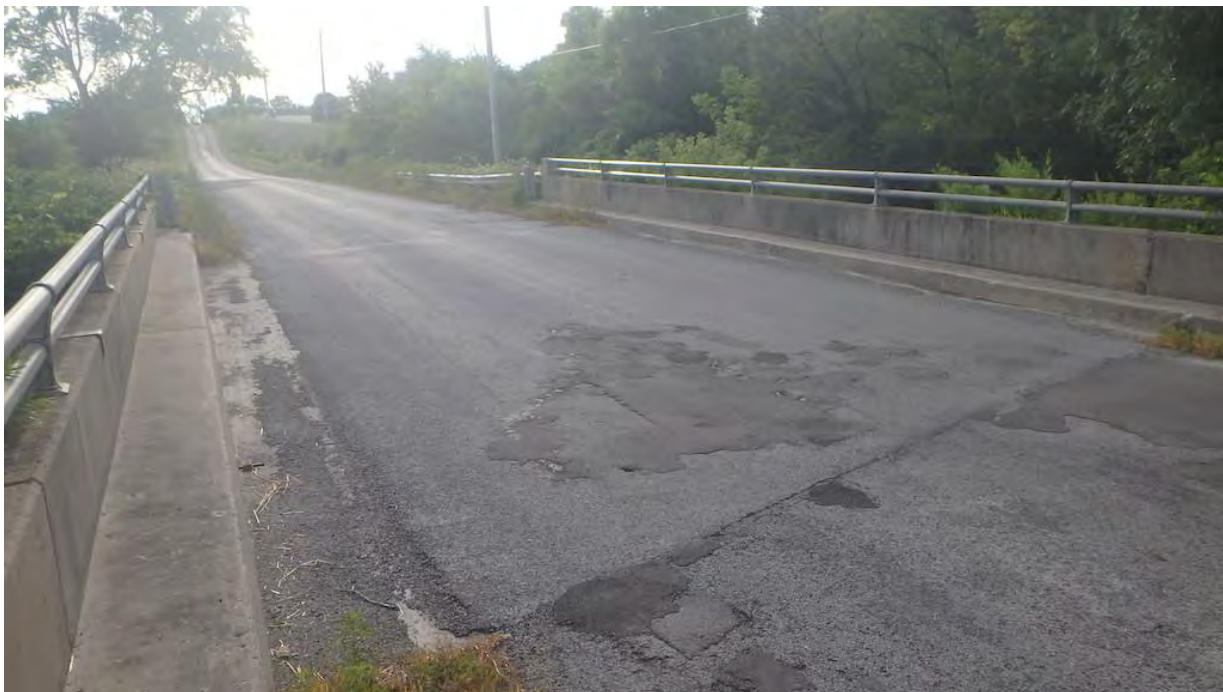
| Comments: Significant areas of patching on west end. | | | | | | | |

Figure 13 Patched Potholes in Wearing Surface

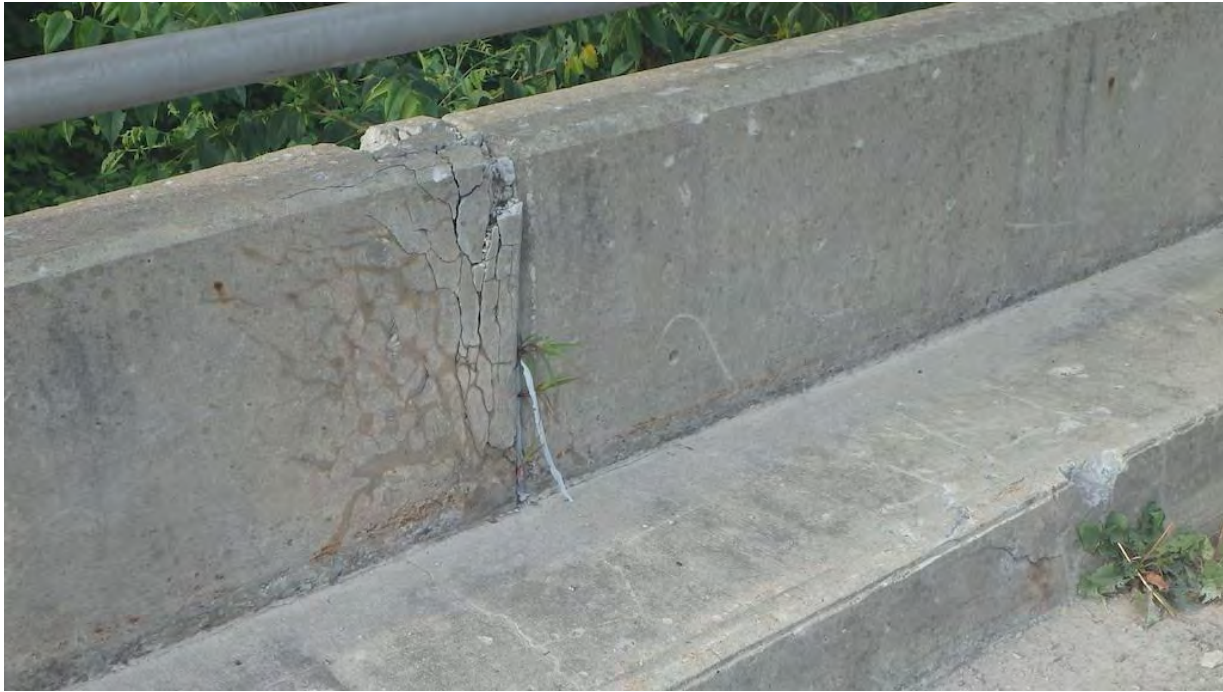
Figure 14 Spalling at Barrier Joints
