LOT 18-19 CONCESSION 5

Site Number 010034

EAST ¼ LINE ROAD, WOODHOUSE

Ontario Structure Inspection Manual - Inspection Form

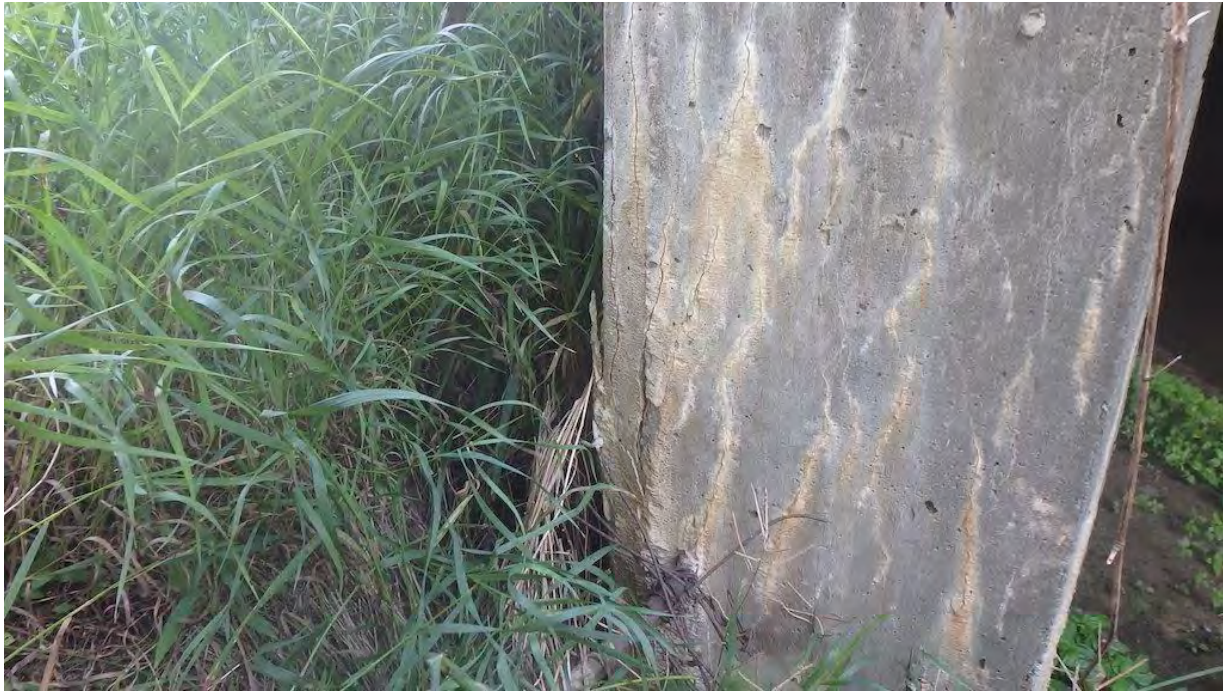
Figure 9 Delamination with chlorides at Southeast Quadrant

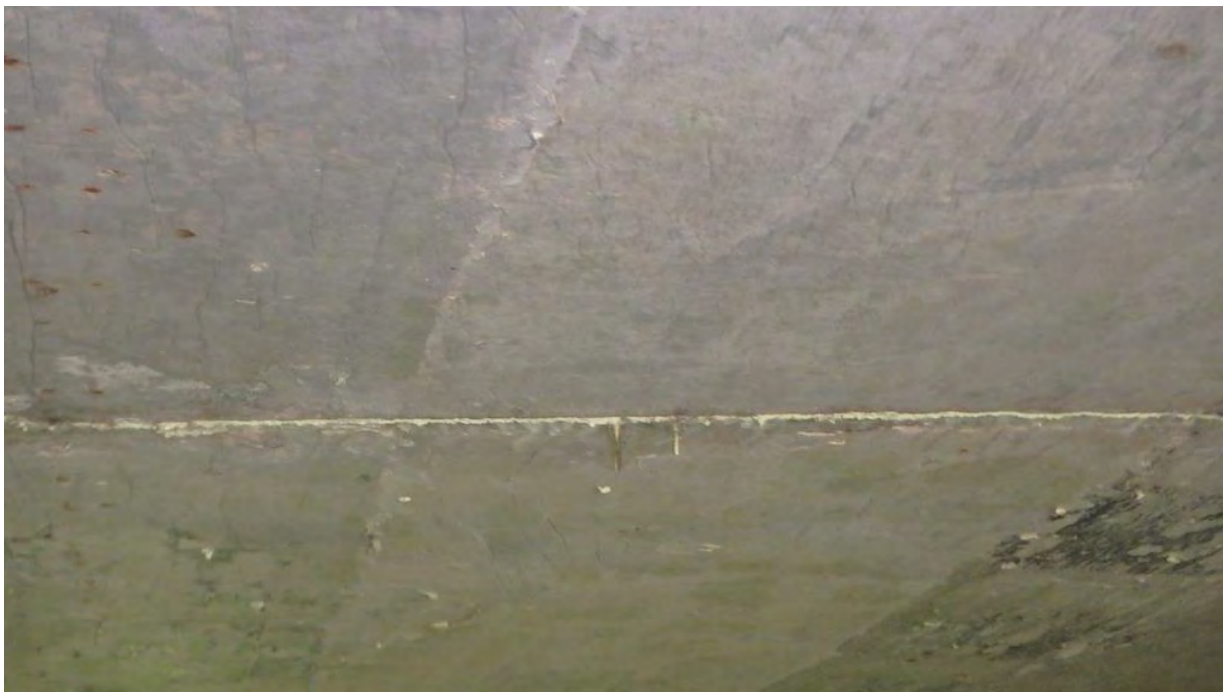
Figure 10 Leakage with chlorides at Joint in North Barrel

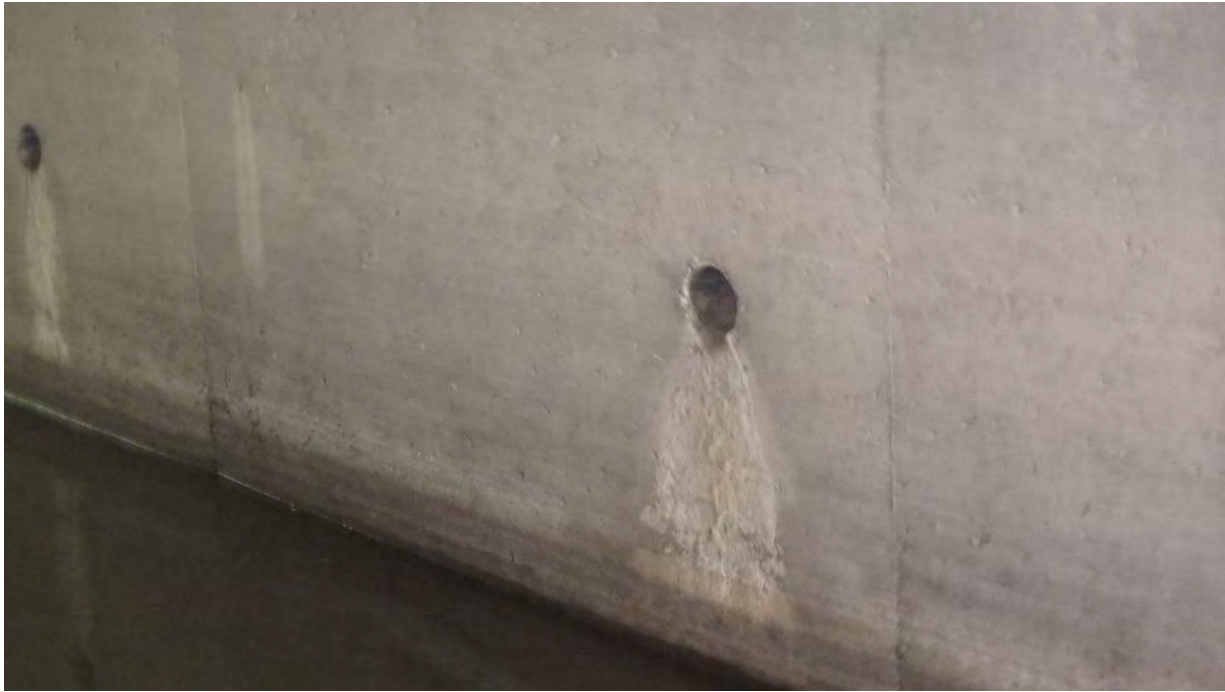
Figure 11 Staining and Deterioration Below Joints in North Barrel

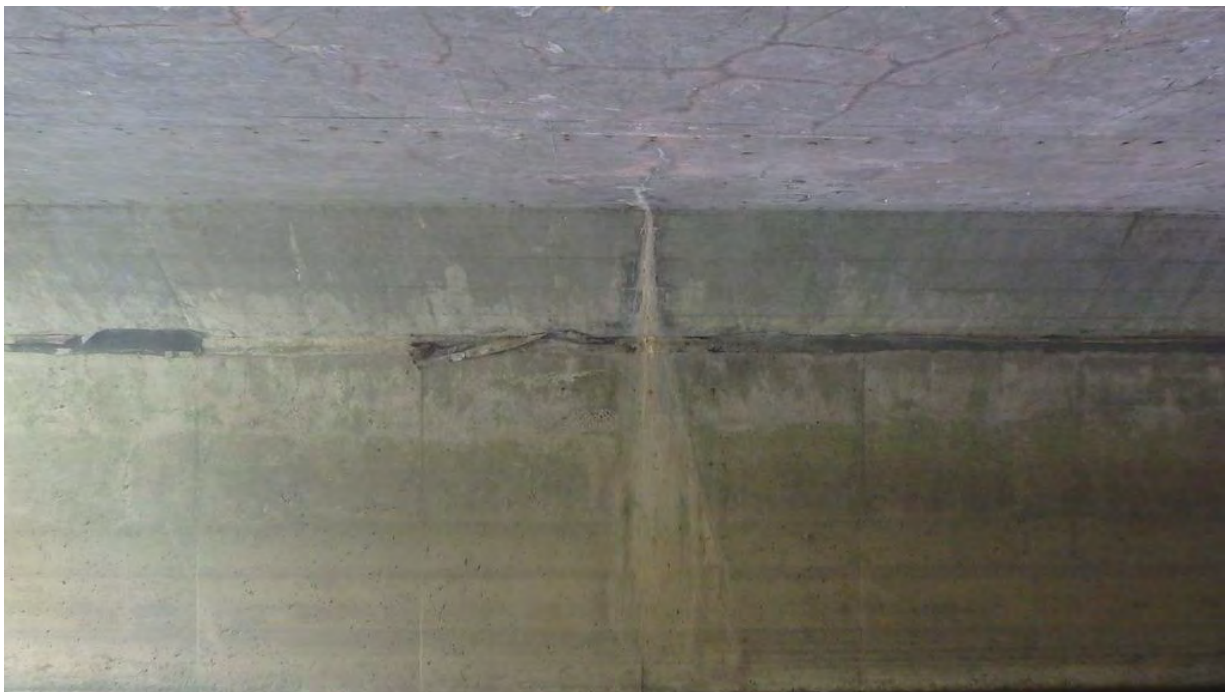
Figure 12 Vertical Crack with Leakage and Chlorides in South Barrel
