McBRIDE BRIDGE

Site Number 010037

LYNN VALLEY ROAD, WOODHOUSE

Ontario Structure Inspection Manual - Inspection Form

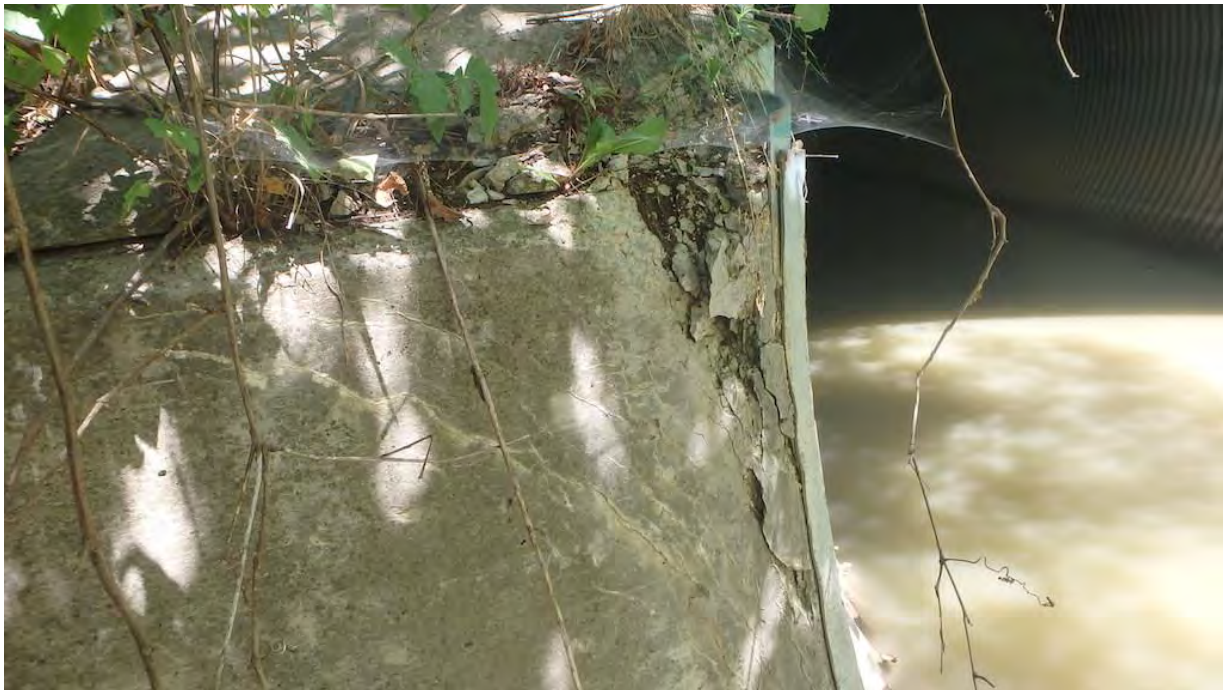
Figure 10 Delamination and Spalling at Southwest Quadrant

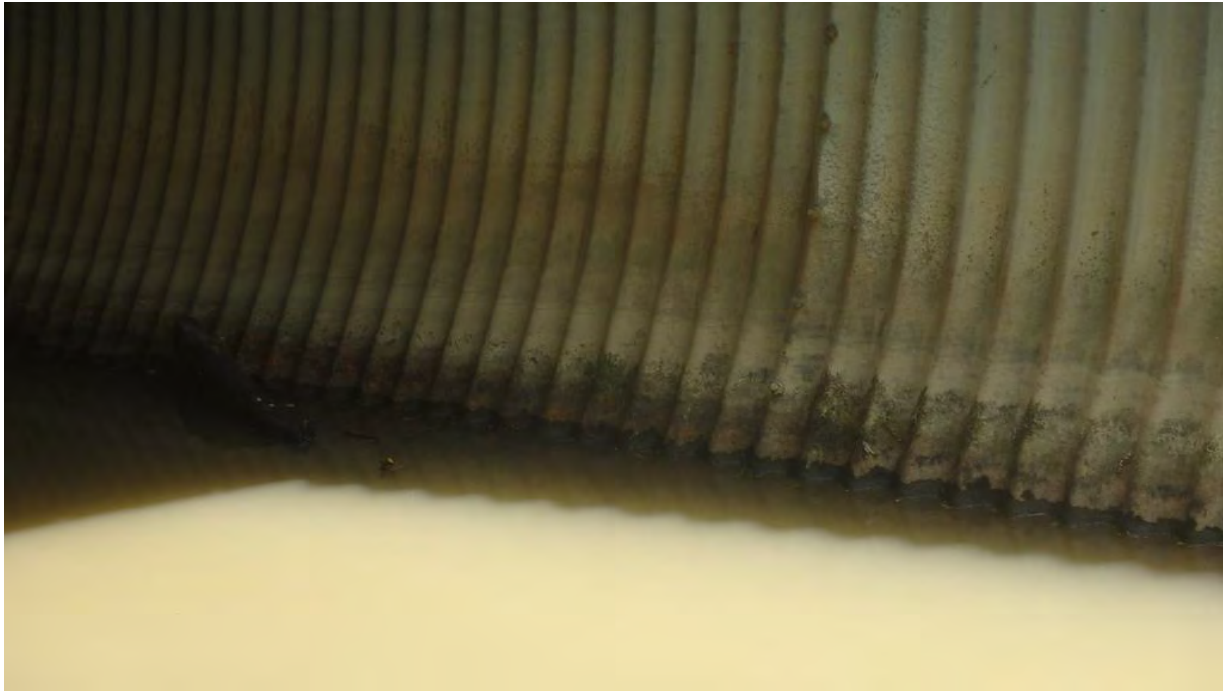
Figure 11 Typical Waterline Corrosion and Staining
