**LOT 19 CONCESSION 14 ROAD**

Site Number 010043

**CONCESSION 14 ROAD, TOWNSEND**

**Ontario Structure Inspection Manual - Inspection Form**

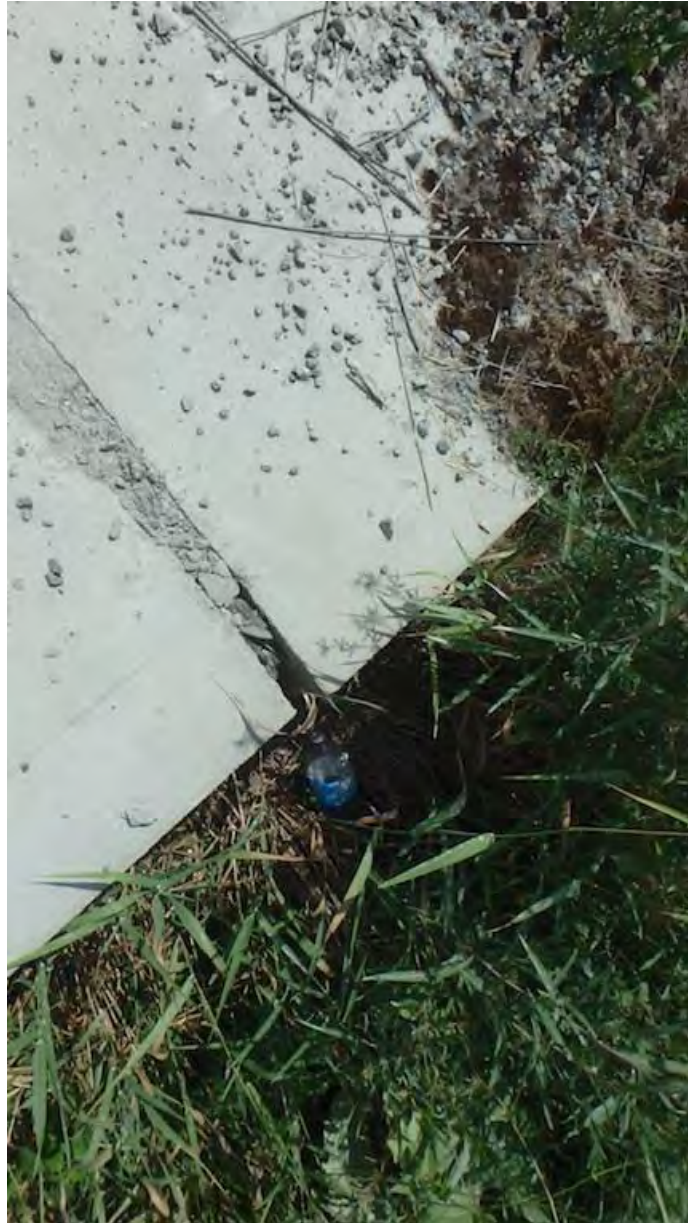
Figure 9 Minor Loss of Parging at Northwest Quadrant

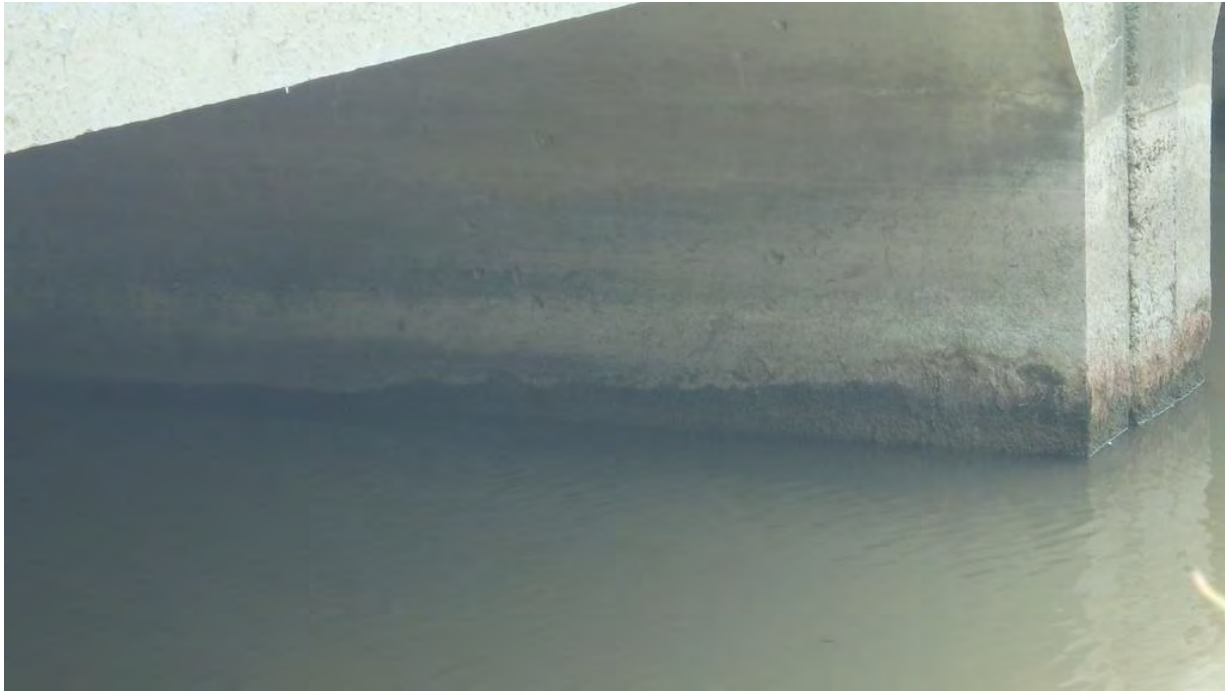
Figure 10 Typical Staining at Water Level
