ROCKFORD BRIDGE

Site Number 010047

CONCESSION 11 ROAD, TOWNSEND

Ontario Structure Inspection Manual - Inspection Form

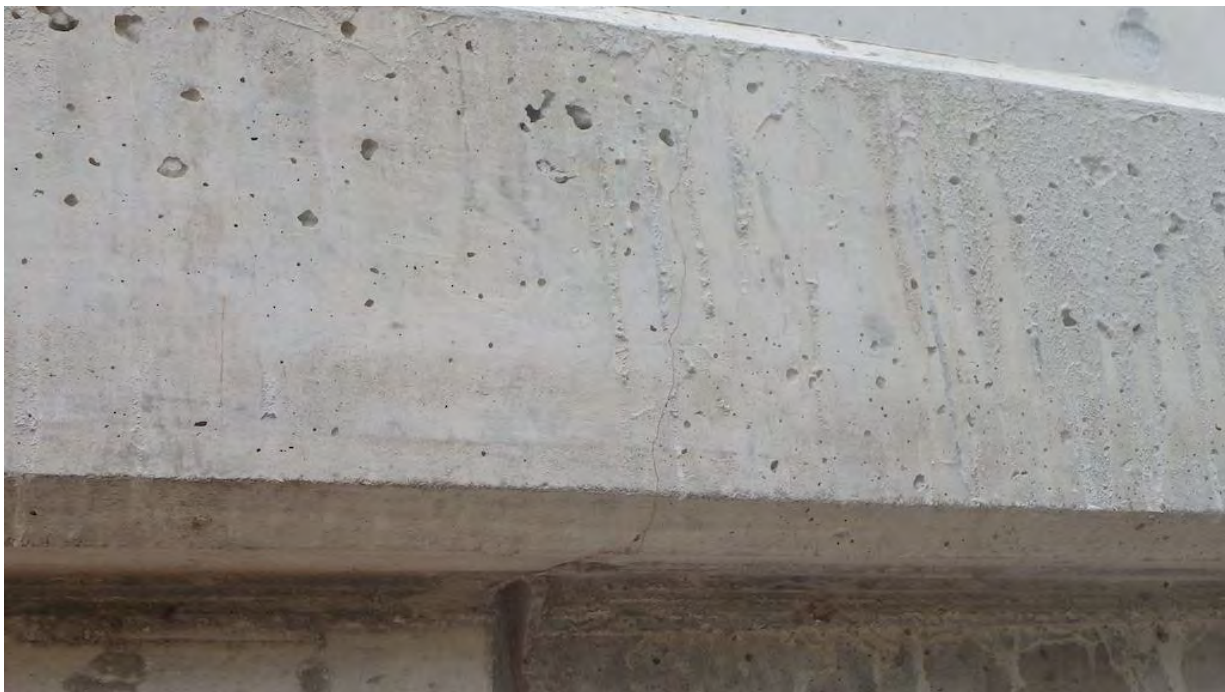
Element Group:		100 Decks				Length:	23.5
Element Name:		103 Soffit Thin Slab				Width:	
Location:		North and South Fascia				Height:	0.6
Material:		4 Cast-in-place Concrete				Count:	2
Element Type:						Total Quantity:	28.2 sq.m
Environment:		Severe				Limited Inspection:	
Protection System:		Unknown				Perform. Deficiencies	
Condition Data:	Units	Exc.	Good	Fair	Poor		
	sq.m	28.2	0	0	0		
Comments: Visible hairline cracking on fascia. Broken asphalt drain at southeast quadrant.							
Recommended Work:				Rehab <input type="checkbox"/> Replace <input type="checkbox"/>		Maintenance Needs: Bridge Cleaning	
Timing:				Urgent <input type="checkbox"/> < 1yr <input type="checkbox"/> 1 - 5 yr <input type="checkbox"/> 6 - 10 yr <input type="checkbox"/>		<input type="checkbox"/> Urgent <input type="checkbox"/> 1 year <input checked="" type="checkbox"/> 2 year

Figure 10 Typical Hairline Crack in Fascia

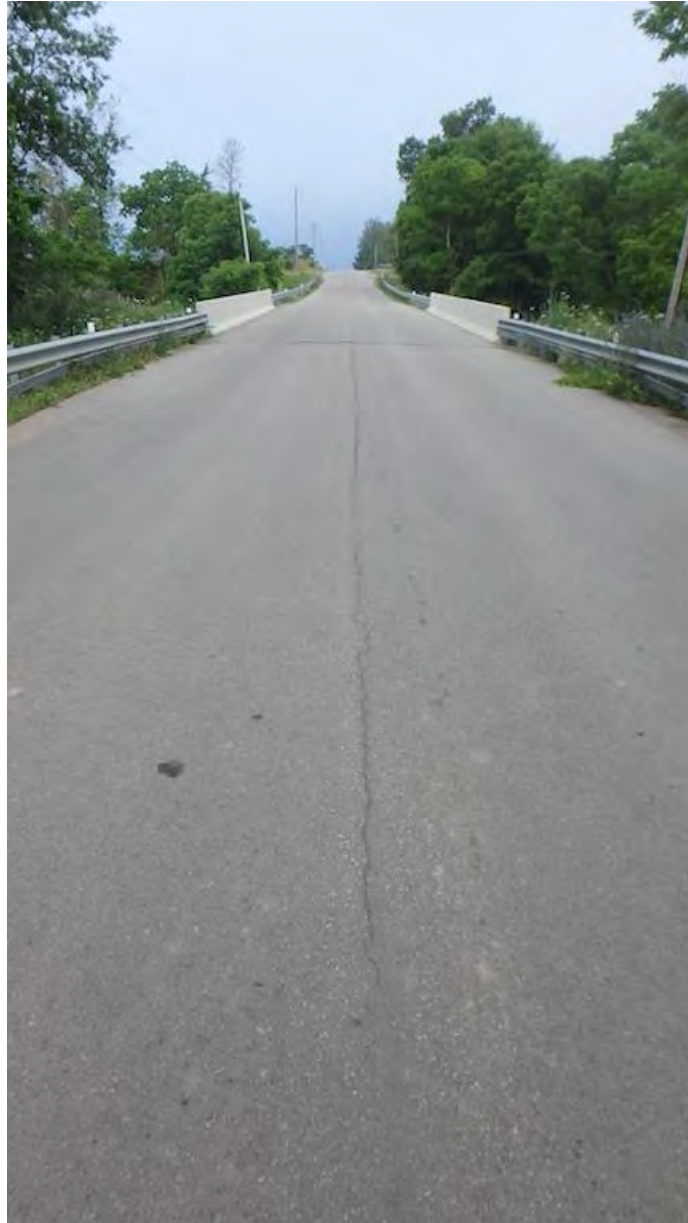
Element Group:	100 Decks	Length:	14		
Element Name:	101 Wearing Surface	Width:	9		
Location:	Top of Deck	Height:			
Material:	2 Asphalt	Count:	1		
Element Type:		Total Quantity:	126 sq.m		
Environment:	Severe	Limited Inspection:			
Protection System:	Unknown	Perform. Deficiencies			
Condition Data:	Units	Exc.	Good	Fair	Poor
	sq.m	126	0	0	0
Comments:					
Recommended Work:			Maintenance Needs:		
Rehab <input type="checkbox"/> Replace <input type="checkbox"/> Timing: Urgent <input type="checkbox"/> < 1yr <input type="checkbox"/> 1 - 5 yr <input type="checkbox"/> 6 - 10 yr <input type="checkbox"/>			<input type="checkbox"/> Urgent <input type="checkbox"/> 1 year <input type="checkbox"/> 2 year

Figure 11 Centreline Longitudinal Crack in Wearing Surface

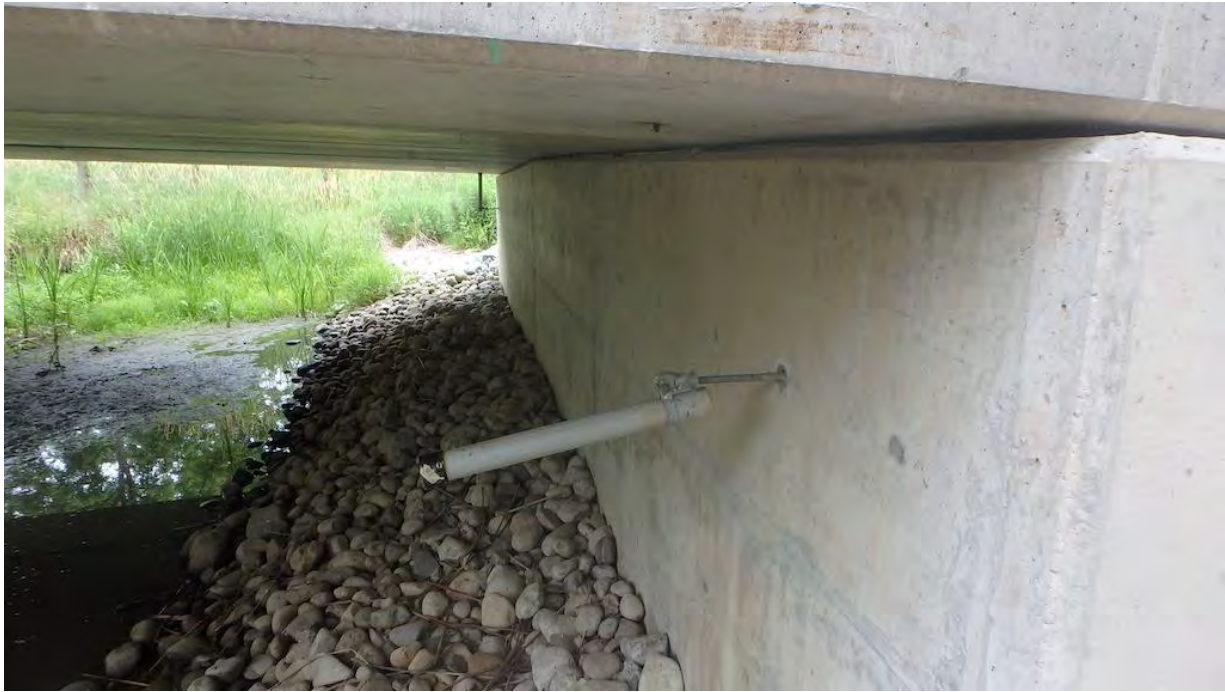
Element Group:	1600 Approaches	Length:	6		
Element Name:	1601 Wearing Surface (Approaches)	Width:	9		
Location:	East and West	Height:			
Material:	10 Other	Count:	2		
Element Type:		Total Quantity:	108 sq.m		
Environment:	Severe	Limited Inspection:			
Protection System:	Unknown	Perform. Deficiencies			
Condition Data:	Units	Exc.	Good	Fair	Poor
	sq.m	106.5	0	1.5	0
Comments:					
Centerline crack on East approach wearing surface.					
Recommended Work:			Maintenance Needs:		
Rehab <input type="checkbox"/> Replace <input type="checkbox"/> Timing: Urgent <input type="checkbox"/> < 1yr <input type="checkbox"/> 1 - 5 yr <input type="checkbox"/> 6 - 10 yr <input type="checkbox"/>			Rout and Seal <input type="checkbox"/> Urgent <input type="checkbox"/> 1 year <input checked="" type="checkbox"/> 2 year

Figure 12 Broken Asphalt Drain at Southeast Quadrant
