**HALL BRIDGE**

Site Number 010048

**CONCESSION 10 ROAD, TOWNSEND**

**Ontario Structure Inspection Manual - Inspection Form**

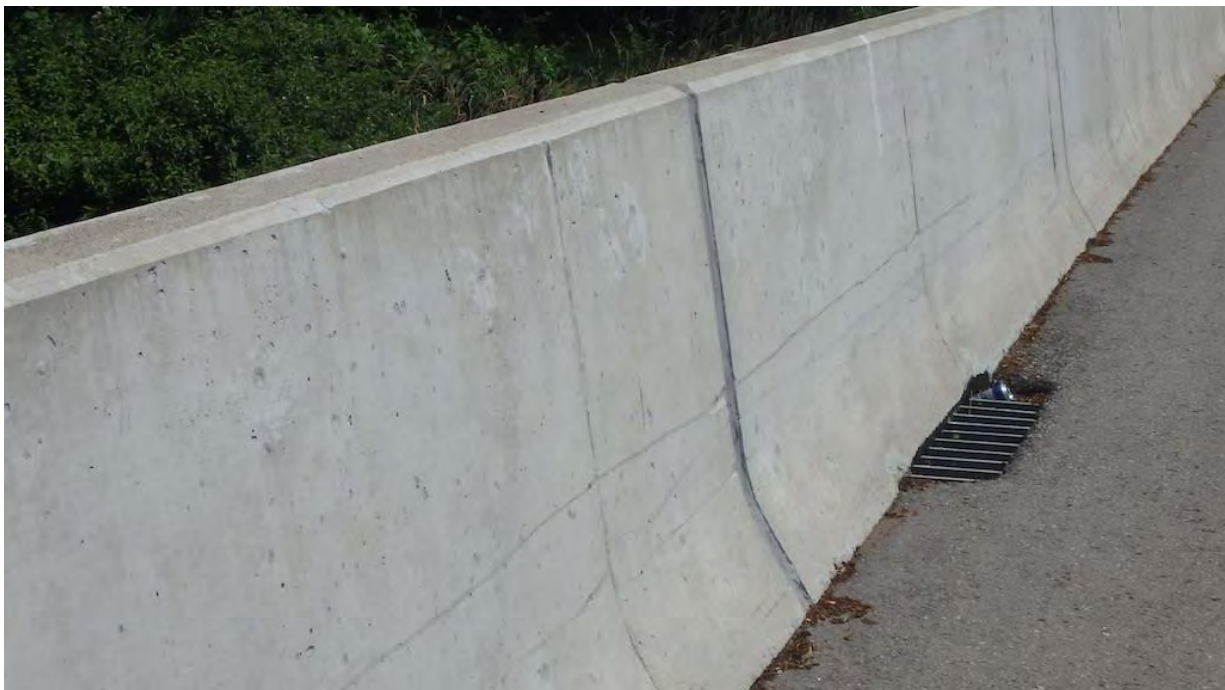
Figure 10 Slight Impact Damage on Barriers

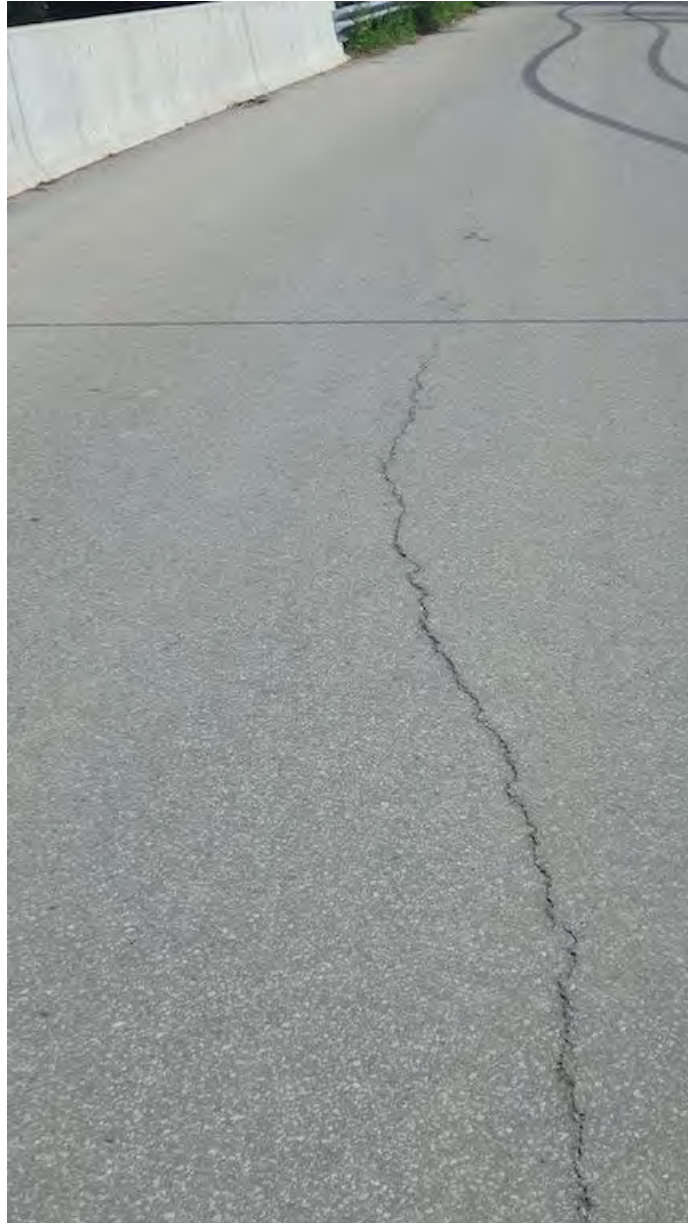
Figure 11 Longitudinal Crack in Wearing Surface
