WATERFORD POND BRIDGE

Site Number 010053

POND ROAD (MECHANIC STREET), WATERFORD

Ontario Structure Inspection Manual - Inspection Form

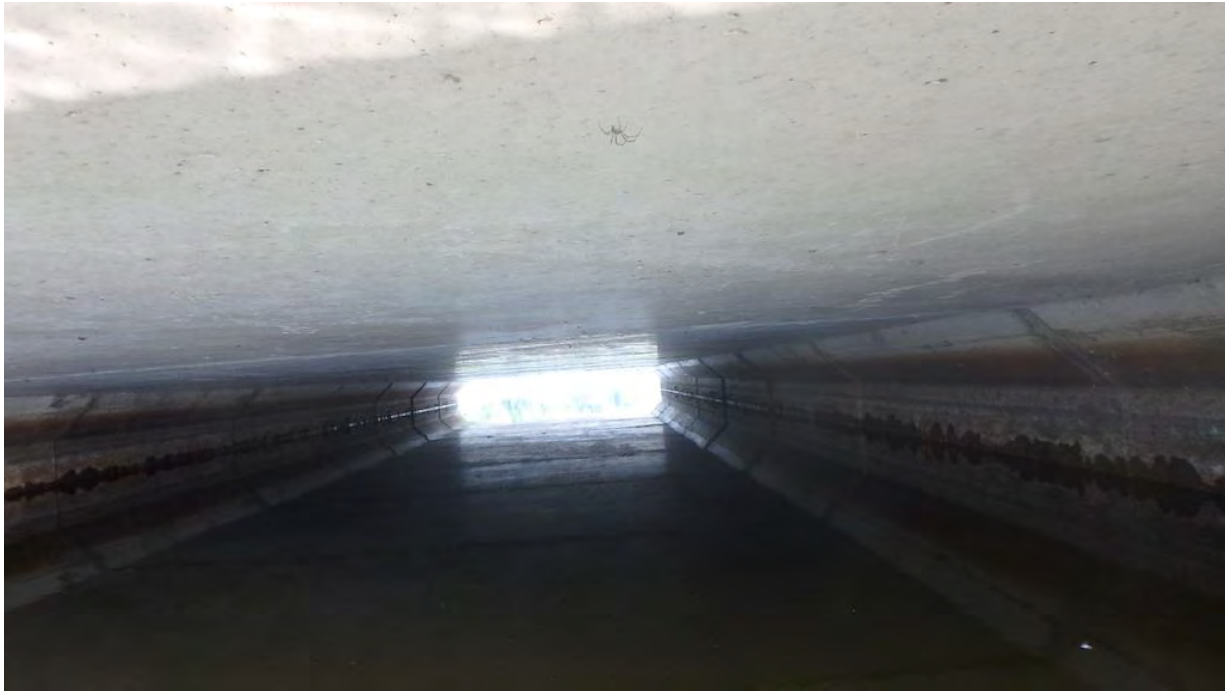
Figure 5 East Barrel

| Comments: Precast twin concrete on footing. Limited inspection due to water level. Some minor vertical cracks in walls. | | | | | | | |

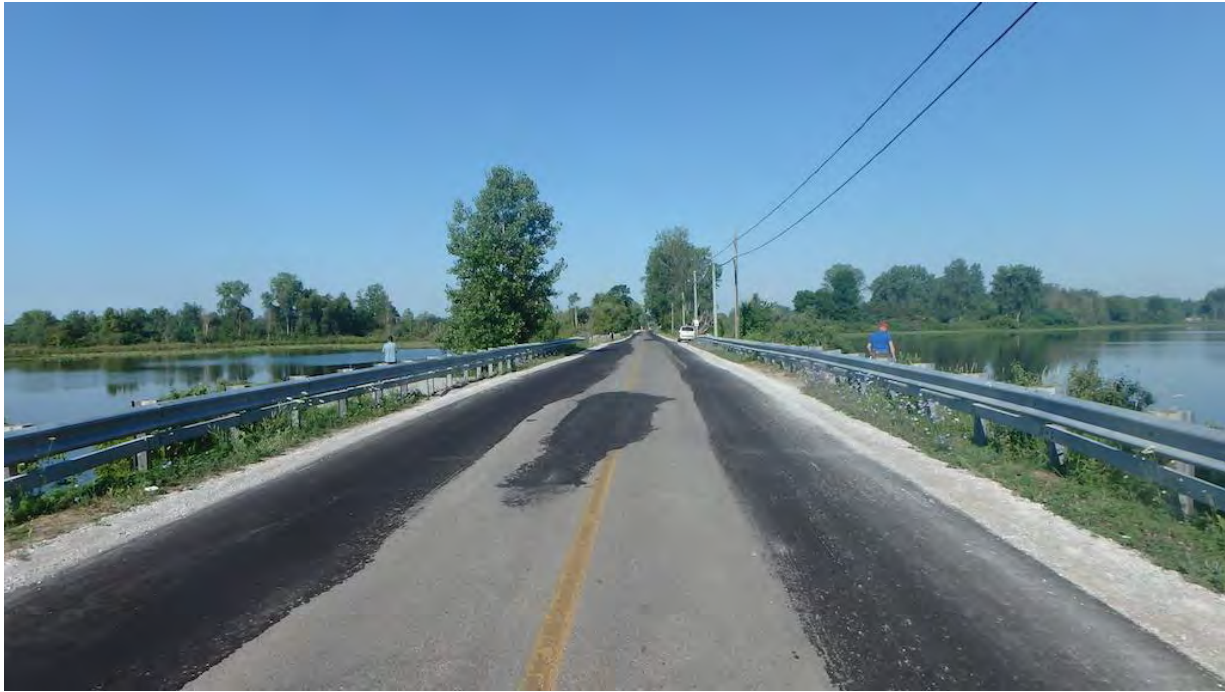
| Comments: No hazard signs. Transverse crack in wearing surface. | | | | | | | |

Figure 7 Patching and Centreline Crack in Wearing Surface

| Recommended Work: | | | | Rehab <input type="checkbox"/> Replace <input type="checkbox"/> | | Maintenance Needs: Rout and Seal | |

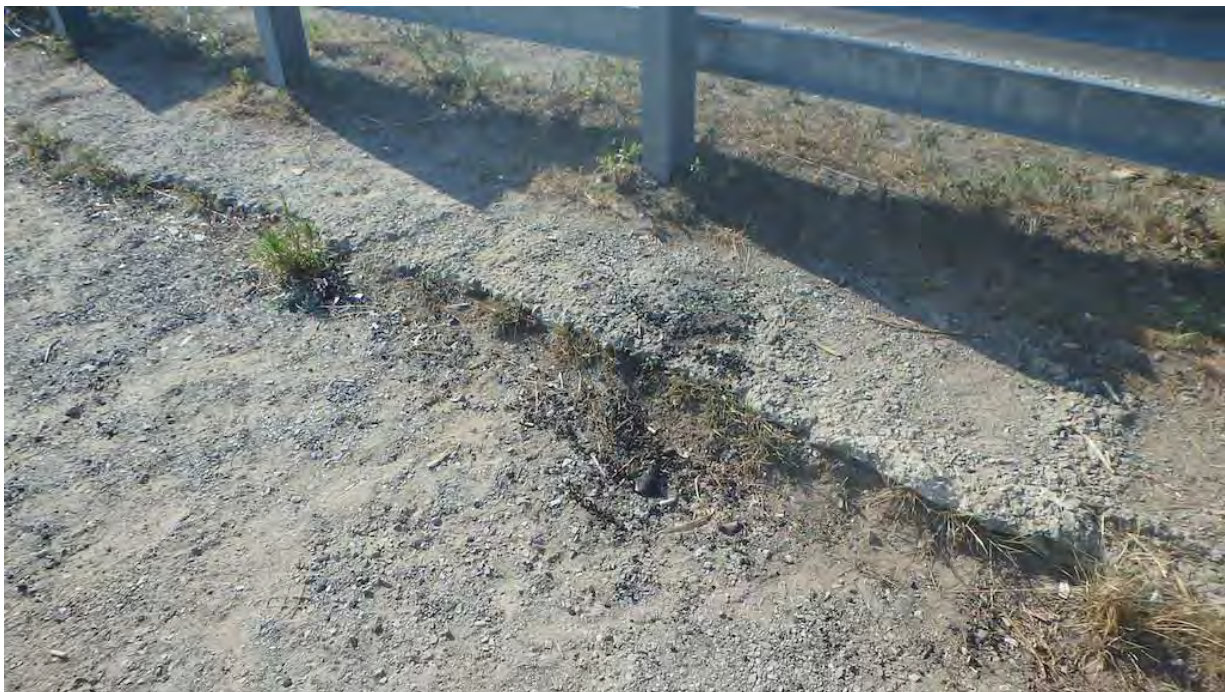
Figure 8 Typical Spalling at Outside Curb Edges
