TOWNLINER BRIDGE

Site Number 010057

BRANT - NORFOLK TOWNLINER ROAD

Ontario Structure Inspection Manual - Inspection Form

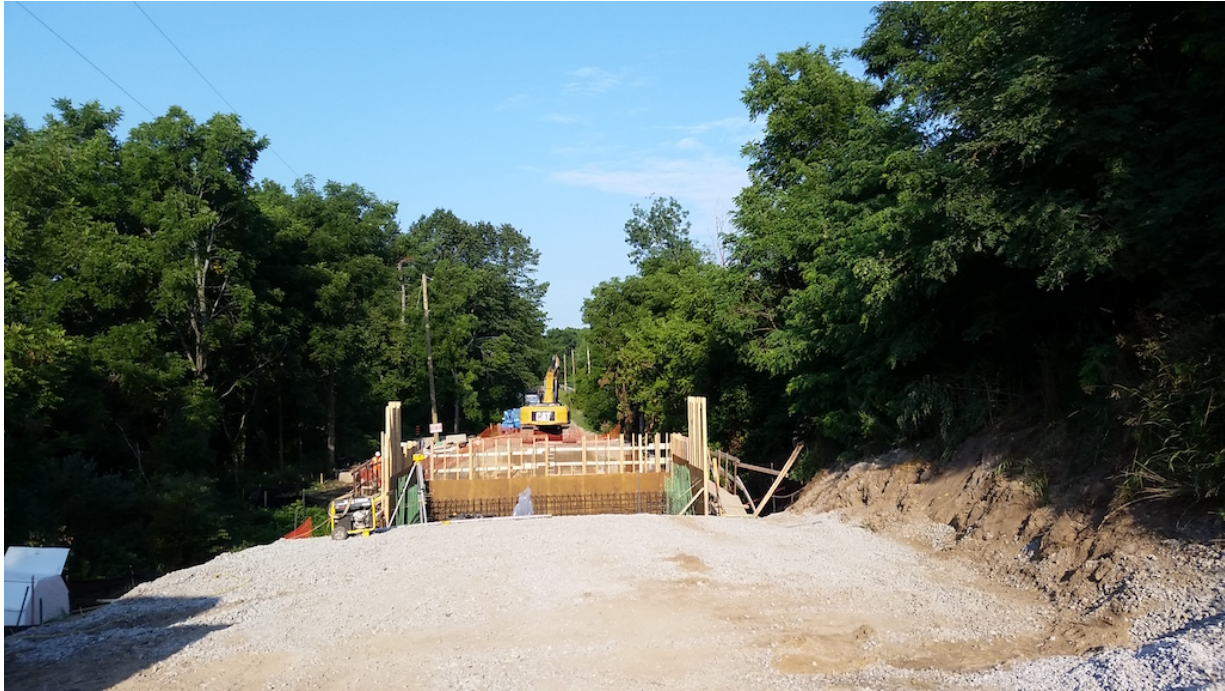
Figure 1 Bridge Under Construction, 2016
