**MILL ROAD CULVERT**

Site Number 010065

**MILL ROAD (CONCESSION 2), WOODHOUSE**

**Ontario Structure Inspection Manual - Inspection Form**

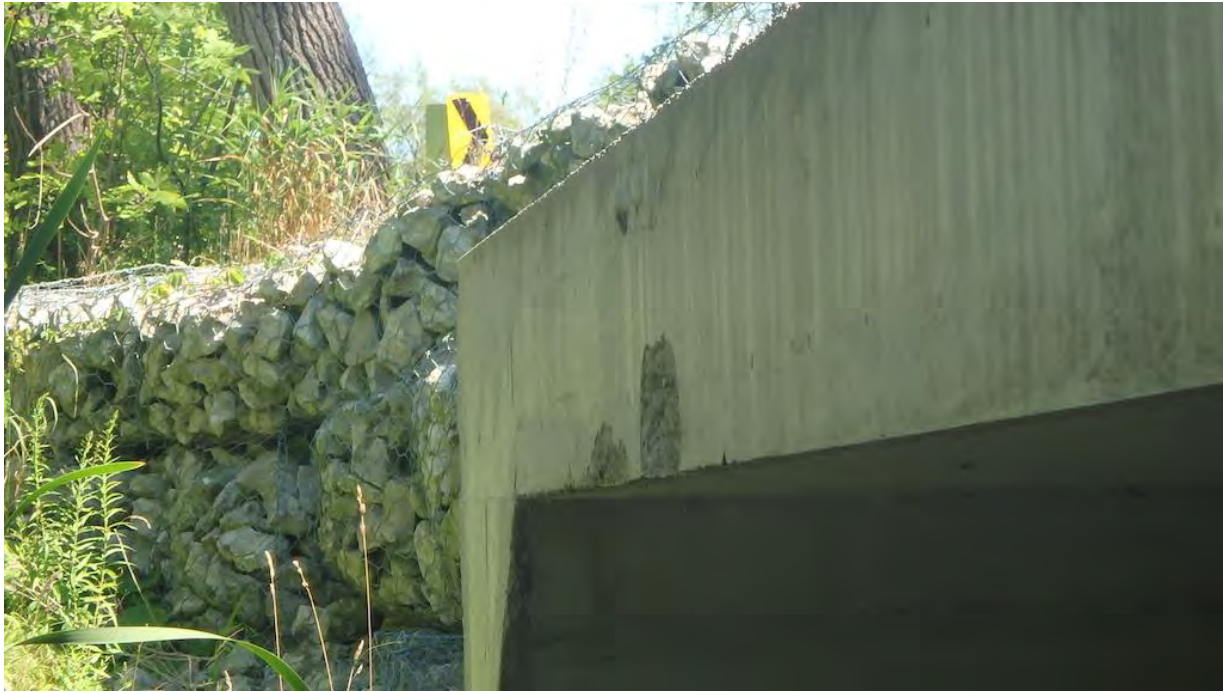
Figure 9 Small Impact Damage on East Fascia

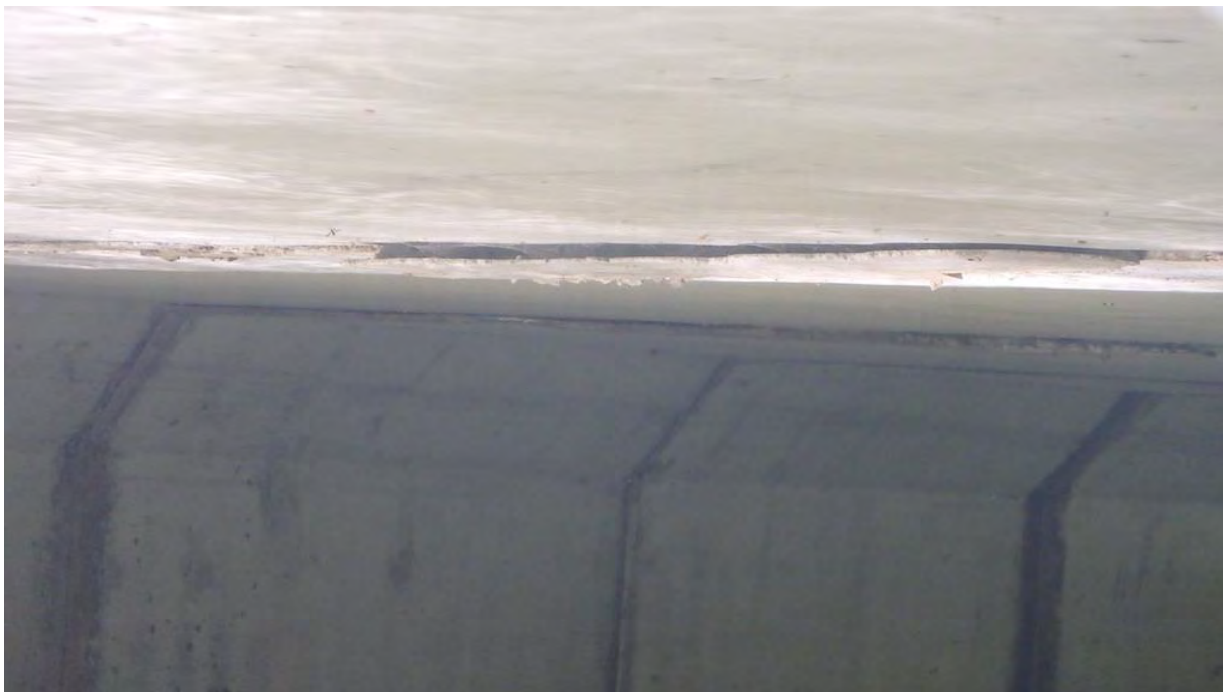
Figure 10 Deterioration of Parging at Joints

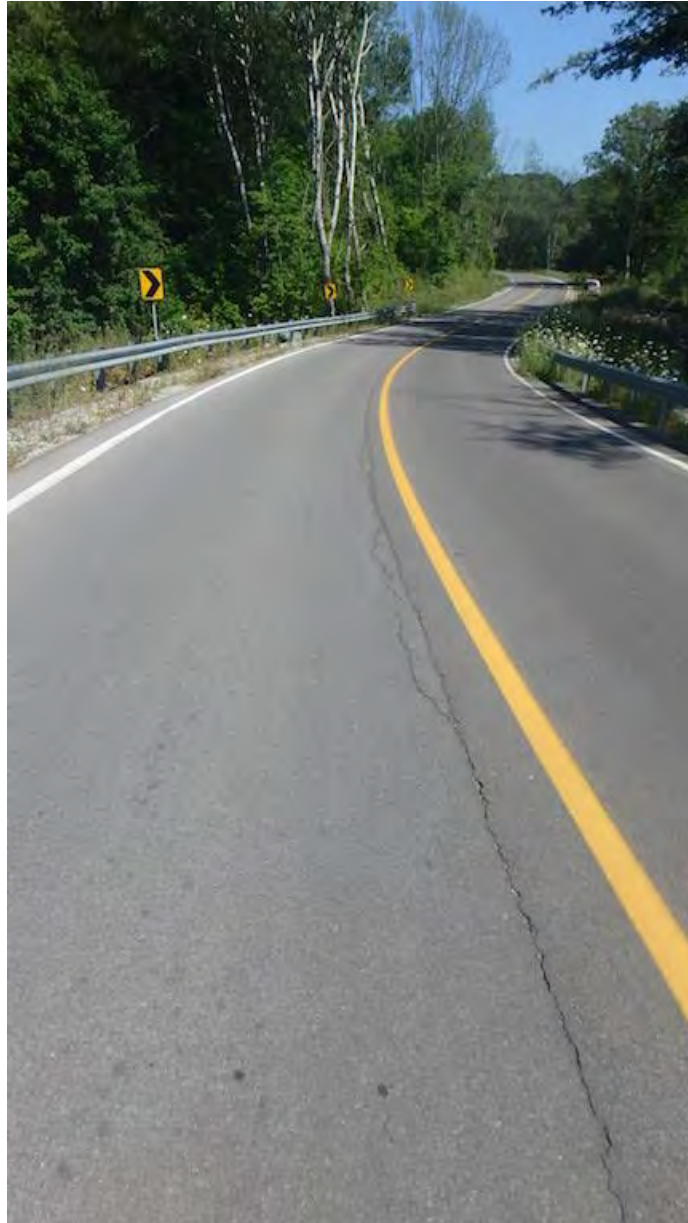
Figure 11 Longitudinal Crack in Wearing Surface at North Surface
