LOT 15 CONCESSION 4 ROAD

Site Number 010069

LYNN VALLEY ROAD, WOODHOUSE

Ontario Structure Inspection Manual - Inspection Form

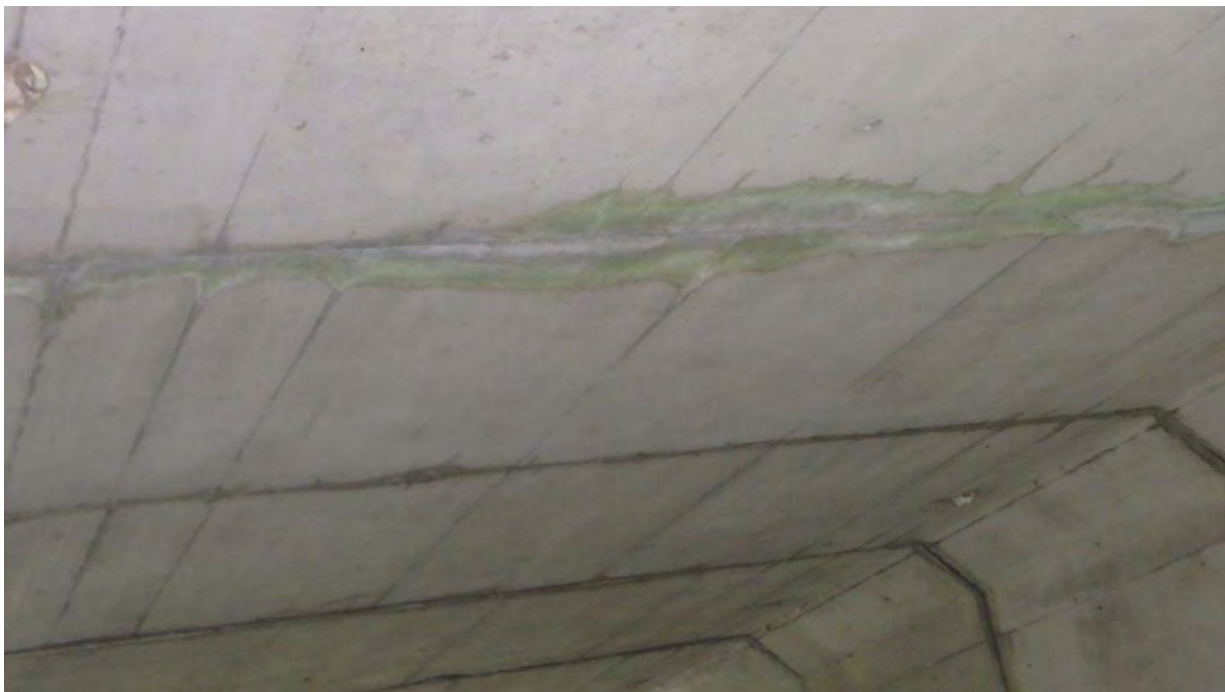
Figure 8 Leakage and Staining at South Joint

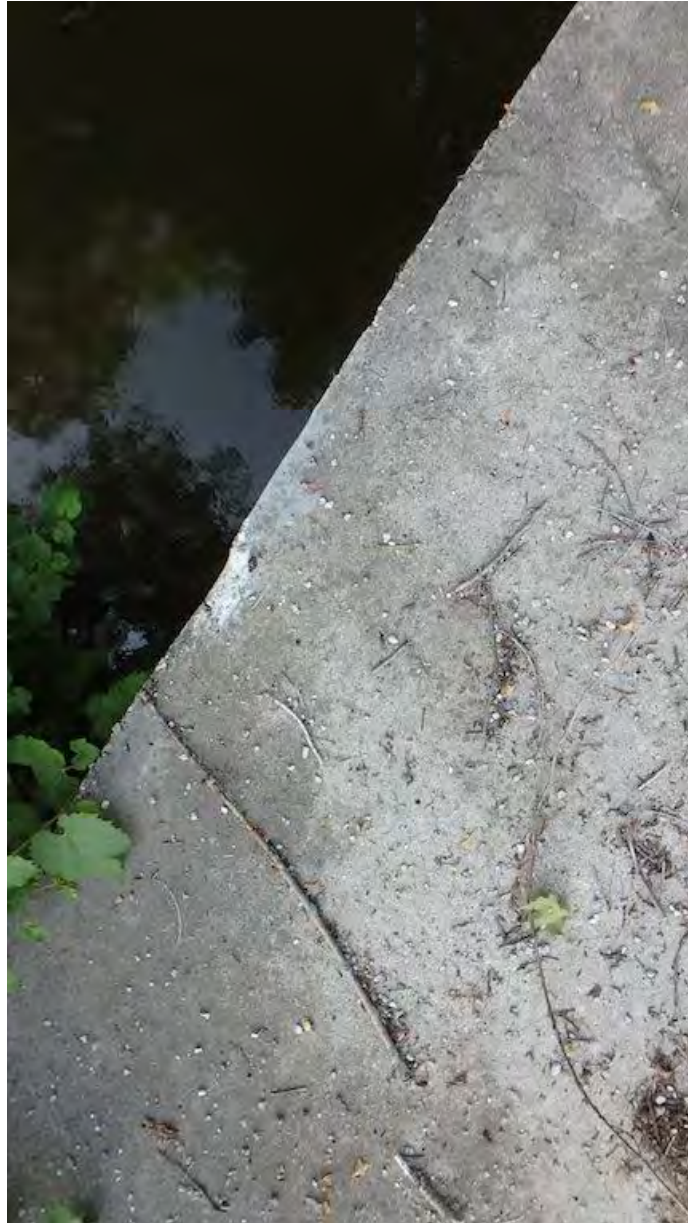
Figure 9 Spall at Outlet End

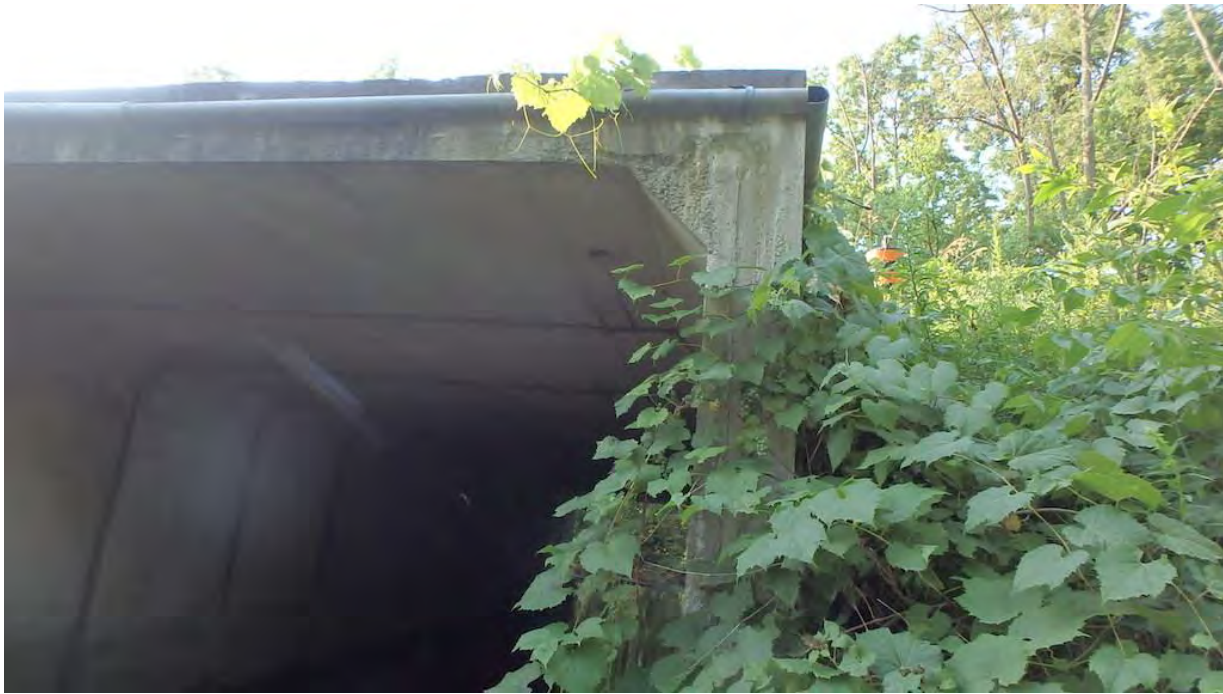
Figure 10 Scaling at Northwest Quadrant

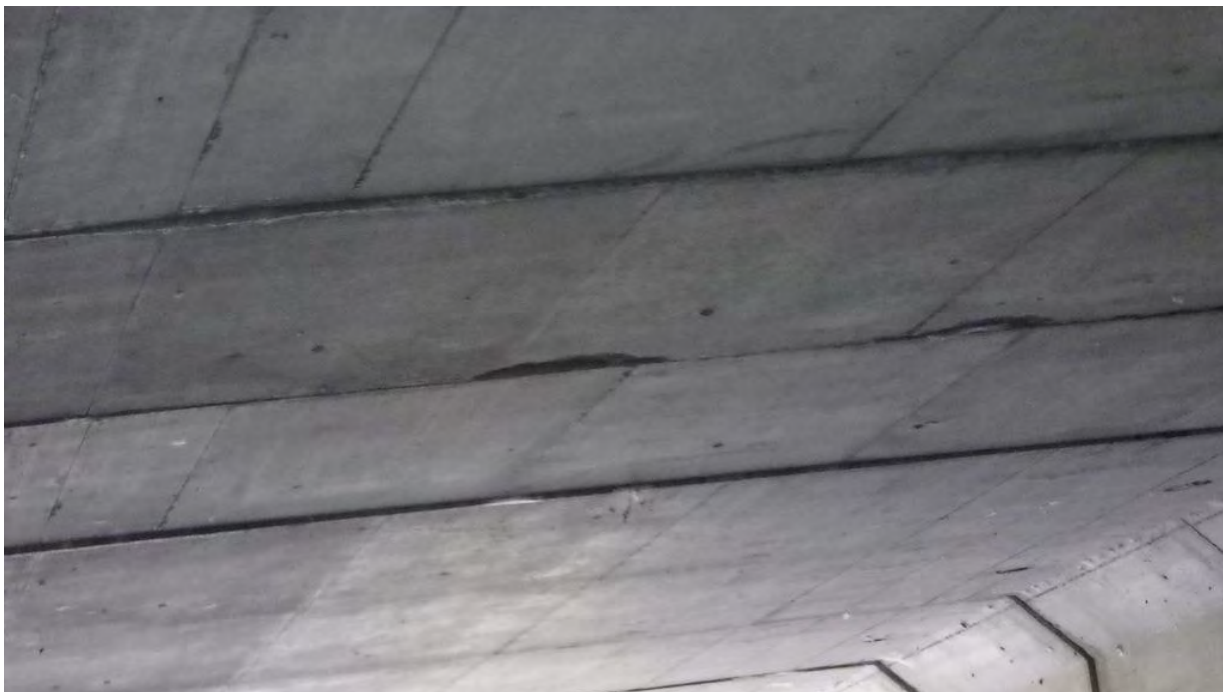
Figure 11 Spalling at Joint in Barrel

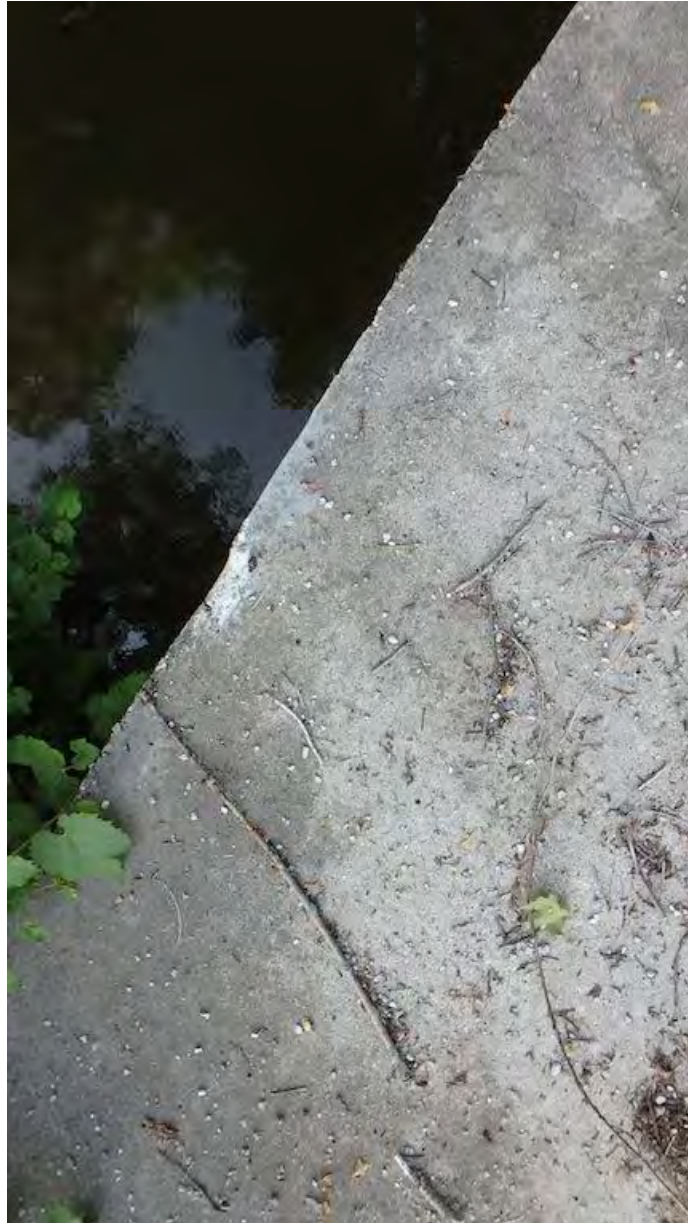
Figure 12 Spall at Outlet End

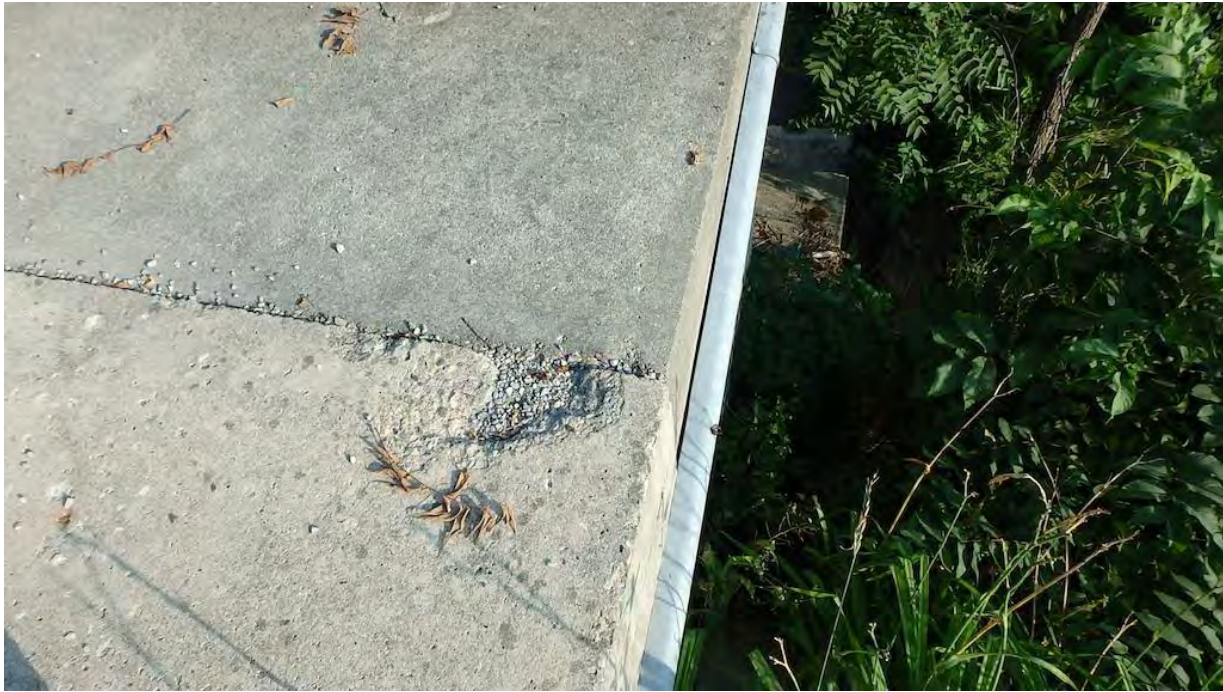
Figure 13 Scaling, Utility at Northwest Quadrant
