**BLACK CREEK CULVERT**

Site Number 010078

**CONCESSION 14 ROAD, TOWNSEND**

**Ontario Structure Inspection Manual - Inspection Form**

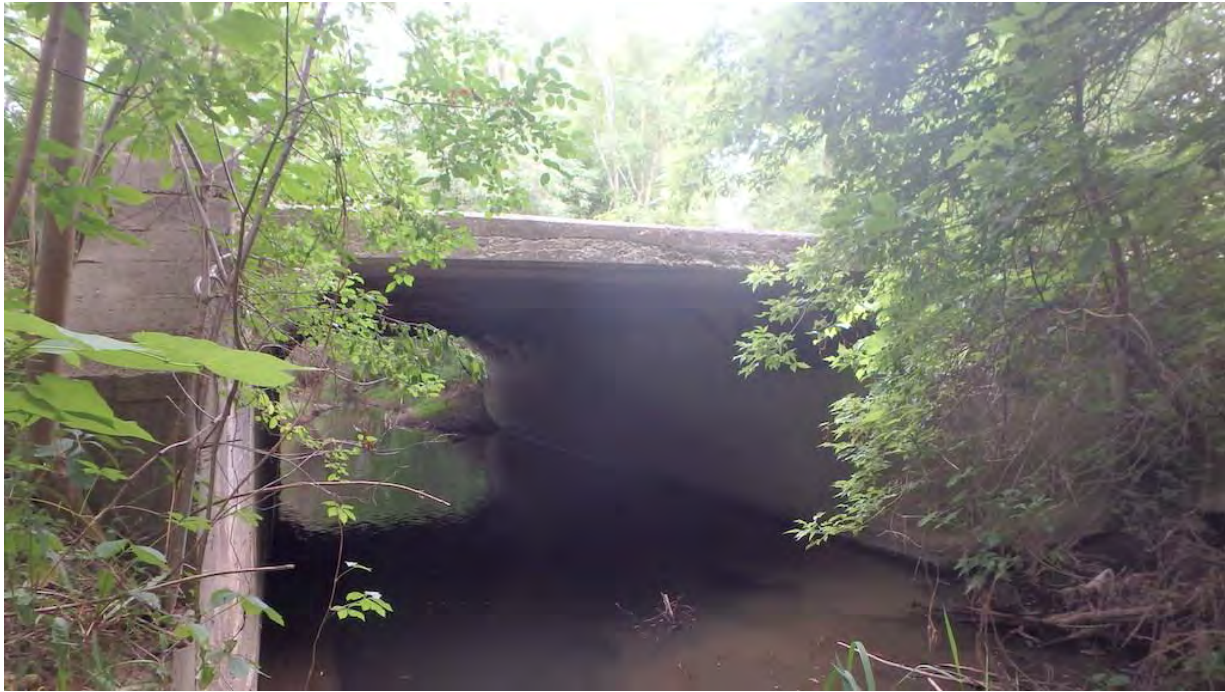
Figure 3 North Profile, Inlet

Element Group:		1200 Culverts				Length:	6.8
Element Name:		1201 Inlet Components				Width:	0.4
Location:		North End				Height:	2.7
Material:		4 Cast-in-place Concrete				Count:	1
Element Type:						Total Quantity:	4.9 sq.m
Environment:		Moderate				Limited Inspection:	
Protection System:		None				Perform. Deficiencies	
Condition Data:	Units sq.m	Exc. 0	Good 2.9	Fair 2	Poor 0		
Comments: Medium scaling on fascia. Wingwall/retaining wall at inlet.							
Recommended Work:				Rehab <input type="checkbox"/> Replace <input type="checkbox"/>		Maintenance Needs:	
Timing:				Urgent <input type="checkbox"/> < 1yr <input type="checkbox"/> 1 - 5 yr <input type="checkbox"/> 6 - 10 yr <input type="checkbox"/>		<input type="checkbox"/> Urgent <input type="checkbox"/> 1 year <input type="checkbox"/> 2 year

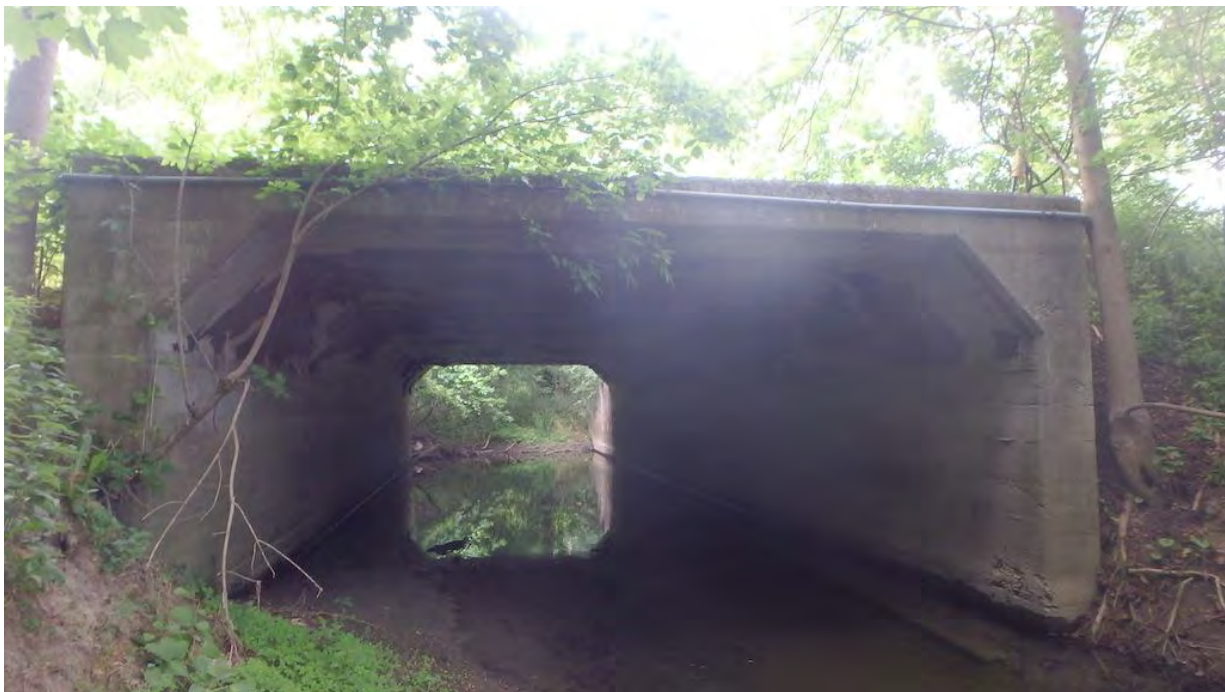
Figure 4 South Profile, Outlet

Element Group:		1200 Culverts				Length:	6.8
Element Name:		1202 Outlet Components				Width:	0.4
Location:		South				Height:	2.7
Material:		4 Cast-in-place Concrete				Count:	1
Element Type:						Total Quantity:	4.9 sq.m
Environment:		Moderate				Limited Inspection:	
Protection System:		None				Perform. Deficiencies	
Condition Data:	Units sq.m	Exc. 0	Good 2.9	Fair 2	Poor 0		
Comments: Utility line on face has been damaged due to damaged pipe casing medium spalling.							
Recommended Work:				Rehab <input type="checkbox"/> Replace <input type="checkbox"/>		Maintenance Needs:	
Timing:				Urgent <input type="checkbox"/> < 1yr <input type="checkbox"/> 1 - 5 yr <input type="checkbox"/> 6 - 10 yr <input type="checkbox"/>		<input type="checkbox"/> Urgent <input type="checkbox"/> 1 year <input type="checkbox"/> 2 year

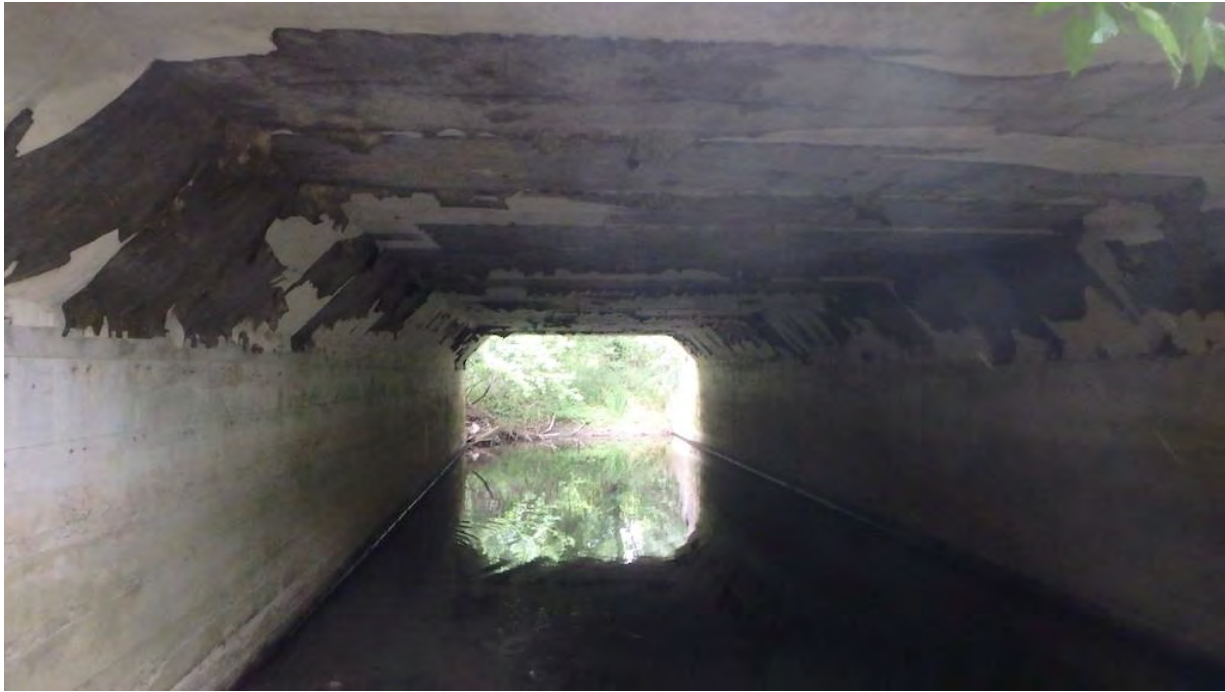
Figure 9 Barrel

Element Group:		1200 Culverts				Length:	18.4
Element Name:		1203 Barrels				Width:	11
Location:						Height:	
Material:		4 Cast-in-place Concrete				Count:	1
Element Type:		Frames - Rigid				Total Quantity:	205.2 sq.m
Environment:		Moderate				Limited Inspection:	
Protection System:		None				Perform. Deficiencies	
Condition	Units	Exc.	Good	Fair	Poor		
Data:	sq.m	0	0	200	5.2		
Comments: Cold joints along length of both walls. Medium scaling.							
Recommended Work:				Rehab <input type="checkbox"/> Replace <input type="checkbox"/>		Maintenance Needs:	
Timing:				Urgent <input type="checkbox"/> < 1yr <input type="checkbox"/> 1 - 5 yr <input type="checkbox"/> 6 - 10 yr <input type="checkbox"/>		<input type="checkbox"/> Urgent <input type="checkbox"/> 1 year <input type="checkbox"/> 2 year

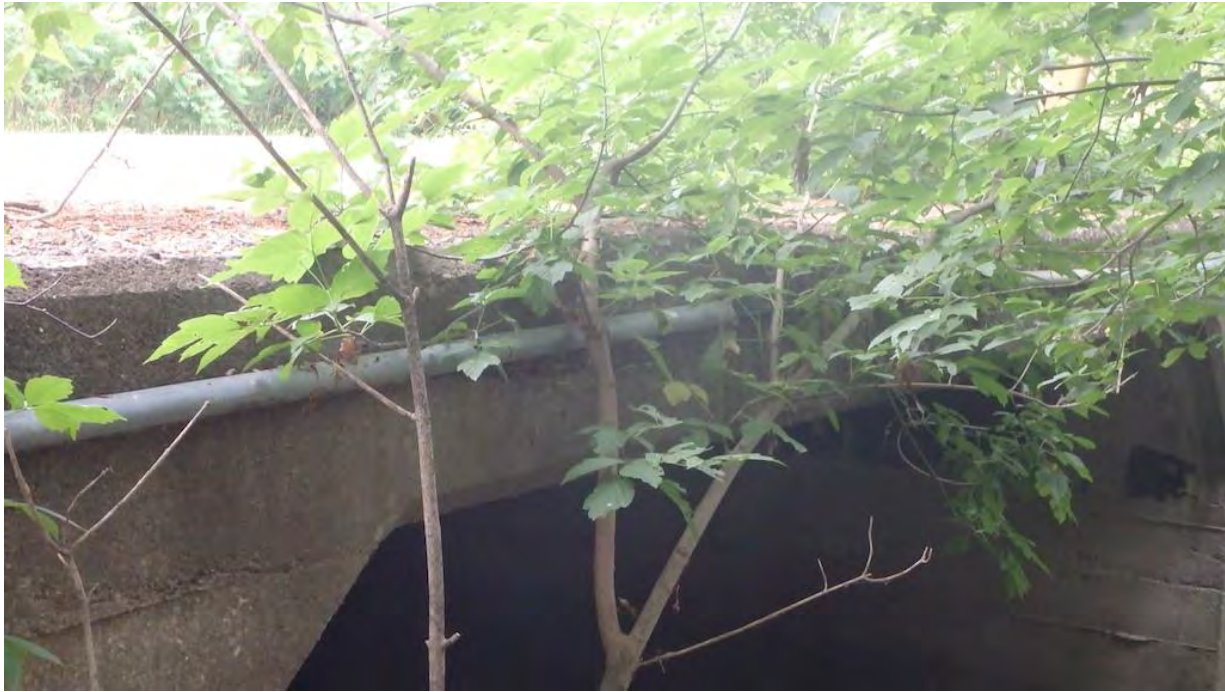
Figure 11 Damaged Utility Cable on South Fascia

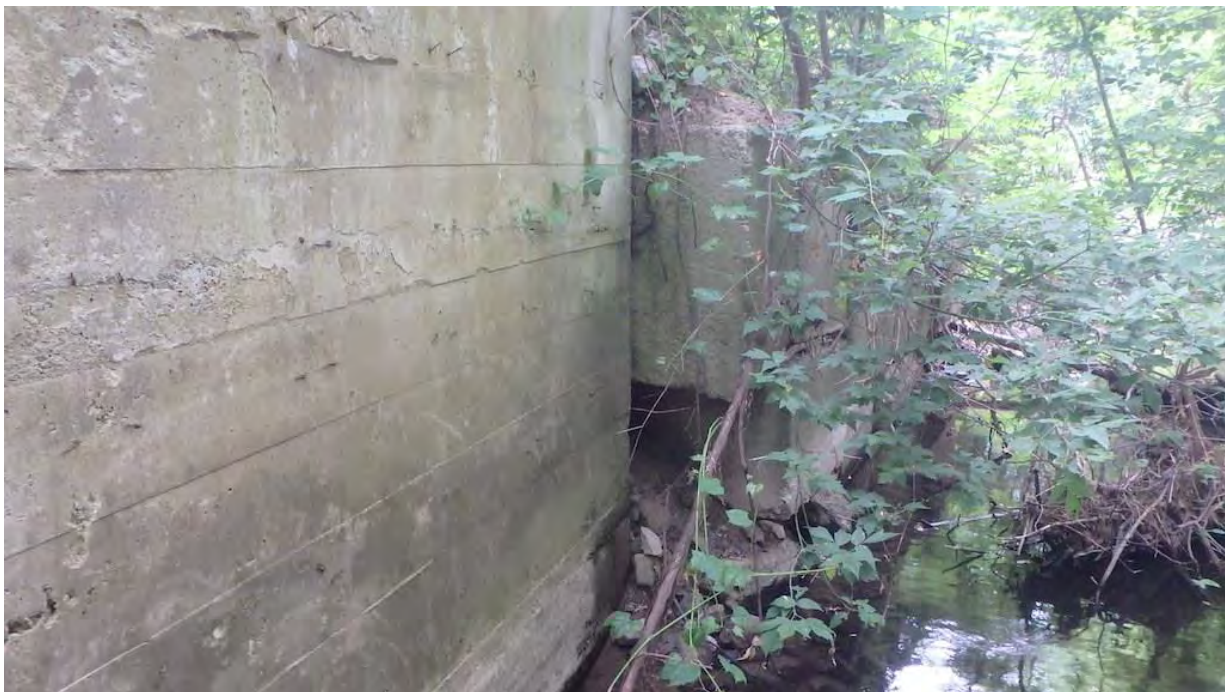
Element Group:		1400 Embankments & Streams				Length:		
Element Name:		1401 Streams and Waterways				Width:		
Location:						Height:		
Material:						Count:		1
Element Type:						Total Quantity:		1 Each
Environment:						Limited Inspection:		
Protection System:		None				Perform. Deficiencies		
Condition Data:	Units	Exc.	Good	Fair	Poor			
	Each	0	0	1	0			
Comments: Stream makes 90 degree turn at inlet (North). Banks stable. Debris blocking inlet. Remove debris.								
Recommended Work:    Rehab <input type="checkbox"/> Replace <input type="checkbox"/> Timing:    Urgent <input type="checkbox"/> < 1yr <input type="checkbox"/> 1 - 5 yr <input type="checkbox"/> 6 - 10 yr <input type="checkbox"/>				Maintenance Needs:    Bridge Cleaning <input type="checkbox"/> Urgent <input checked="" type="checkbox"/> 1 year <input type="checkbox"/> 2 year

Figure 12 Minor Erosion at Northwest Quadrant
