LOT CONCESSION 13 ROAD

Site Number 010080

CONCESSION 13 ROAD, TOWNSEND

Ontario Structure Inspection Manual - Inspection Form

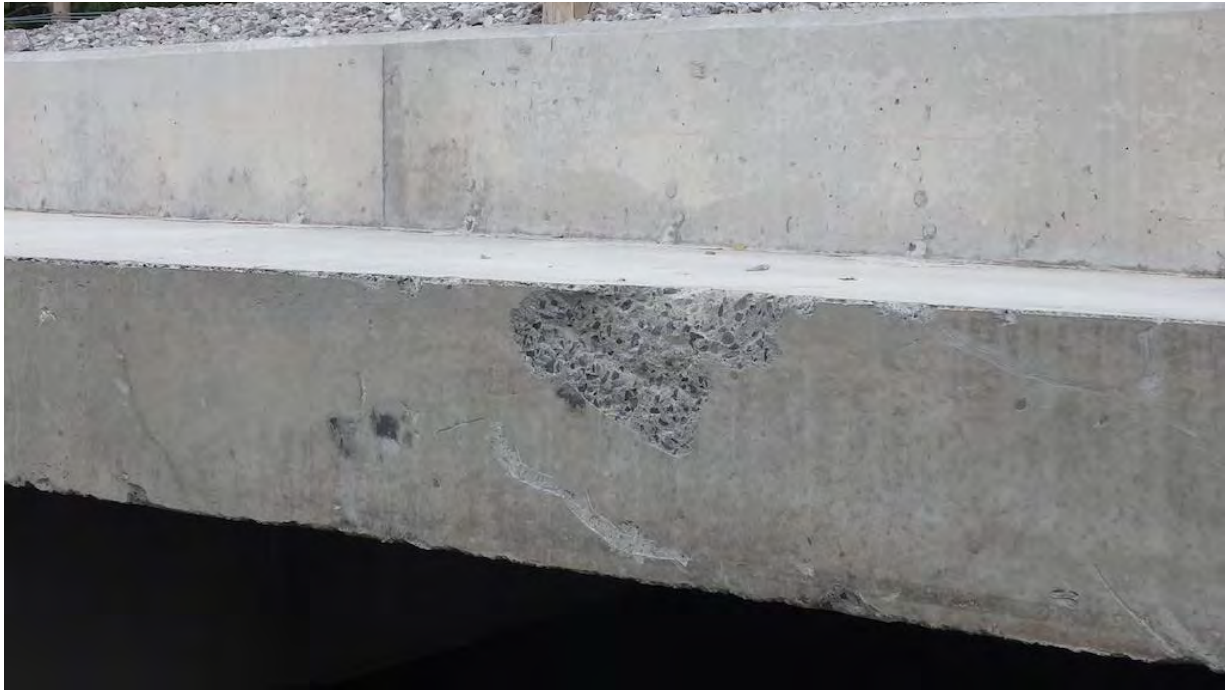
Figure 9 Light Impact Damage on North Fascia

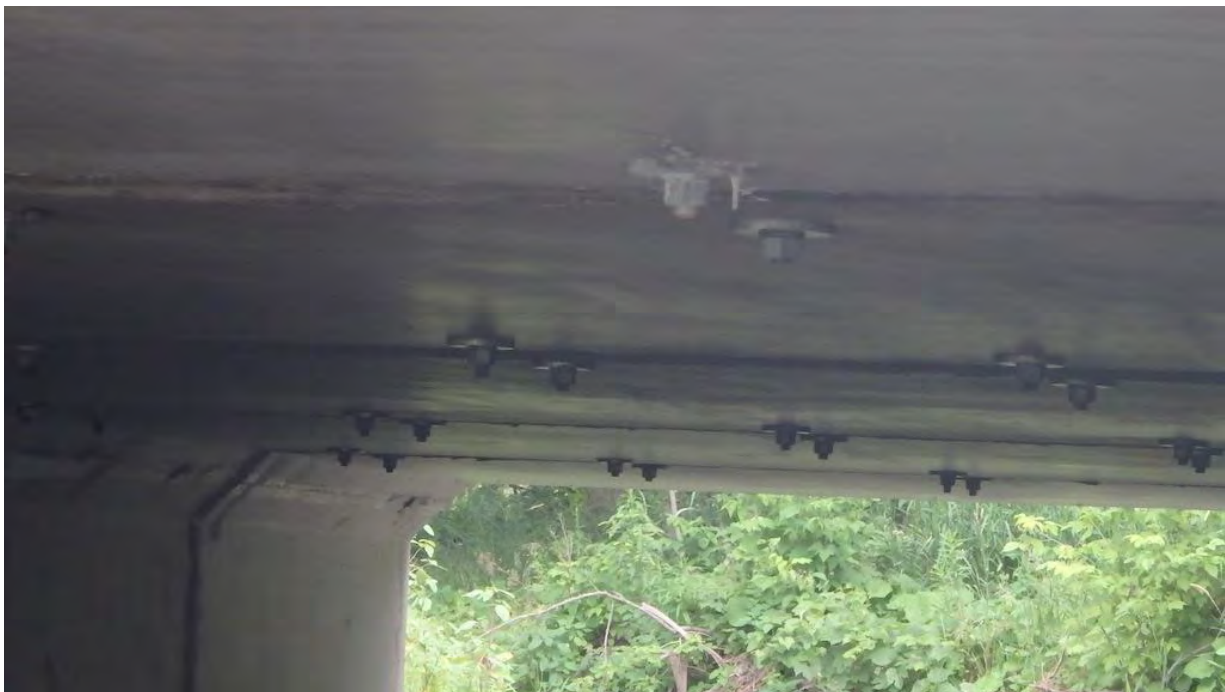
Figure 10 Light Leakage with Chlorides at Bolts in Soffit
