**CLOET ROAD BRIDGE**

Site Number 010084

**CLOET ROAD LOT 2-3 CONCESSION 12, TOWNSEND**

**Ontario Structure Inspection Manual - Inspection Form**

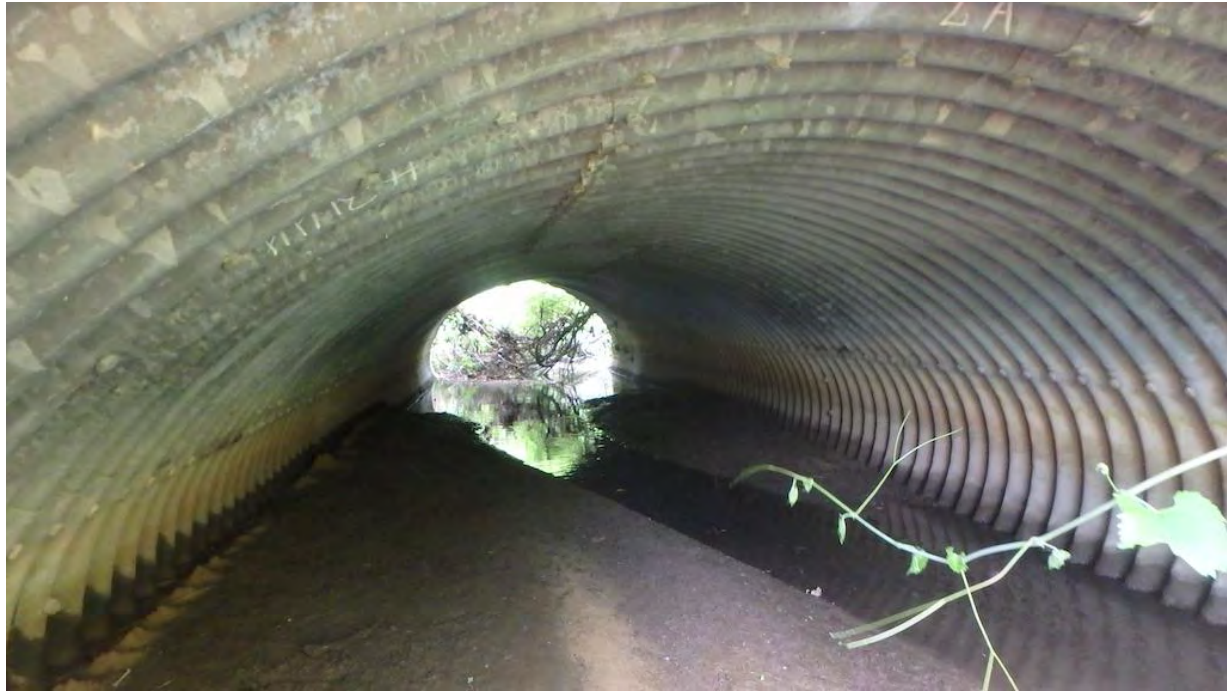
Figure 7      Barrel

Element Group:	1200 Culverts					Length:	16.4
Element Name:	1203 Barrels					Width:	3.5
Location:						Height:	3.3
Material:	5 Corrugated Steel					Count:	1
Element Type:						Total Quantity:	54.1 sq.m
Environment:	Moderate					Limited Inspection:	
Protection System:	Unknown					Perform. Deficiencies	
Condition Data:	Units	Exc.	Good	Fair	Poor	Surface Corrosion at Waterline	
	sq.m	0	0	54.1	0		
Comments: Small deformation in top plate at East end. Monitor.							
Recommended Work: Rehab <input type="checkbox"/> Replace <input type="checkbox"/>						Maintenance Needs:	
Timing: Urgent <input type="checkbox"/> < 1yr <input type="checkbox"/> 1 - 5 yr <input type="checkbox"/> 6 - 10 yr <input type="checkbox"/>						<input type="checkbox"/> Urgent <input type="checkbox"/> 1 year <input type="checkbox"/> 2 year

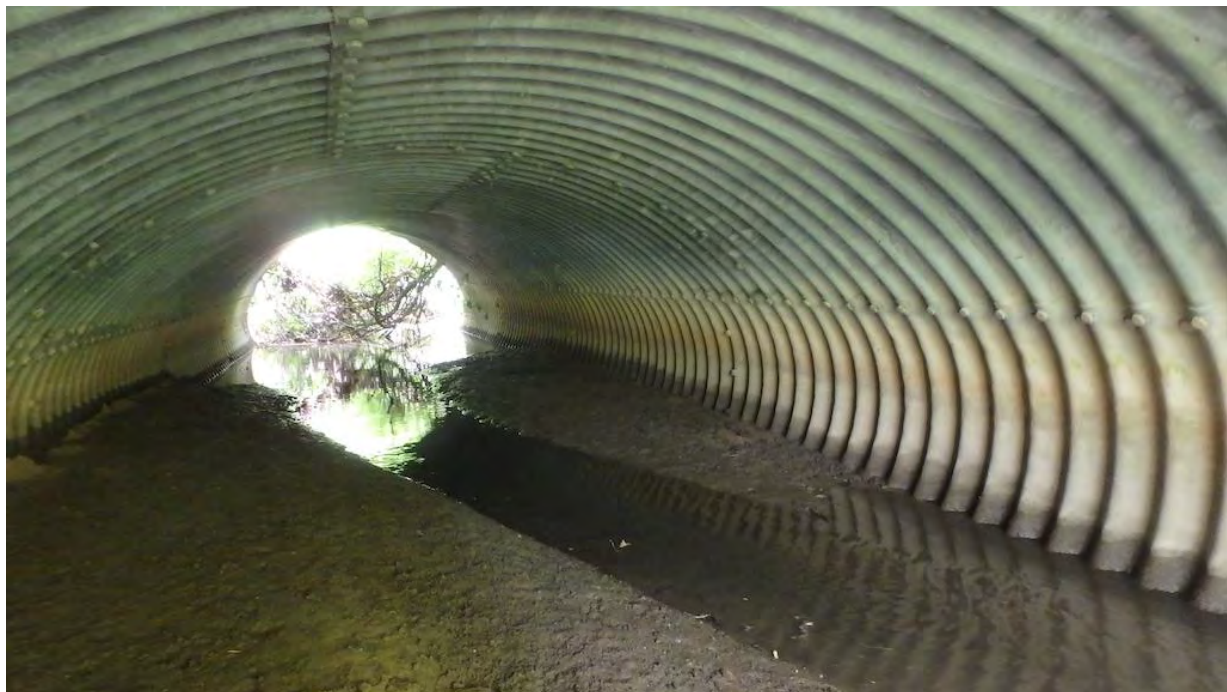
Figure 8      Minor Surface Corrosion
