LOT 3 CONCESSION 7 ROAD

Site Number 010097

CONCESSION 7 ROAD, TOWNSEND

Ontario Structure Inspection Manual - Inspection Form

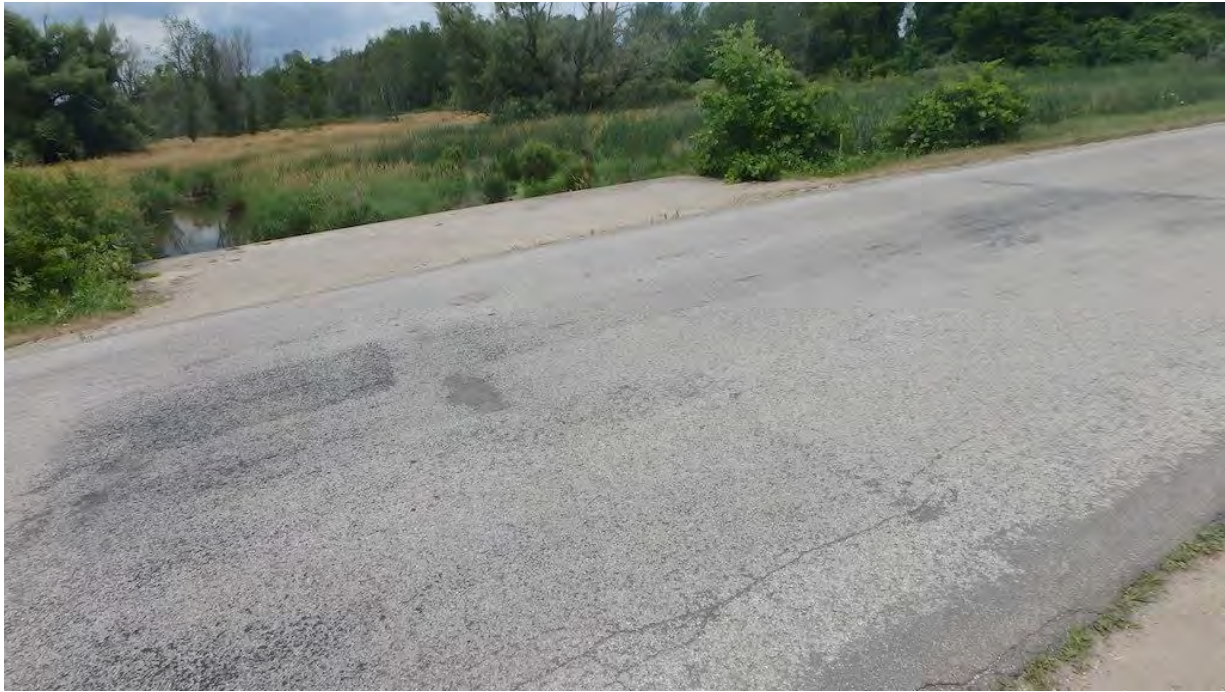
Figure 9 Settlement in Wearing Surface at Culvert

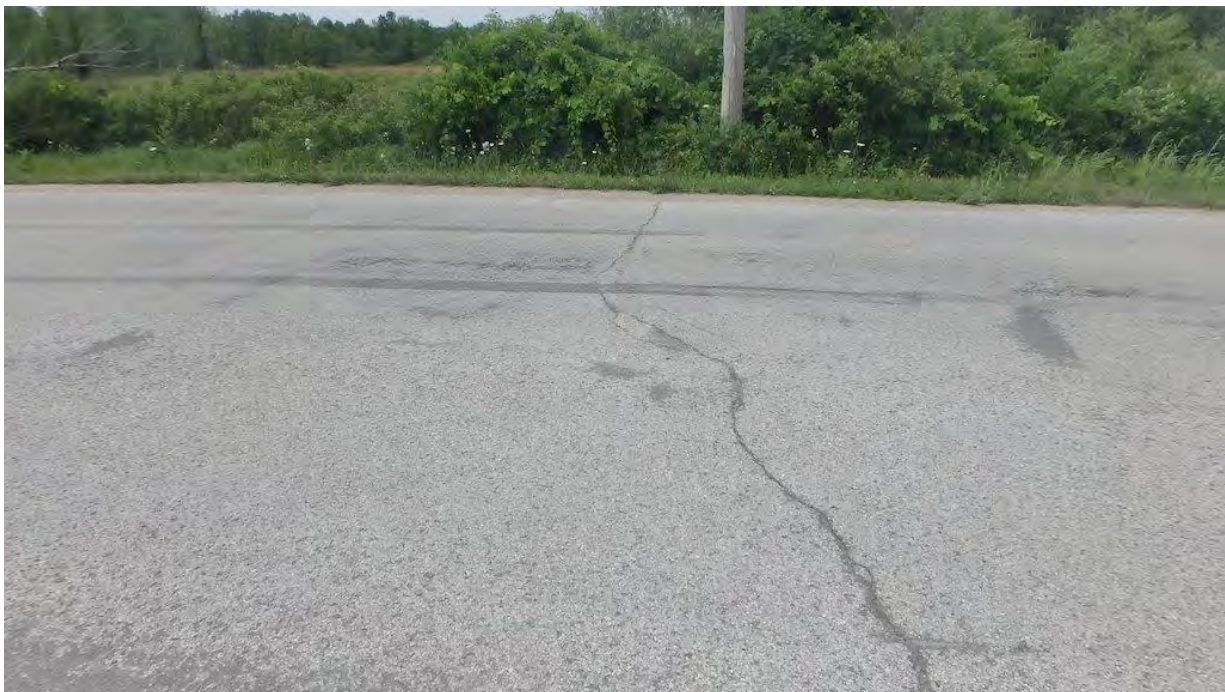
Figure 10 Transverse Crack at West Approach
