**LOT 17 CONCESSION 7 ROAD**

Site Number 010098

**CONCESSION 7 ROAD, TOWNSEND**

**Ontario Structure Inspection Manual - Inspection Form**

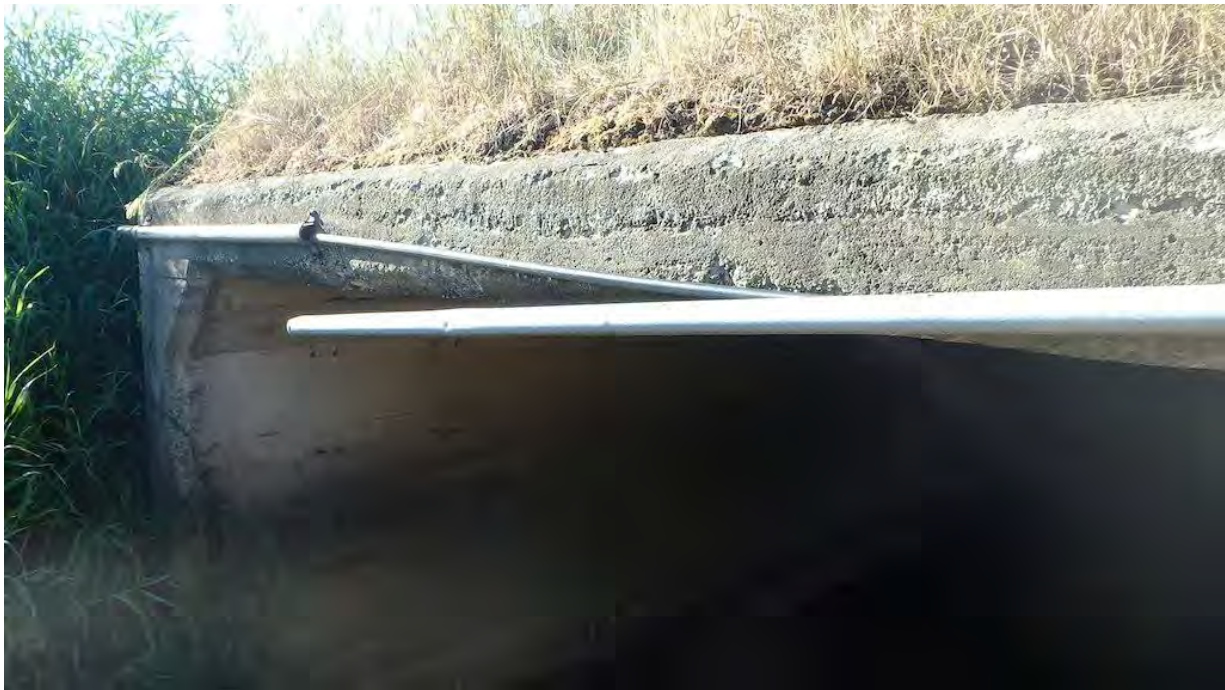
Figure 8 Detached Conduit on North Fascia

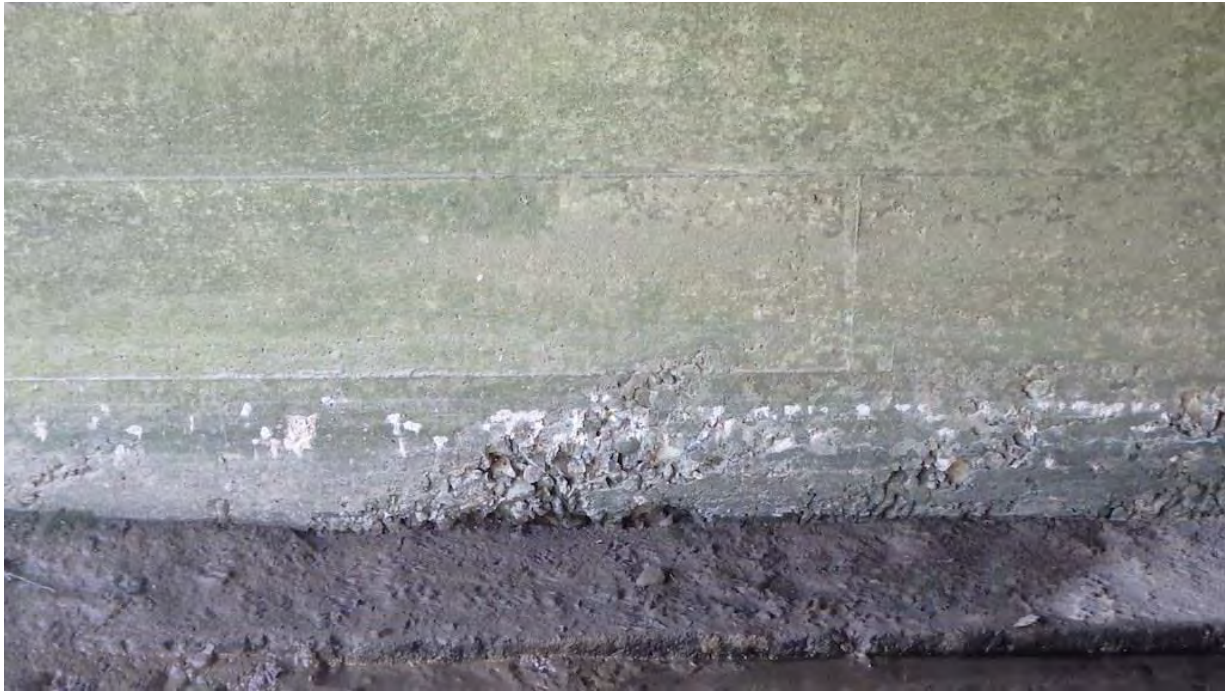
Figure 9 Minor Scaling and Honeycombing on East Wall

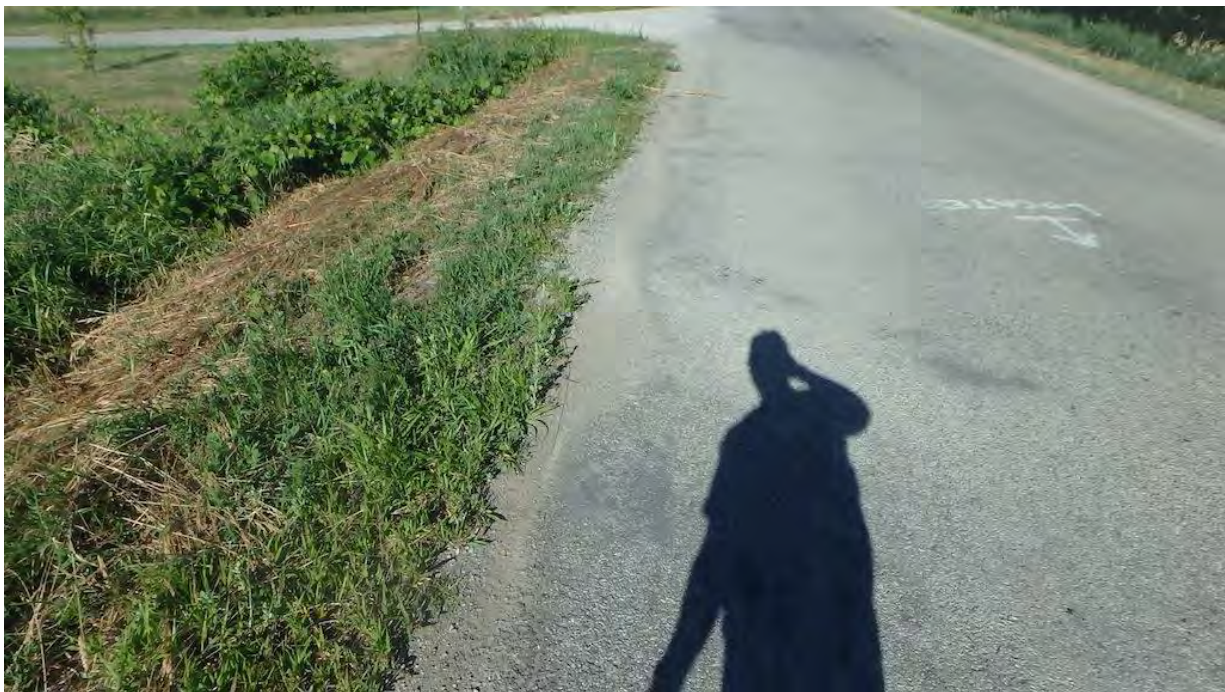
Figure 10 Minor Erosion of Asphalt Wearing Surface

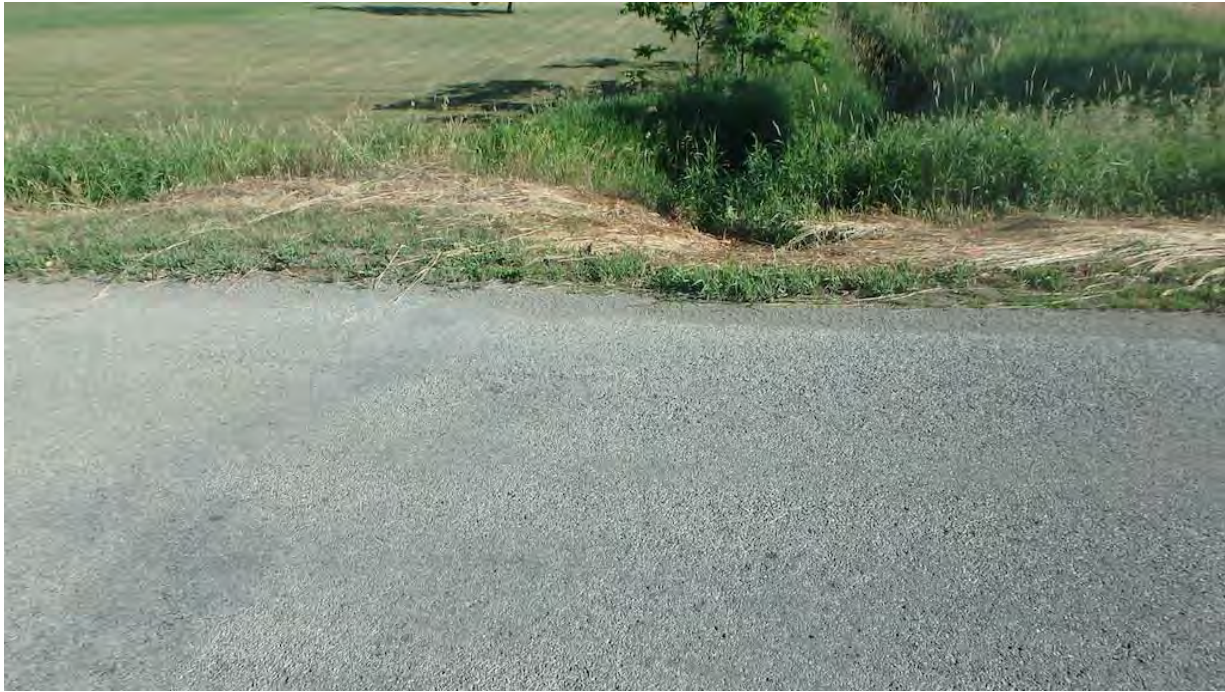
Figure 11 Minor Settlement of Wearing Surface at Structure Edges
