LOT 3 CONCESSION 6 ROAD

Site Number 010100

CONCESSION 6 ROAD, TOWNSEND

Ontario Structure Inspection Manual - Inspection Form

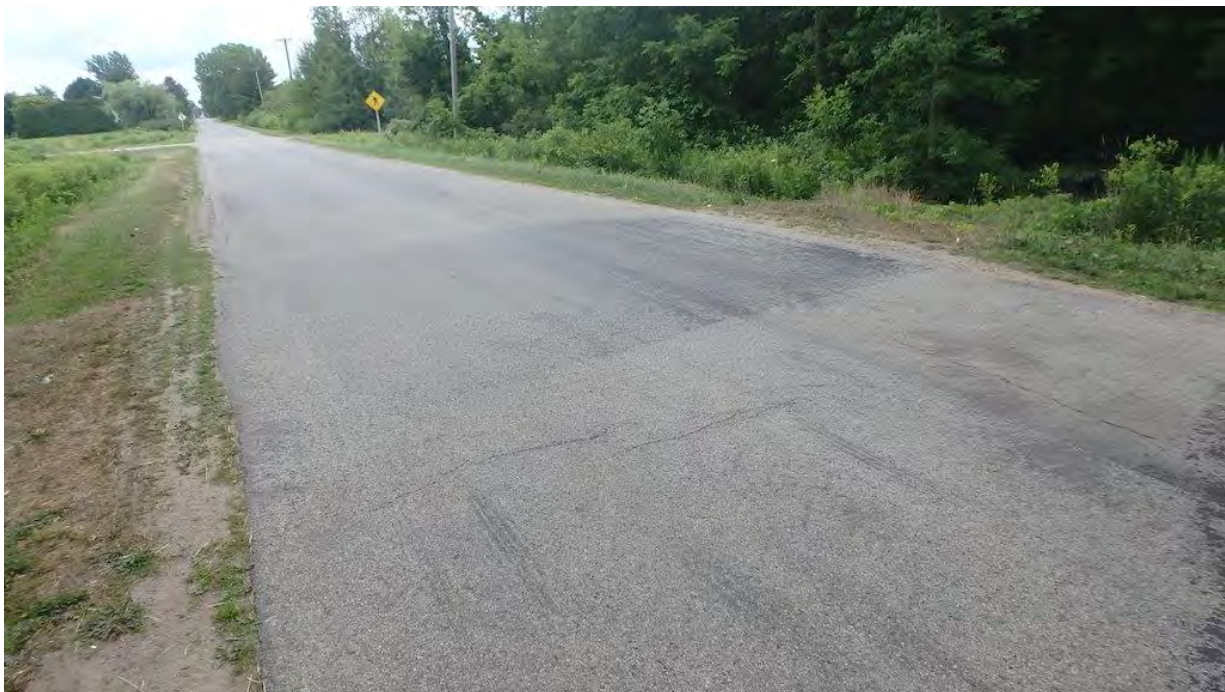
Figure 8 Settlement in Wearing Surface at Culvert

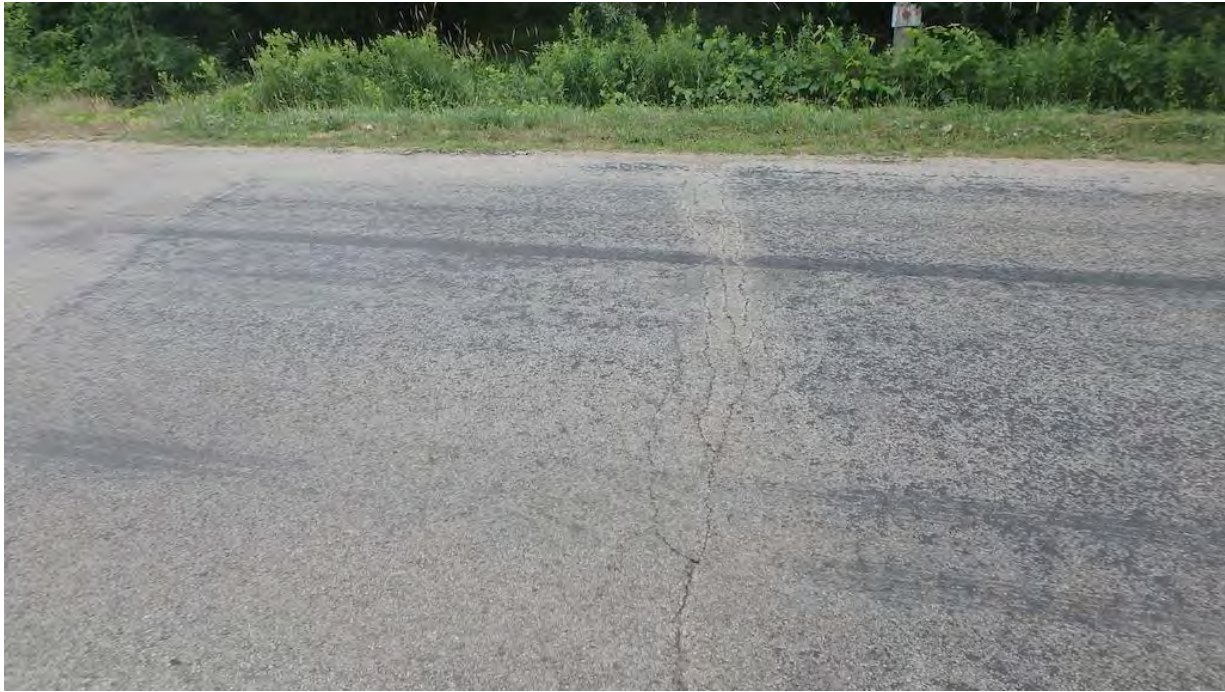
Figure 9 Longitudinal and Transverse Cracking in Wearing Surface
