**LOT 2 CONCESSION 5 ROAD**

Site Number 010101

**CONCESSION 5 ROAD, TOWNSEND**

**Ontario Structure Inspection Manual - Inspection Form**

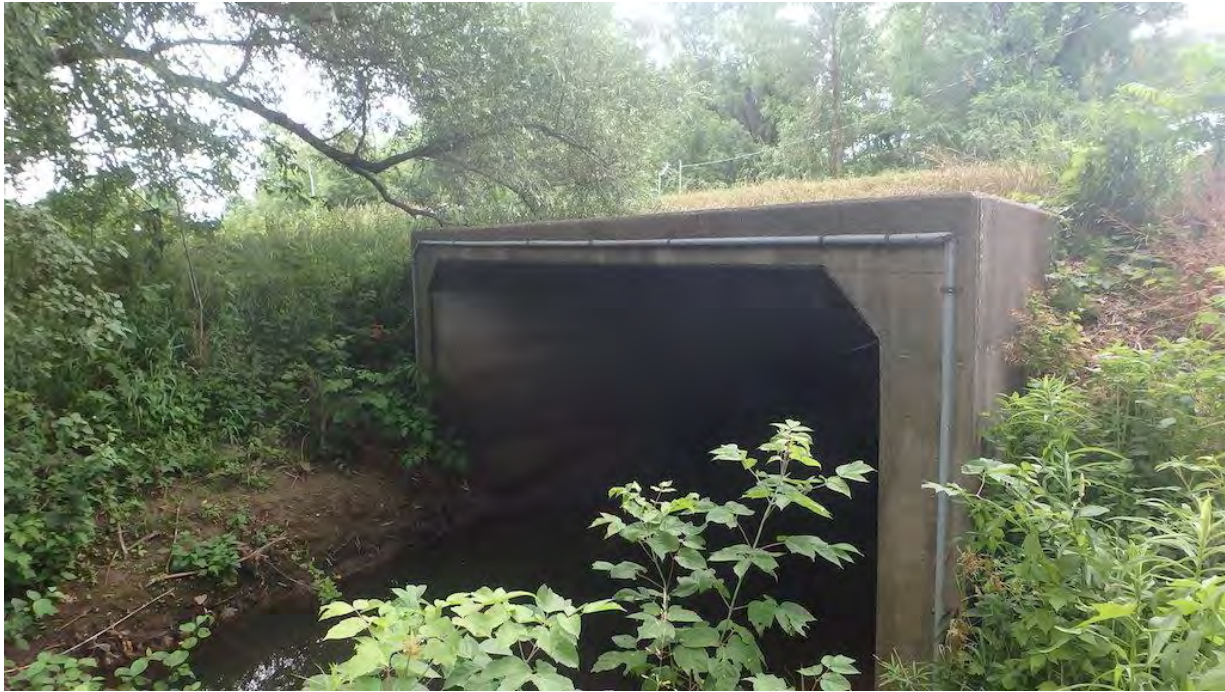
Figure 3 North Profile, Inlet

Element Group:		1200 Culverts				Length:		6
Element Name:		1201 Inlet Components				Width:		0.4
Location:		North				Height:		2.4
Material:						Count:		1
Element Type:						Total Quantity:		4.3 sq.m
Environment:		Moderate				Limited Inspection:		
Protection System:		Unknown				Perform. Deficiencies		
Condition	Units	Exc.	Good	Fair	Poor			
Data:	sq.m	0	4.3	0	0			
Comments:								
Utility attached to North side.								
Recommended Work:				Rehab <input type="checkbox"/>		Replace <input type="checkbox"/>		
Timing:				Urgent <input type="checkbox"/>		< 1yr <input type="checkbox"/>		
				1 - 5 yr <input type="checkbox"/>		6 - 10 yr <input type="checkbox"/>		
Maintenance Needs:								
				Urgent <input type="checkbox"/>		1 year <input type="checkbox"/>		
				2 year <input type="checkbox"/>

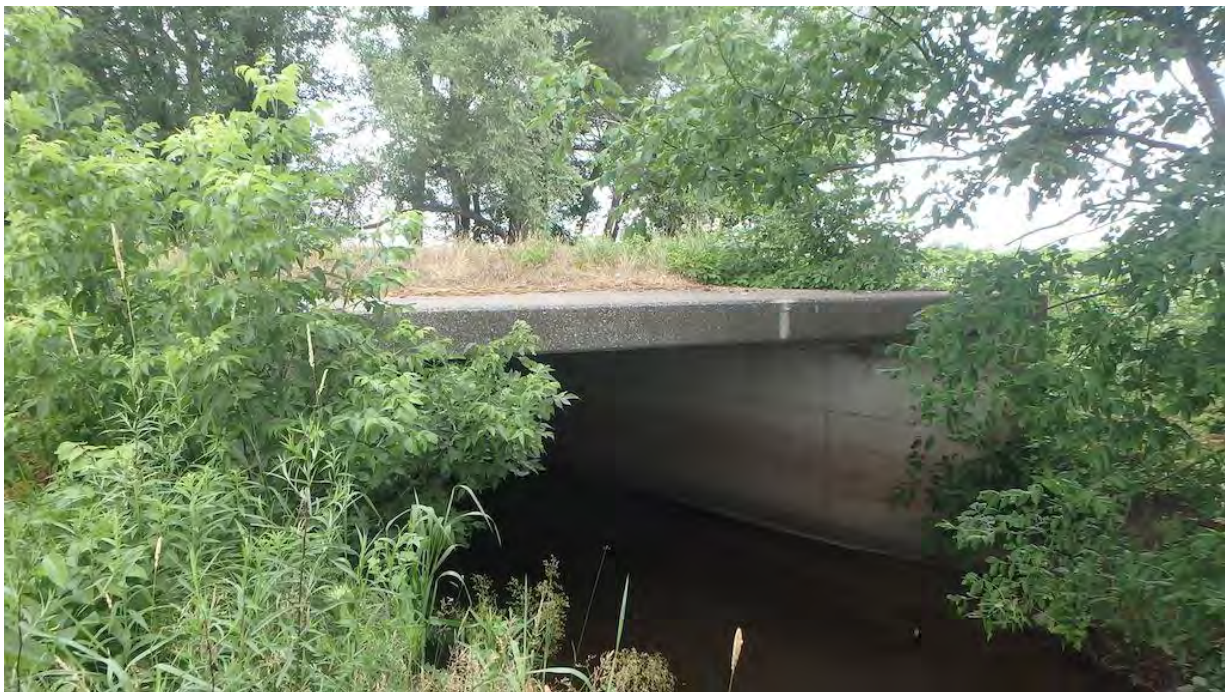
Figure 4 South Profile, Outlet

Element Group:		1200 Culverts				Length:	6
Element Name:		1202 Outlet Components				Width:	0.4
Location:		South				Height:	2.4
Material:						Count:	1
Element Type:						Total Quantity:	4.3 sq.m
Environment:		Moderate				Limited Inspection:	
Protection System:		Unknown				Perform. Deficiencies	
Condition Data:	Units	Exc.	Good	Fair	Poor		
	sq.m	0	4.3	0	0		
Comments:							
Recommended Work:						Maintenance Needs:	
Rehab <input type="checkbox"/> Replace <input type="checkbox"/> Timing: Urgent <input type="checkbox"/> < 1yr <input type="checkbox"/> 1 - 5 yr <input type="checkbox"/> 6 - 10 yr <input type="checkbox"/>						<input type="checkbox"/> Urgent <input type="checkbox"/> 1 year <input type="checkbox"/> 2 year

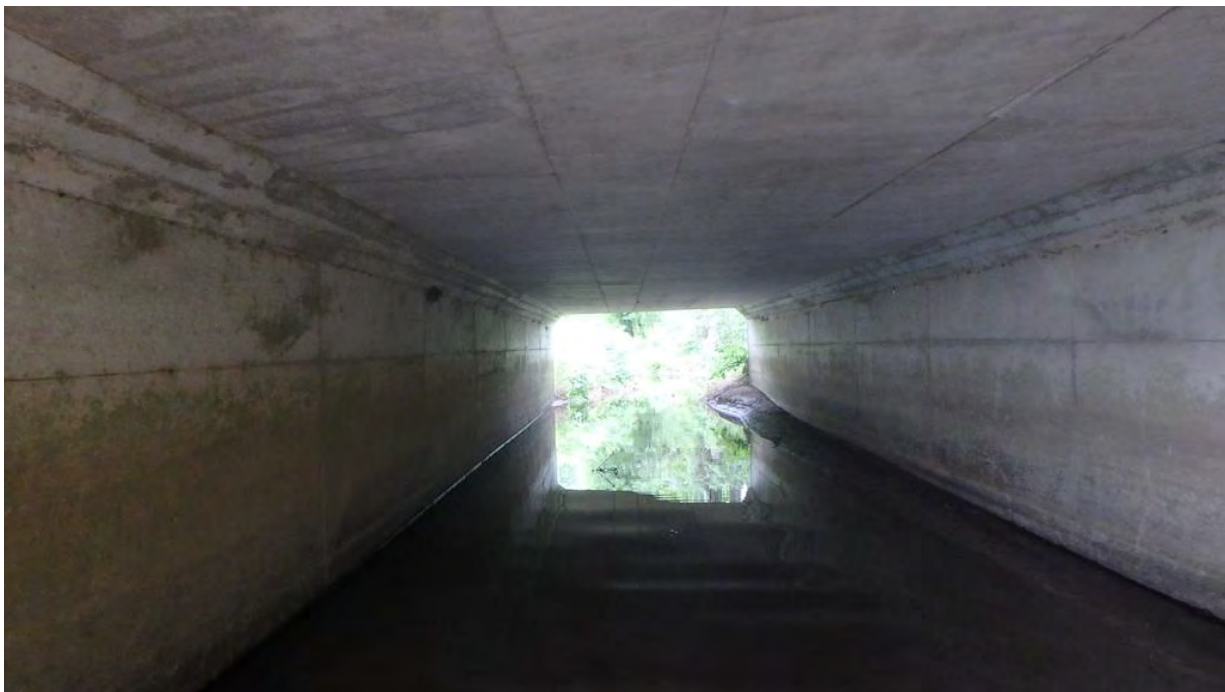
Figure 10      Barrel

Element Group:		1200 Culverts				Length:		19.8
Element Name:		1203 Barrels				Width:		10
Location:		Inside				Height:		
Material:		4 Cast-in-place Concrete				Count:		1
Element Type:						Total Quantity:		198 sq.m
Environment:		Moderate				Limited Inspection:		
Protection System:		Unknown				Perform. Deficiencies		
Condition	Units	Exc.	Good	Fair	Poor			
Data:	sq.m	0	198	0	0			
Comments:								
Narrow cracks near center. Showing leakage. (minor)								
Recommended Work:				Rehab <input type="checkbox"/>		Replace <input type="checkbox"/>		
Timing:				Urgent <input type="checkbox"/>		< 1yr <input type="checkbox"/>		
				1 - 5 yr <input type="checkbox"/>		6 - 10 yr <input type="checkbox"/>		
Maintenance Needs:				Concrete Sealing				
				Urgent <input type="checkbox"/>		1 year <input type="checkbox"/>		
				2 year <input checked="" type="checkbox"/>

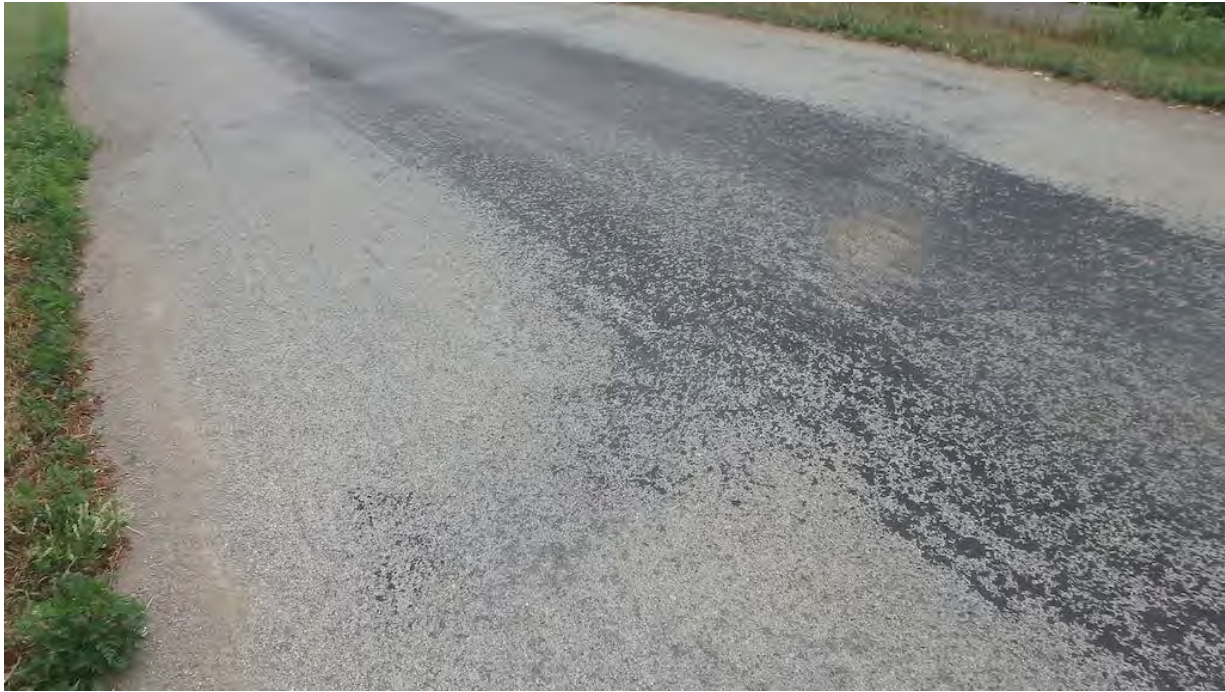
Element Group:		1600 Approaches				Length:		
Element Name:		1601 Wearing Surface (Approaches)				Width:		
Location:		Top of Road				Height:		
Material:		2 Asphalt				Count:		1
Element Type:						Total Quantity:		1 Each
Environment:						Limited Inspection:		
Protection System:		Unknown				Perform. Deficiencies		
Condition	Units	Exc.	Good	Fair	Poor			
Data:	Each	0	0	1	0			
Comments:								
Includes: Roadway slopes (grass), (no signs, no barriers). Asphalt is polished. Settlement at structure edges.								
Recommended Work:				Rehab <input type="checkbox"/>		Replace <input type="checkbox"/>		
Timing:				Urgent <input type="checkbox"/>		< 1yr <input type="checkbox"/>		
				1 - 5 yr <input type="checkbox"/>		6 - 10 yr <input type="checkbox"/>		
Maintenance Needs:				Bridge Surface Repair				
				Urgent <input type="checkbox"/>		1 year <input checked="" type="checkbox"/>		
				2 year <input type="checkbox"/>

Figure 11 Polishing and Settlement of Wearing Surface at Culvert
