LOT 19 CONCESSION 3, TOWNSEND

Site Number 010106

Ontario Structure Inspection Manual - Inspection Form

Field Inspection Information:	
Date of Inspection:	June 29, 2016
Type of Inspection:	<input checked="" type="checkbox"/> OSIM <input type="checkbox"/> Enhanced OSIM
Inspector:	Ben Buchwald M.Eng., EIT, G. Douglas Vallee Ltd.
Others in Party:	John McMorrow
Access Equipment Used:	Hammer, Binoculars, Measuring Tape, Camera, etc.
Weather:	Sunny
Temperature:	23 °C

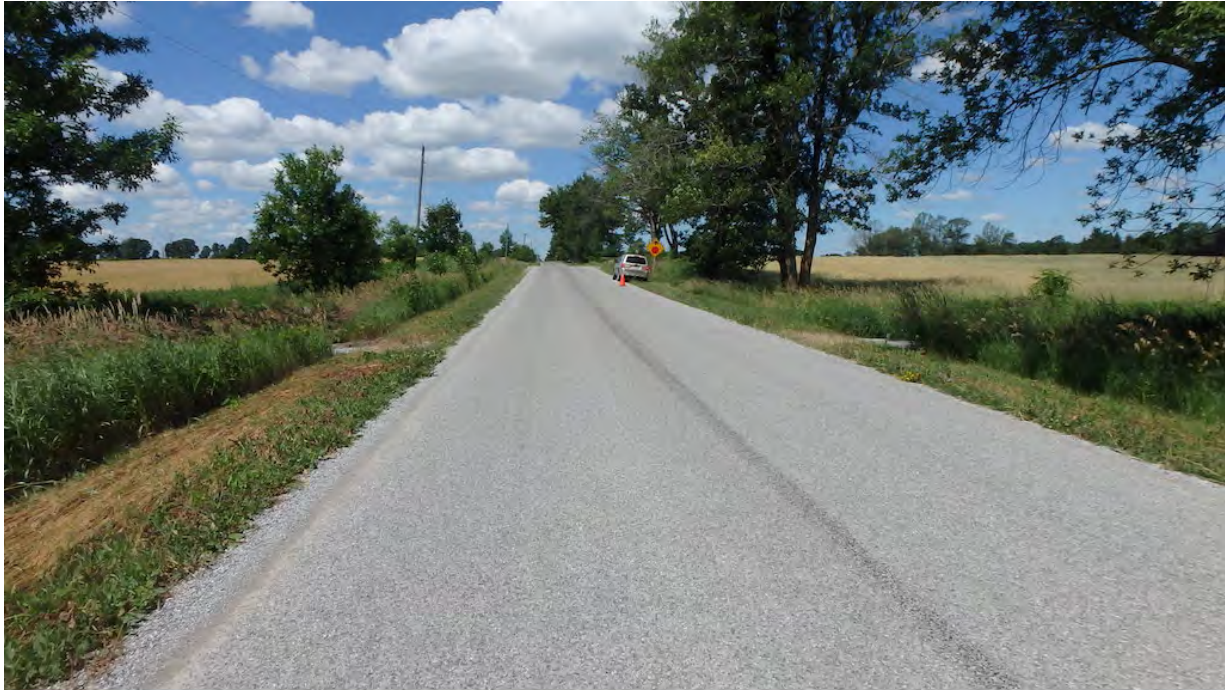
Figure 1 East Approach

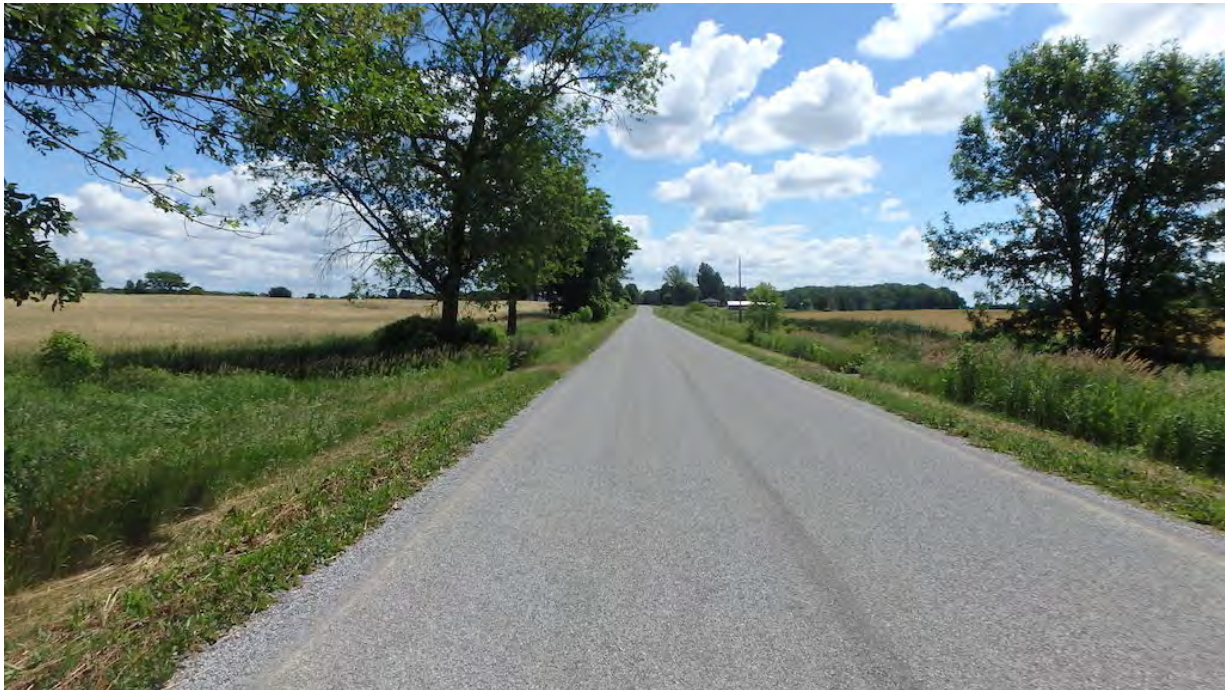
Figure 2 West Approach

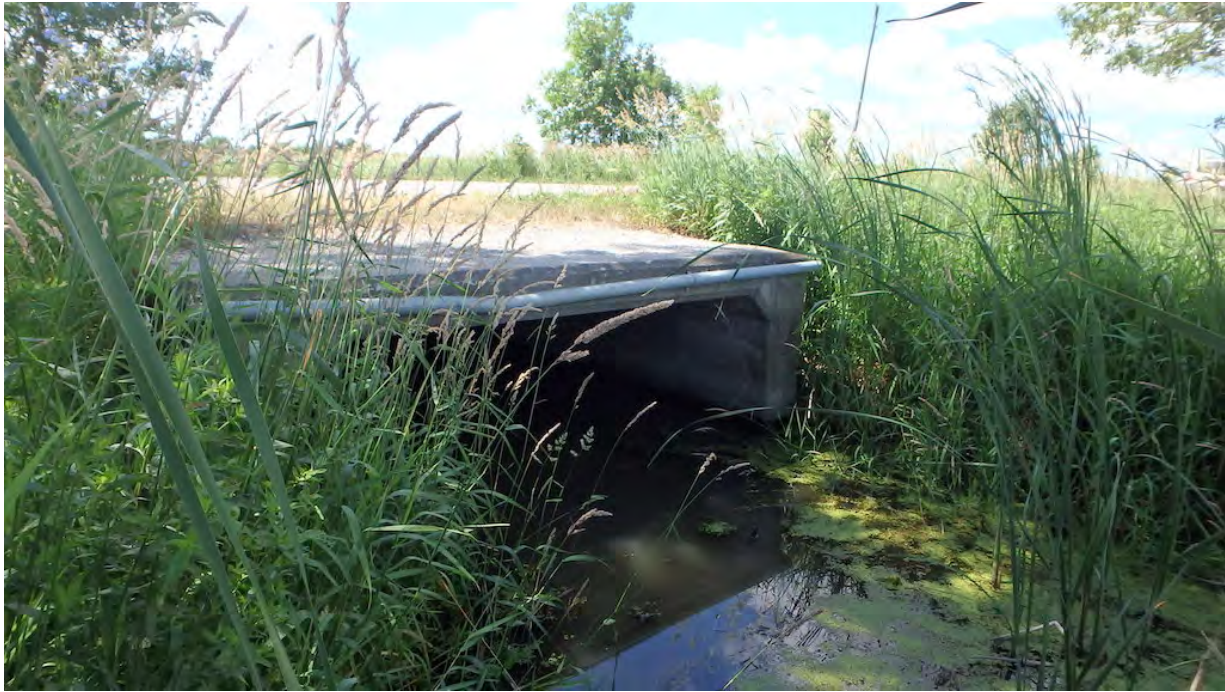
Figure 3 North Profile, Inlet

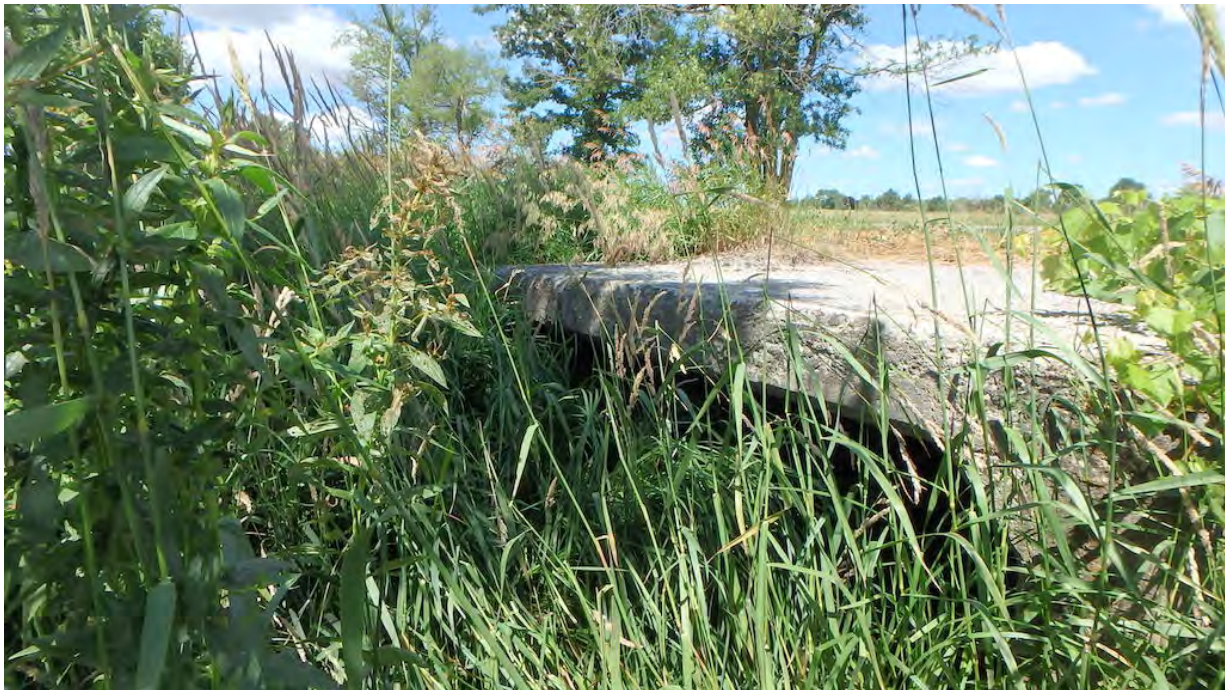
Figure 4 South Profile, Outlet

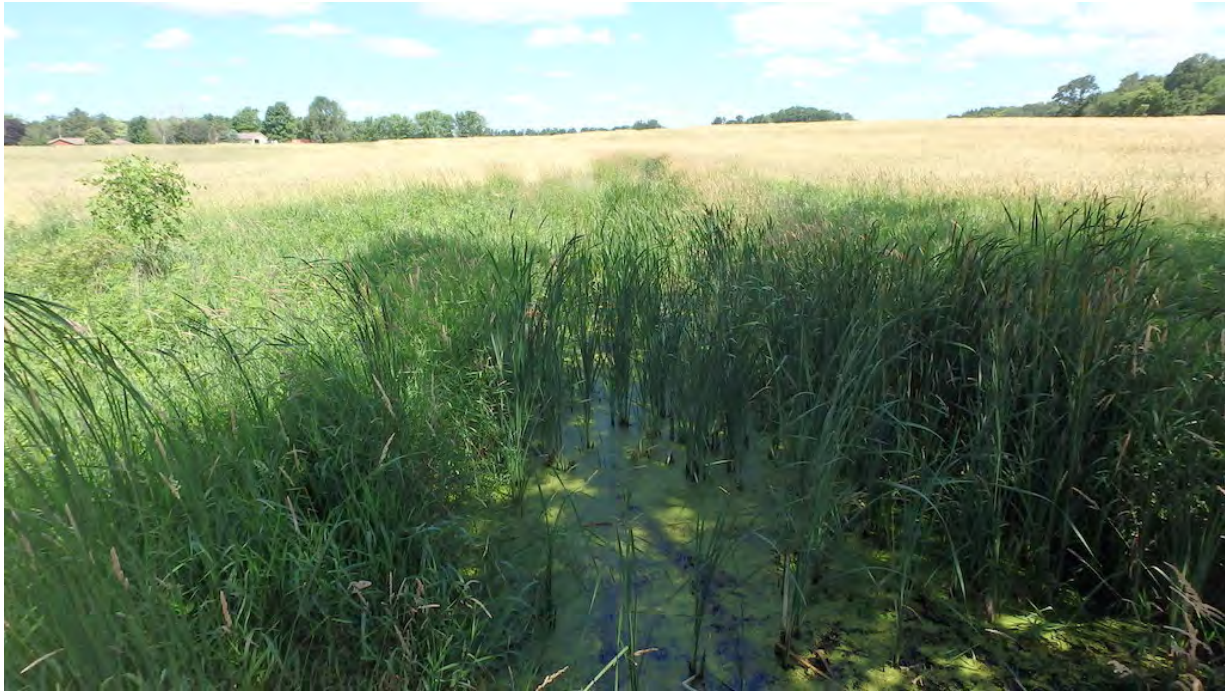
Figure 5 Upstream

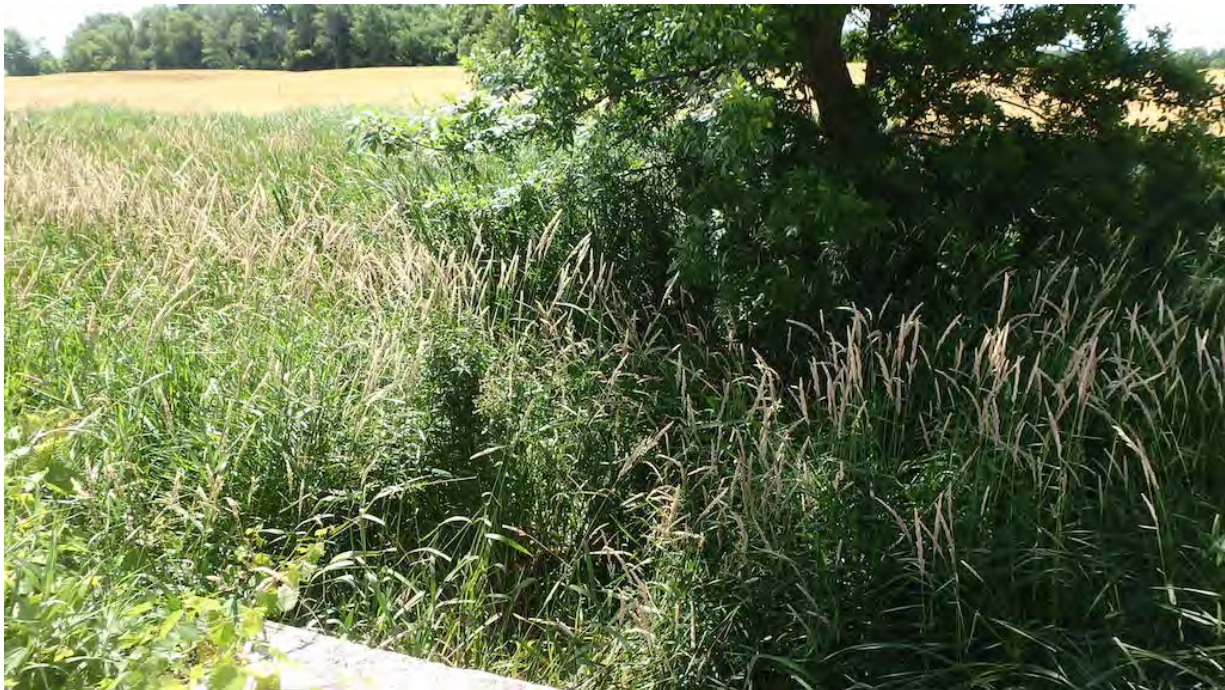
Figure 6 Downstream

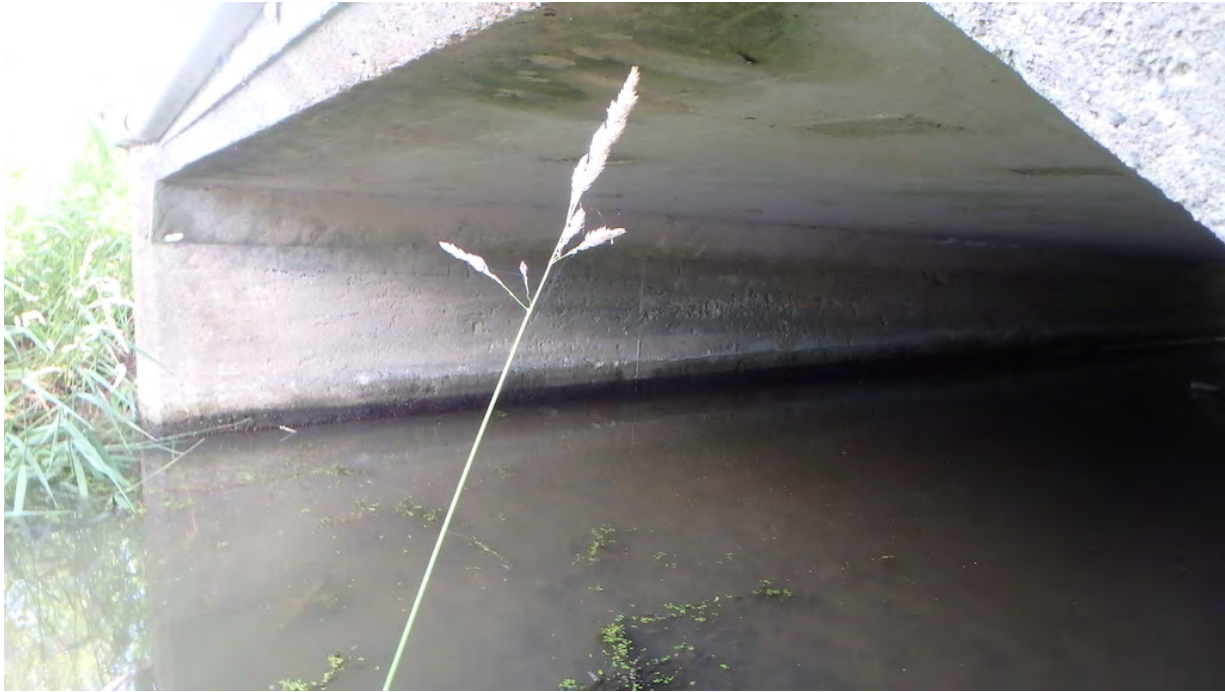
Figure 7 East Culvert Wall

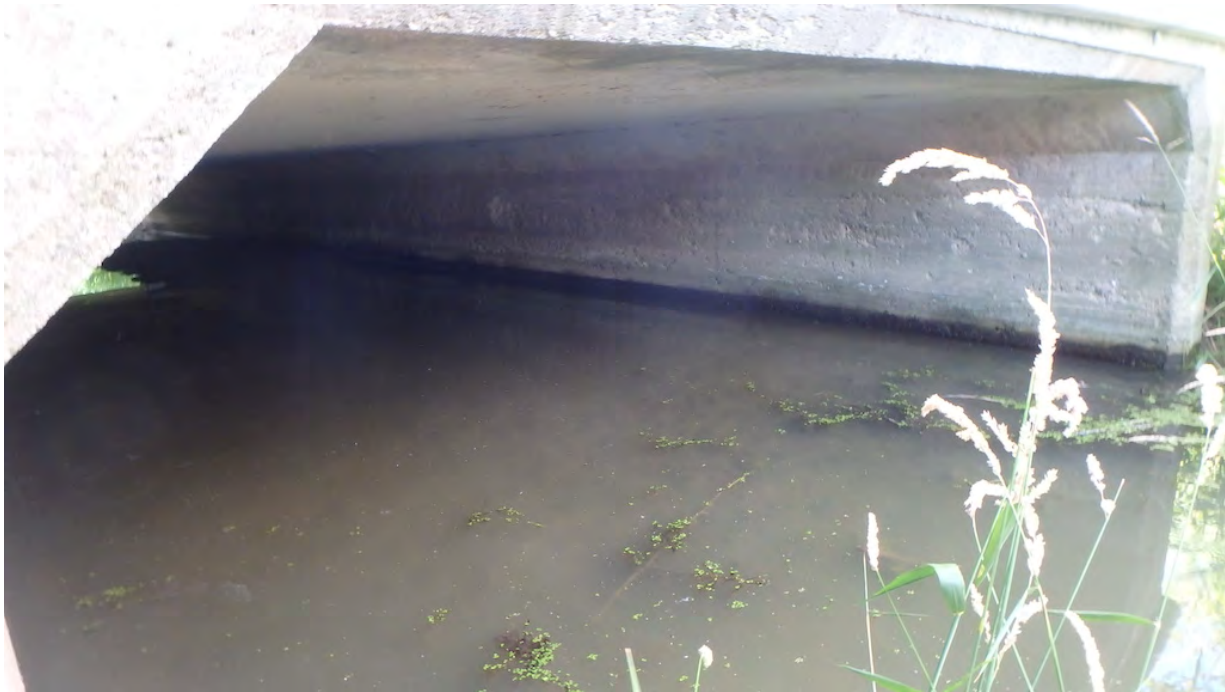
Figure 8 West Culvert Wall

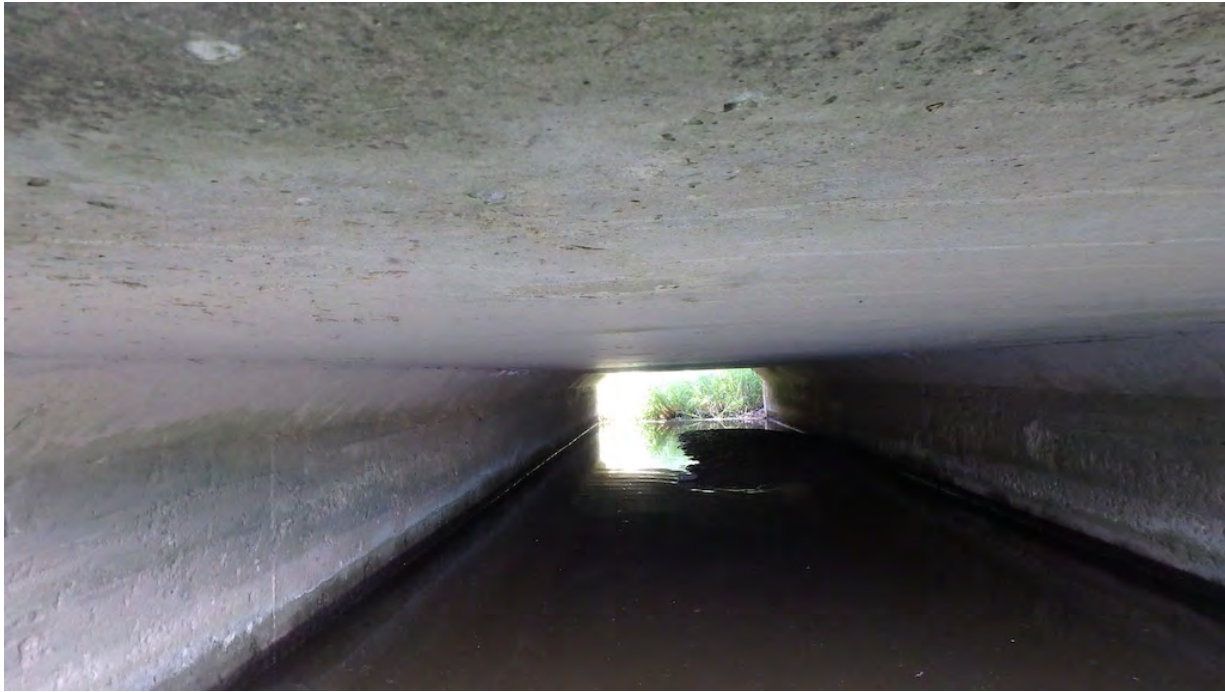
Element Group:		1200 Culverts				Length:		13.8
Element Name:		1203 Barrels				Width:		5.2
Location:		Interior				Height:		
Material:						Count:		1
Element Type:						Total Quantity:		71.8 sq.m
Environment:		Benign				Limited Inspection:		
Protection System:		None				Perform. Deficiencies		
Condition	Units	Exc.	Good	Fair	Poor			
Data:	sq.m	0	61.8	10	0			
Comments: Scaling throughout barrel.								
Recommended Work: Rehab <input type="checkbox"/> Replace <input type="checkbox"/>				Maintenance Needs:				
Timing: Urgent <input type="checkbox"/> < 1yr <input type="checkbox"/> 1 - 5 yr <input type="checkbox"/> 6 - 10 yr <input type="checkbox"/>				<input type="checkbox"/> Urgent <input type="checkbox"/> 1 year <input type="checkbox"/> 2 year

Figure 9 Barrel

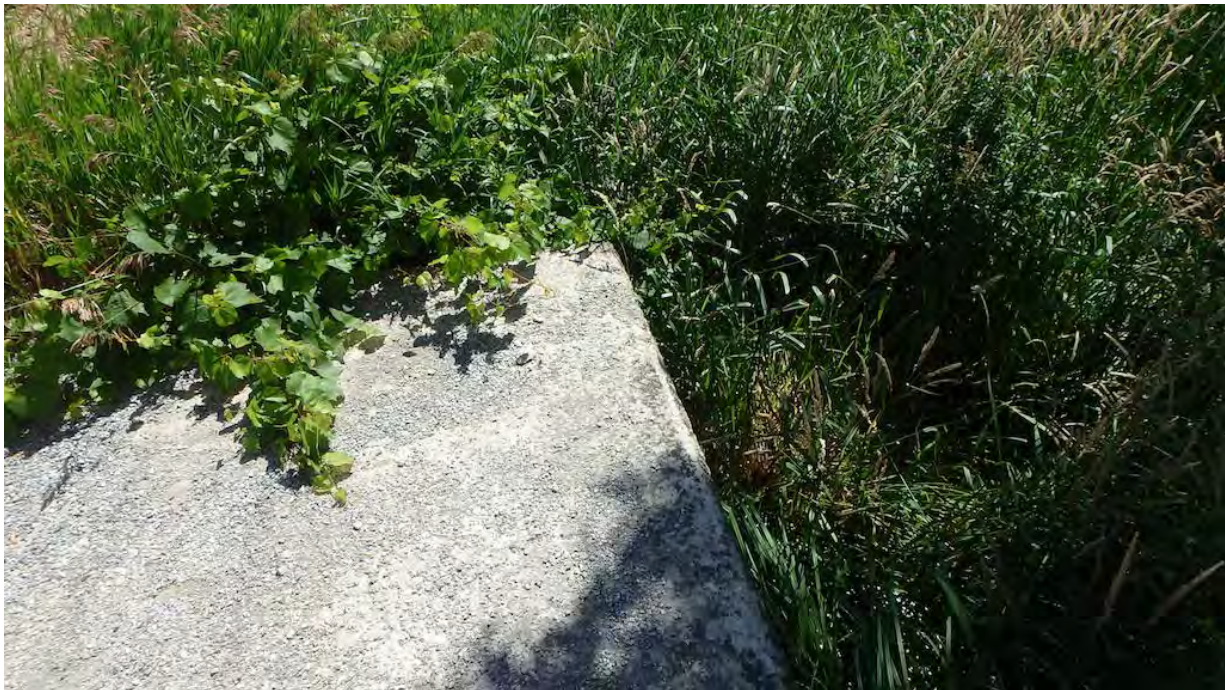
Figure 10 Moderate Spalling on Top of Culvert
