**UNITED CHURCH ROAD CULVERT**

Site Number 030002

**UNITED CHURCH ROAD LOT 3-4, WOODHOUSE**

**Ontario Structure Inspection Manual - Inspection Form**

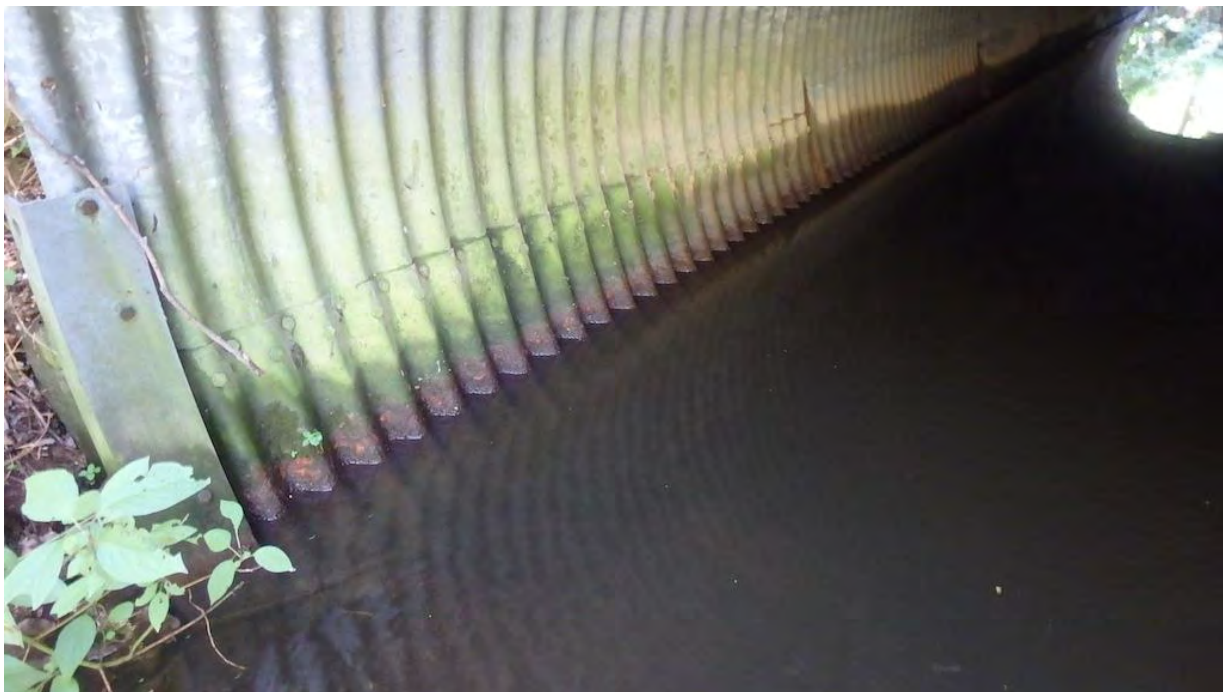
Figure 8 Corrosion at Water Line
