LOT 18 CONCESSION 12

Site Number 030046

CONCESSION 12 ROAD, TOWNSEND

Ontario Structure Inspection Manual - Inspection Form

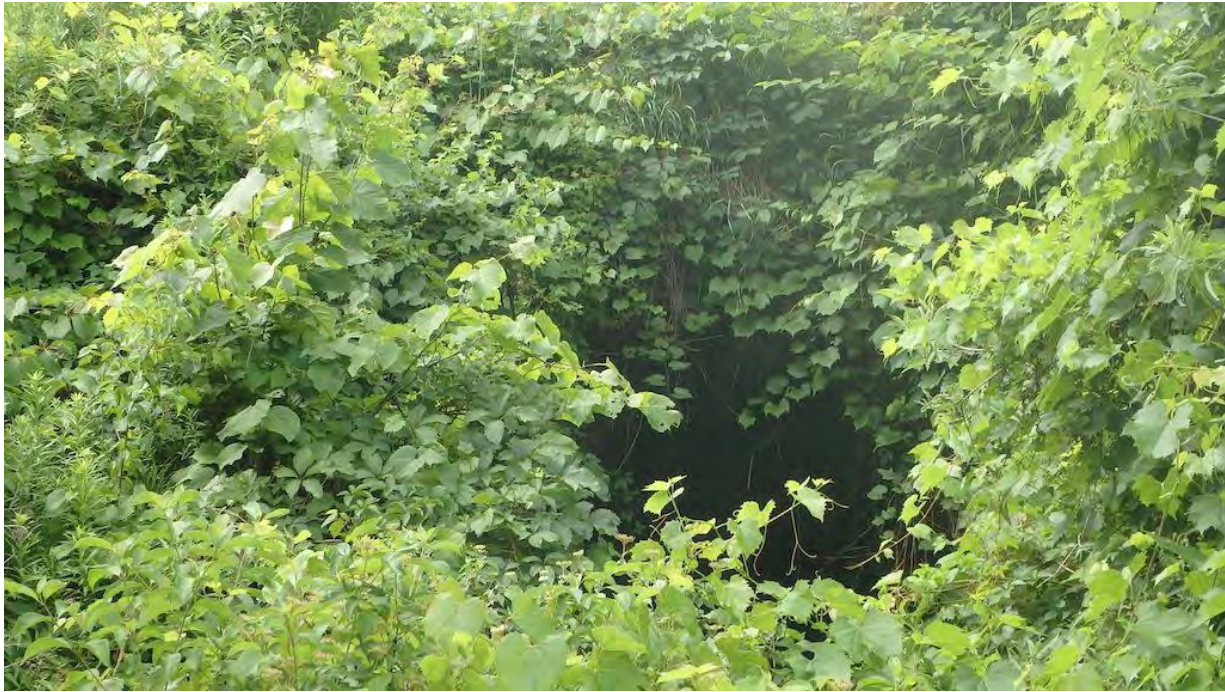
Figure 3 North Profile, Inlet

Element Group:		1200 Culverts				Length:	
Element Name:		1201 Inlet Components				Width:	3.8
Location:		North End				Height:	3
Material:		5 Corrugated Steel				Count:	1
Element Type:						Total Quantity:	11.3 sq.m
Environment:		Moderate				Limited Inspection:	
Protection System:		Unknown				Perform. Deficiencies	
Condition	Units	Exc.	Good	Fair	Poor		
Data:	sq.m	0	11.25	0	0		
Comments: Inlet heavily overgrown. Some erosion at corrugated steel pipe wingwalls.							
Recommended Work: Rehab <input type="checkbox"/> Replace <input type="checkbox"/>					Maintenance Needs:		
Timing: Urgent <input type="checkbox"/> < 1yr <input type="checkbox"/> 1 - 5 yr <input type="checkbox"/> 6 - 10 yr <input type="checkbox"/>					<input type="checkbox"/> Urgent <input type="checkbox"/> 1 year <input type="checkbox"/> 2 year

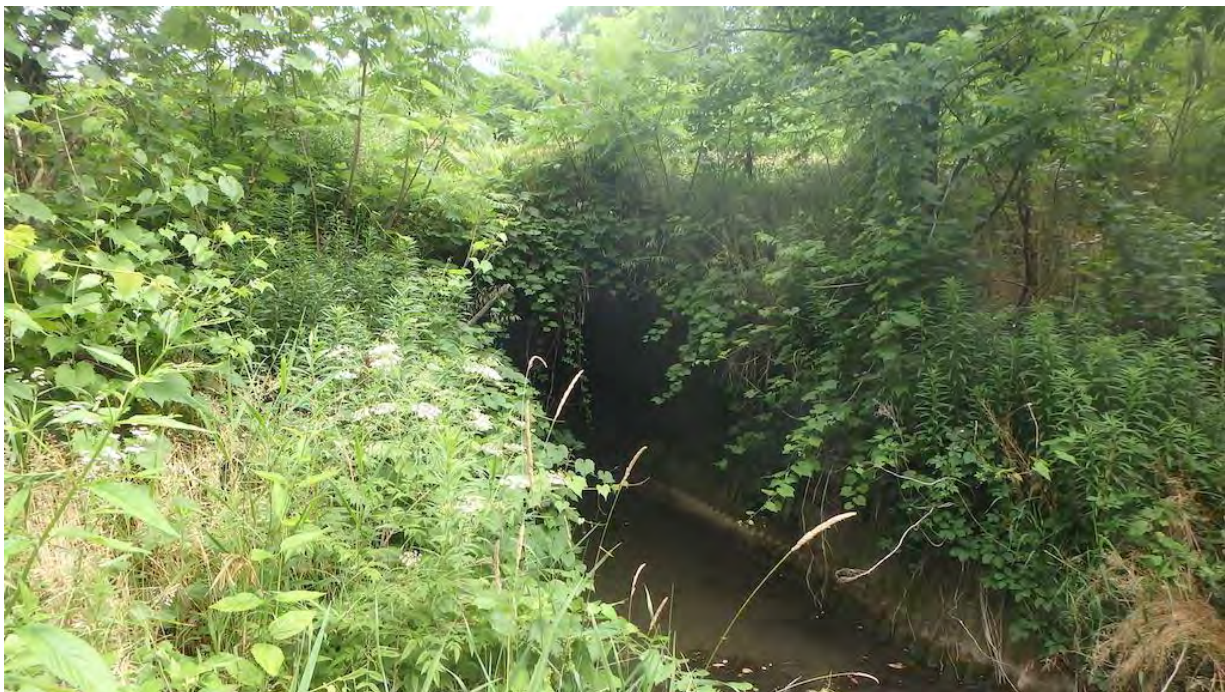
Figure 4 South Profile, Outlet

Element Group:		1200 Culverts				Length:	
Element Name:		1202 Outlet Components				Width:	3.8
Location:		South End				Height:	3
Material:		5 Corrugated Steel				Count:	1
Element Type:						Total Quantity:	11.3 sq.m
Environment:		Moderate				Limited Inspection:	
Protection System:		Unknown				Perform. Deficiencies	
Condition	Units	Exc.	Good	Fair	Poor		
Data:	sq.m	0	11.25	0	0		
Comments:							
Recommended Work: Rehab <input type="checkbox"/> Replace <input type="checkbox"/>					Maintenance Needs:		
Timing: Urgent <input type="checkbox"/> < 1yr <input type="checkbox"/> 1 - 5 yr <input type="checkbox"/> 6 - 10 yr <input type="checkbox"/>					<input type="checkbox"/> Urgent <input type="checkbox"/> 1 year <input type="checkbox"/> 2 year

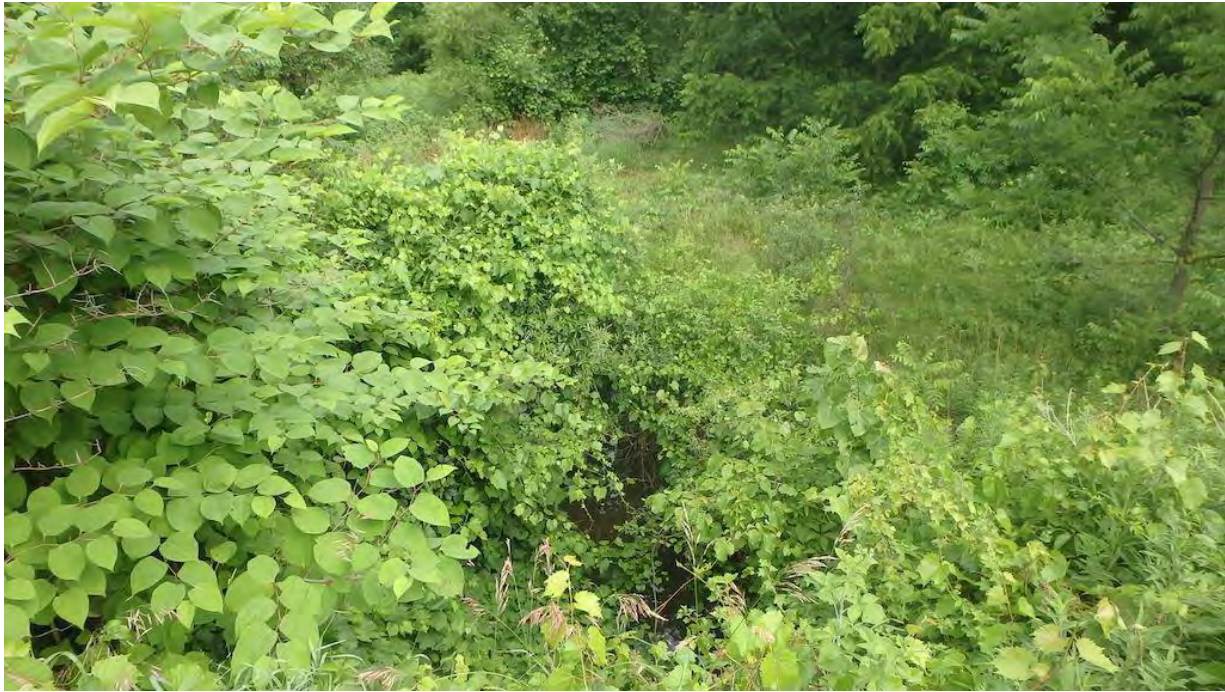
Figure 5 Upstream

Element Group:		1400 Embankments & Streams				Length:		
Element Name:		1401 Streams and Waterways				Width:		
Location:						Height:		
Material:						Count:		1
Element Type:						Total Quantity:		1 Each
Environment:						Limited Inspection:		
Protection System:		Unknown				Perform. Deficiencies		
Condition Data:	Units	Exc.	Good	Fair	Poor			
	Each	0	1	0	0			
Comments:								
Recommended Work:				Rehab <input type="checkbox"/>		Replace <input type="checkbox"/>		
Timing:				Urgent <input type="checkbox"/>		< 1yr <input type="checkbox"/>		
				1 - 5 yr <input type="checkbox"/>		6 - 10 yr <input type="checkbox"/>		
				Maintenance Needs:		<input type="checkbox"/> Urgent <input type="checkbox"/> 1 year <input type="checkbox"/> 2 year

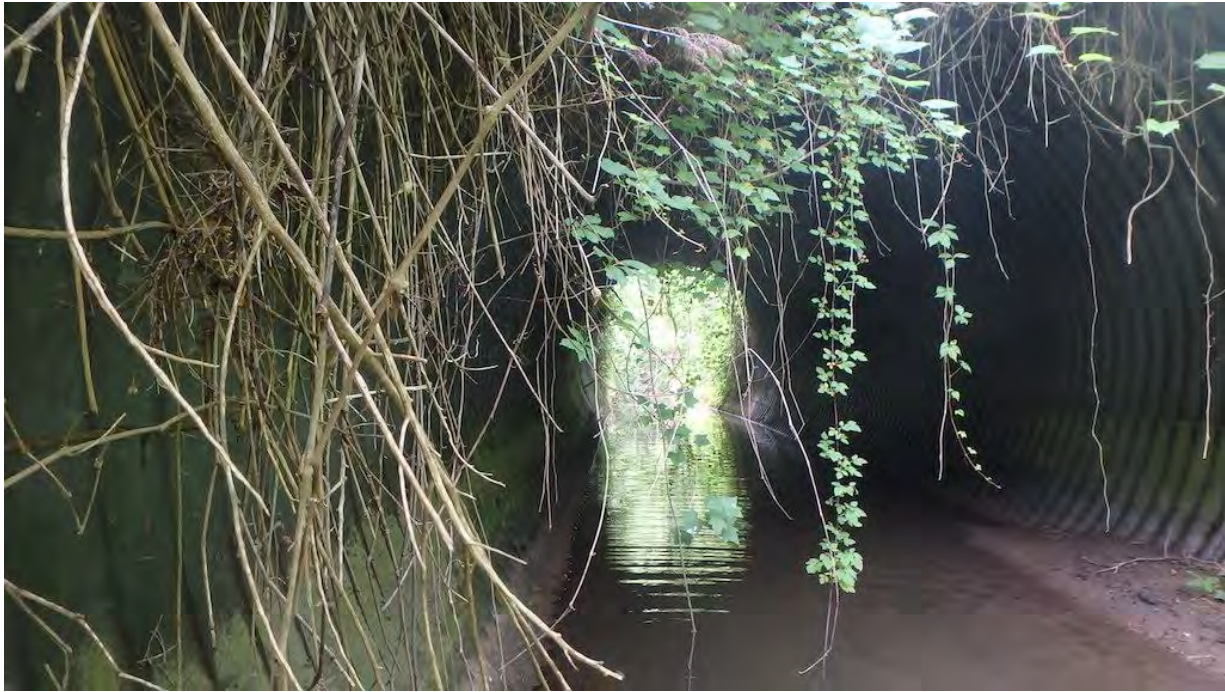
Figure 7 Barrel from North

Element Group:		1200 Culverts				Length:	18
Element Name:		1203 Barrels				Width:	3.8
Location:						Height:	3
Material:		5 Corrugated Steel				Count:	1
Element Type:						Total Quantity:	202.5 sq.m
Environment:		Benign				Limited Inspection:	
Protection System:		Hot dip galvanizing				Perform. Deficiencies	
Condition	Units	Exc.	Good	Fair	Poor		
Data:	sq.m	0	202	0	0		
Comments: Surface corrosion at waterline.							
Recommended Work: Rehab <input type="checkbox"/> Replace <input type="checkbox"/>					Maintenance Needs:		
Timing: Urgent <input type="checkbox"/> < 1yr <input type="checkbox"/> 1 - 5 yr <input type="checkbox"/> 6 - 10 yr <input type="checkbox"/>					<input type="checkbox"/> Urgent <input type="checkbox"/> 1 year <input type="checkbox"/> 2 year

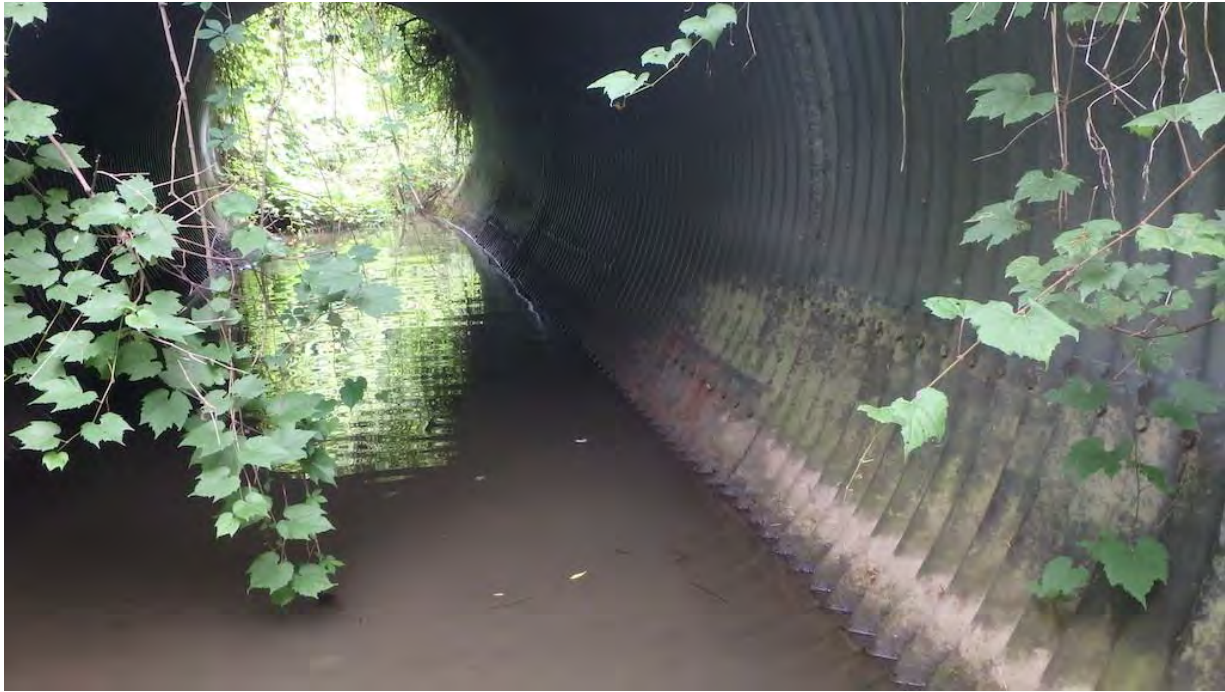
Figure 9 Surface Corrosion in Barrel

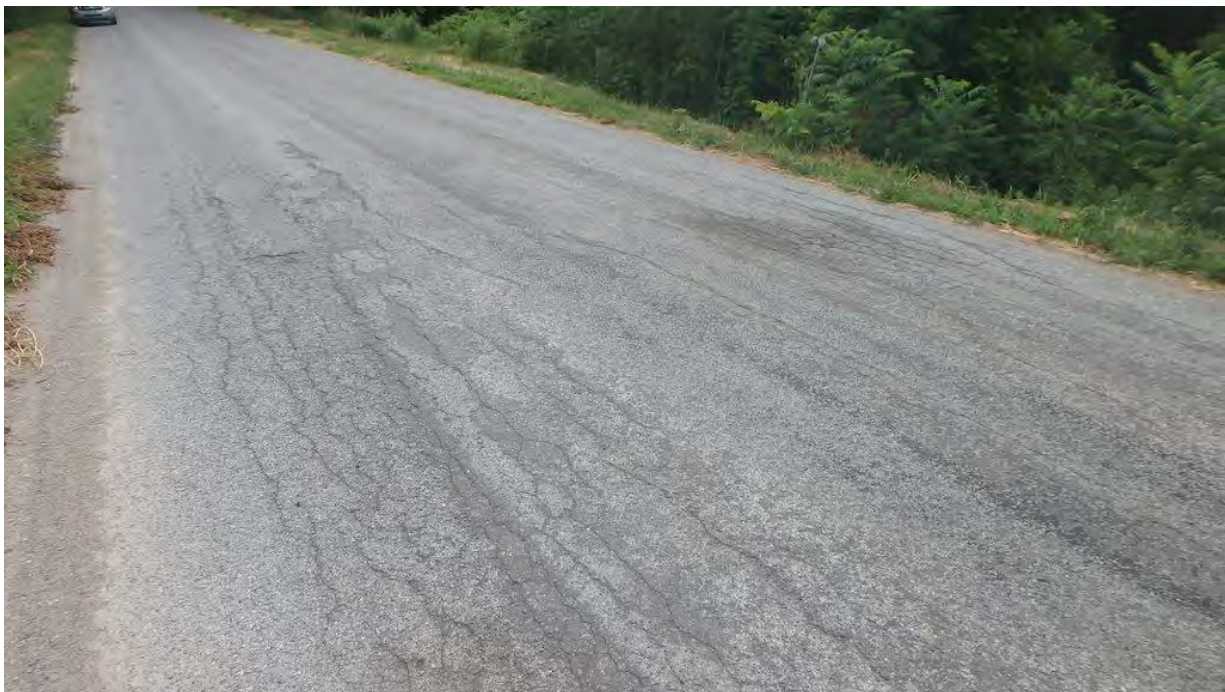
Figure 10 Alligator Cracking and Rutting at Edges of Wearing Surface
